Post Installation Report

Long Stratton Town Council

Manor Road, Long Stratton, NR15 2XR

Inspection Ref: 2083314

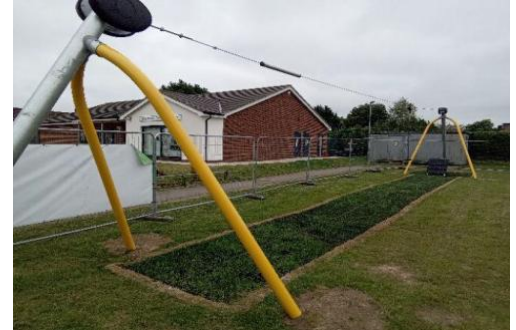
Item: Cable Runway
Manufacturer: Hags
Surface Type: Grass Matrix Tiles
Item Quantity: 1
Equipment Compliance: Yes
Surface Area Compliance: Yes

There are large gaps between the grass mat tiles - Refer to the contractor

The cable is rubbing against the side of the drum - Refer to the contractor

The installation of the cable end does not appear to have been installed in accordance with the manufacturers recommendations - Refer to the contractor

There is no identification label affixed to the equipment - Provide an identification label

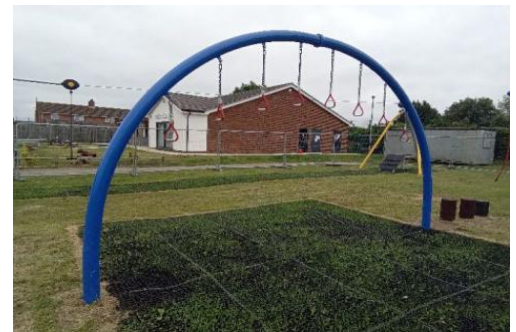
Item: Rope Traverse
Manufacturer: Hags
Surface Type: Grass Matrix Tiles
Item Quantity: 1
Equipment Compliance: Yes
Surface Area Compliance: Yes

There is no identification label affixed to the equipment - Provide an identification label

There are gaps between the grass mat tiles - Refer to the contractor

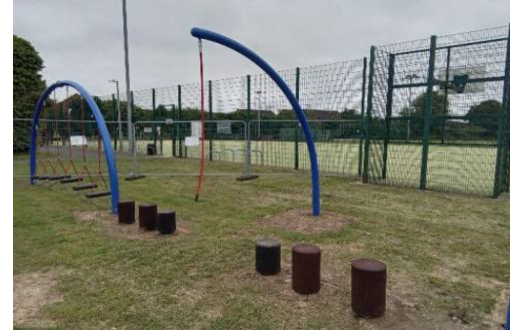
Item: Rope Traverse
Manufacturer: Hags
Surface Type: Grass
Item Quantity: 1
Equipment Compliance: Yes
Surface Area Compliance: No

There is no identification label affixed to the equipment - Provide an identification label

The item of equipment has a fall height exceeding 1.50 metres (1.70m) and grass has been provided as a safety surface, in contravention of the applicable standard - Refer to the designer

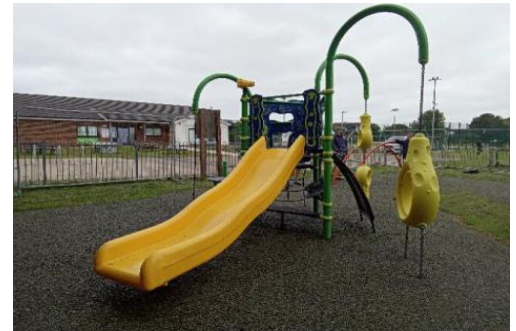
Item:	Multi Play (Junior)
Manufacturer:	Hags
Surface Type:	Bonded Rubber Mulch
Item Quantity:	1
Equipment Compliance:	No
Surface Area Compliance:	Yes
Total Findings:	2

The item has been installed marginally too high which has resulted in the platform height being in excess of 600mm (615 mm) and technically, barriers are now required to meet the requirements of BS EN 1176 Part 1. This is however a very low risk technicality and no remedial action is recommended - No action given the risk assessment

There is no identification label affixed to the equipment - Provide an identification label

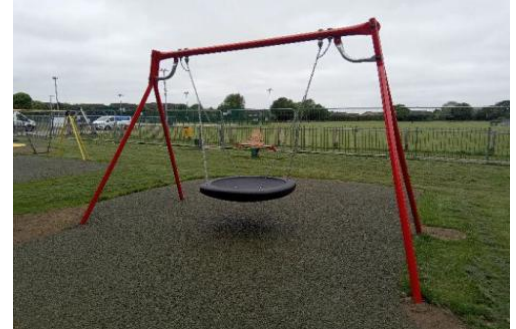
Item: Basket Swing - Type 1
Manufacturer: Hags
Surface Type: Bonded Rubber Mulch
Item Quantity: 1
Equipment Compliance: Yes
Surface Area Compliance: Yes

There are trip hazards at the edges of the surface - Refer to the contractor

There is no identification label affixed to the equipment - Provide an identification label

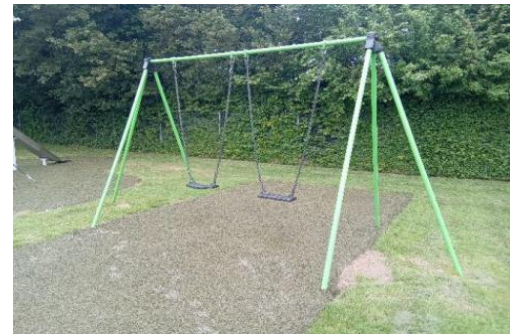
Item: 1 Bay 2 Seat (Flat)
Manufacturer: Wicksteed Playgrounds
Surface Type: Bonded Rubber Mulch
Item Quantity: 1
Equipment Compliance: N/A
Surface Area Compliance: Yes

There is a steep gradient along the edge of the surface that may cause users to trip or roll ankles - Build up ground levels to remove

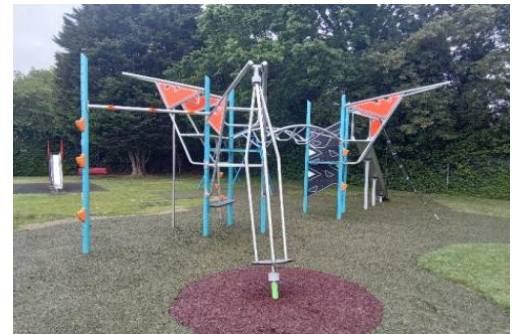
Item: Multi Play (Senior)
Manufacturer: Hags
Surface Type: Bonded Rubber Mulch
Surface Nominal Depth: 70mm
Item Quantity: 1
Equipment Compliance: Yes
Surface Area Compliance: Yes
Total Findings: 2

The surfacing has been damaged during the installation (vandalism) - Refer to the contractor

There is a steep gradient along the edge of the surface that may cause users to trip or roll ankles - Build up ground levels to remove

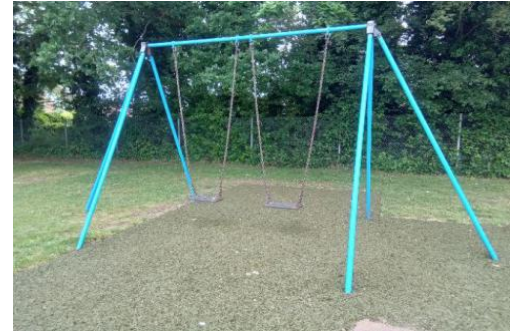
Item: 1 Bay 2 Seat (Flat)
Manufacturer: Wicksteed Playgrounds
Surface Type: Bonded Rubber Mulch
Surface Nominal Depth: 55mm
Item Quantity: 1
Equipment Compliance: N/A
Surface Area Compliance: Yes
Total Findings: 4

There is a steep gradient along the edge of the surface that may cause users to trip or roll ankles - Build up ground levels to remove

The surfacing dimensions are short and do not meet with the requirements of the current applicable standard (3.70m required / 3.60 provided). NOTE - Fall height 1.57m - Refer to the designer / contractor

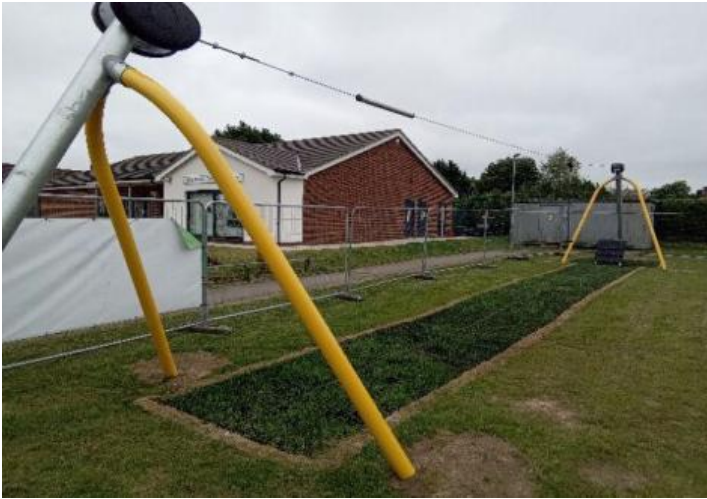
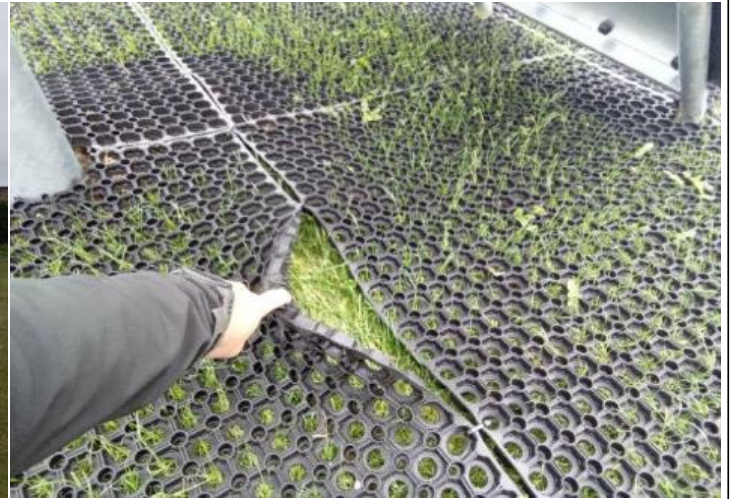
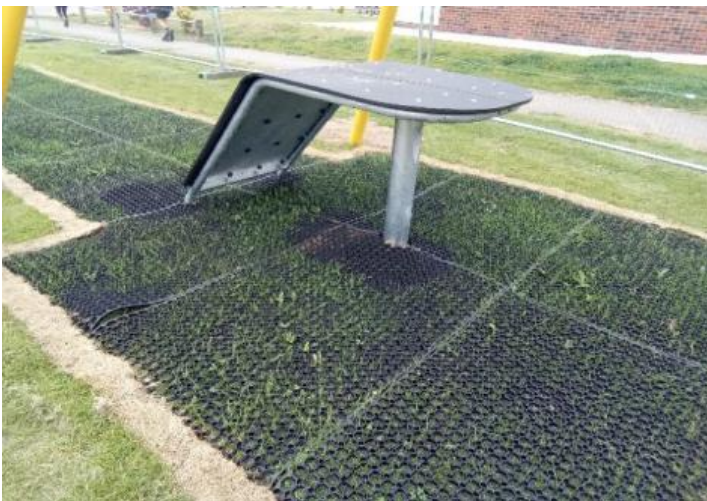
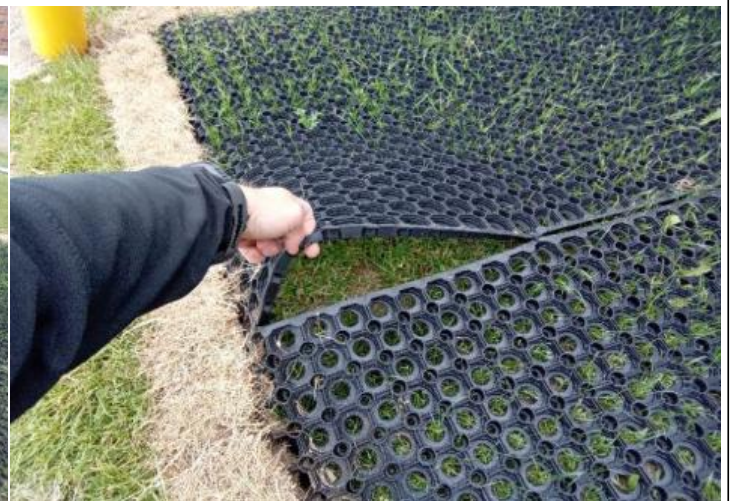
Finding: There are large gaps between the grass mat tiles **Action:** Refer to the contractor

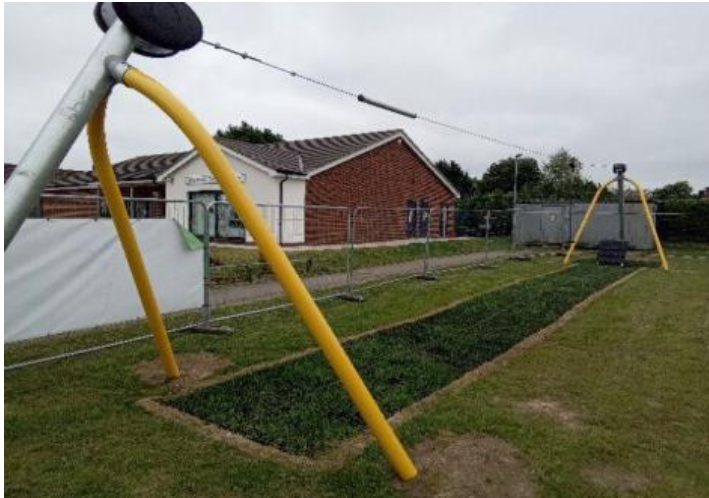
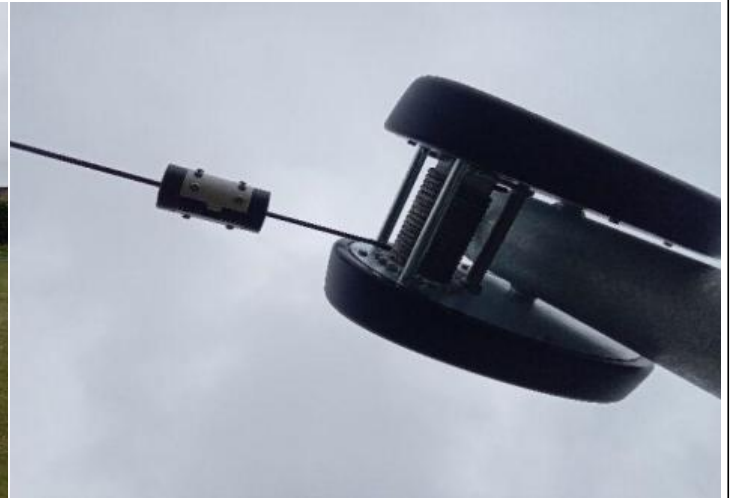
Finding: The cable is rubbing against the side of the drum **Action:** Refer to the contractor

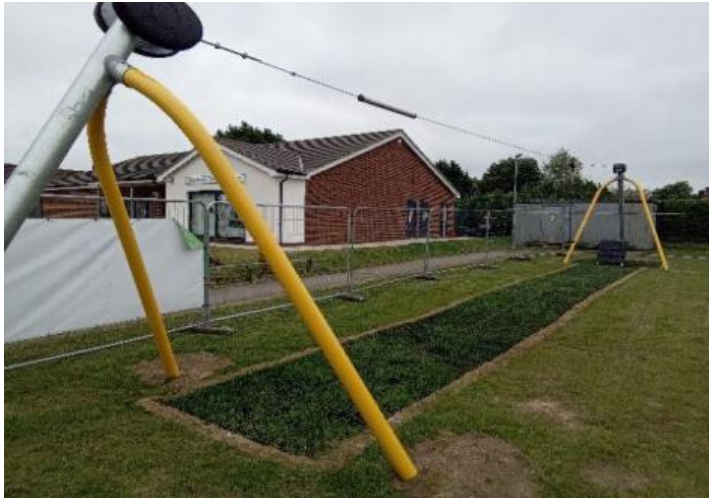
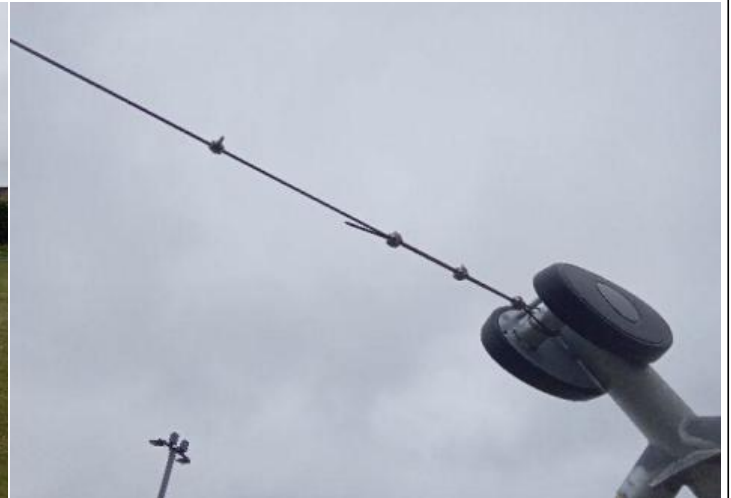
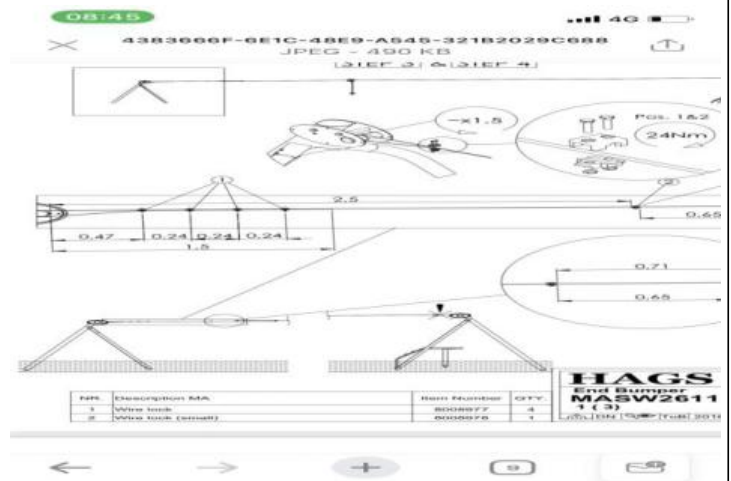
Finding: The installation of the cable end does not appear to have been installed in accordance with the manufacturers recommendations

Action: Refer to the contractor

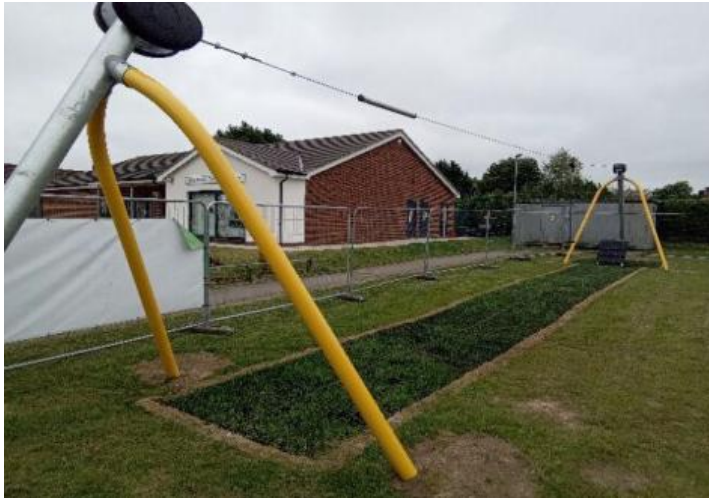
Finding: There is no identification label affixed to the equipment

Action: Provide an identification label

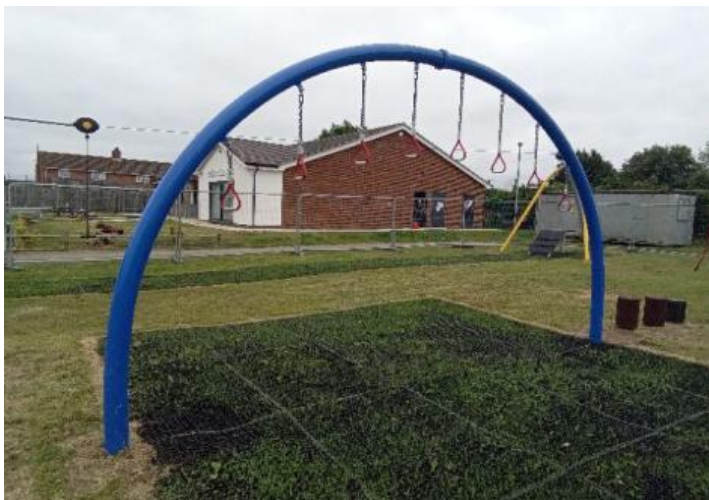
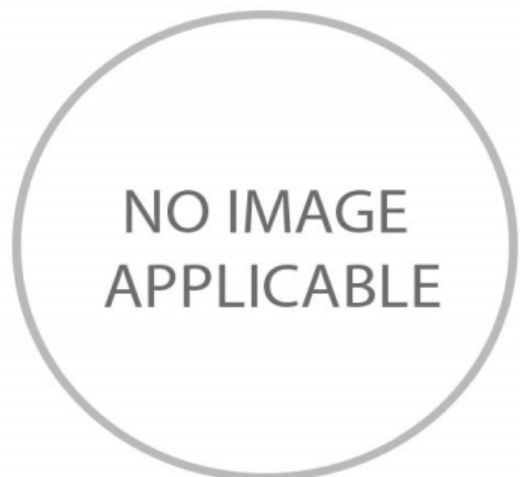
Finding: There is no identification label affixed to the equipment

Action: Provide an identification label

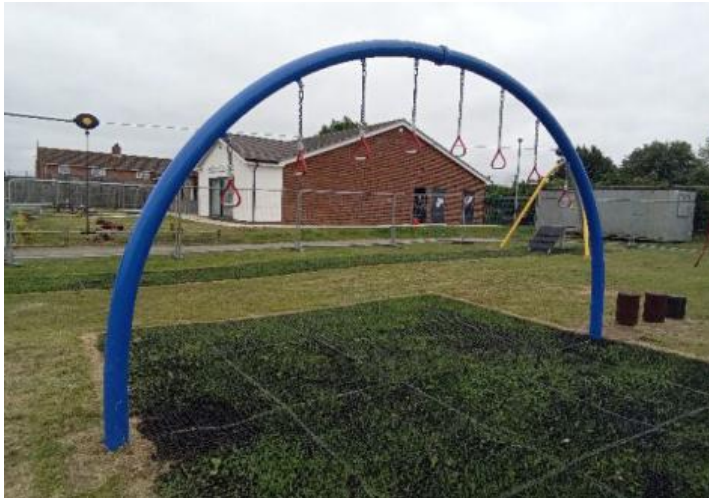
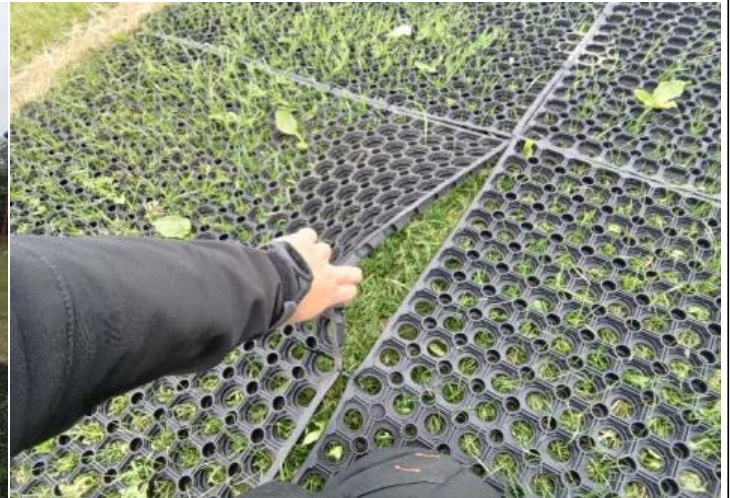
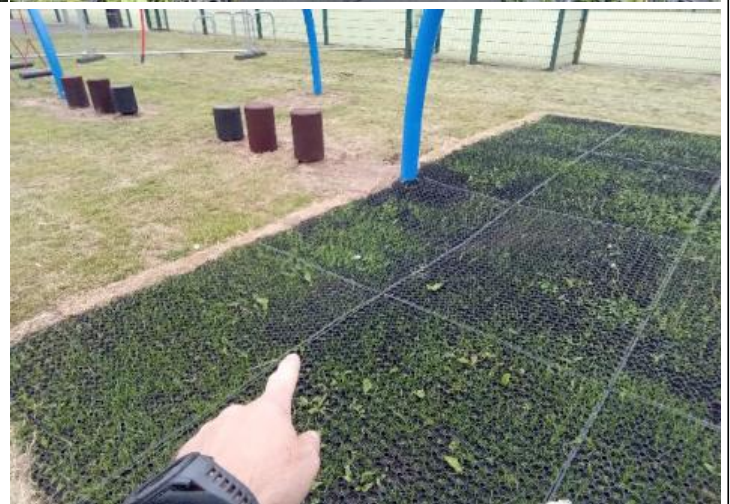
Finding: There are gaps between the grass mat tiles

Action: Refer to the contractor

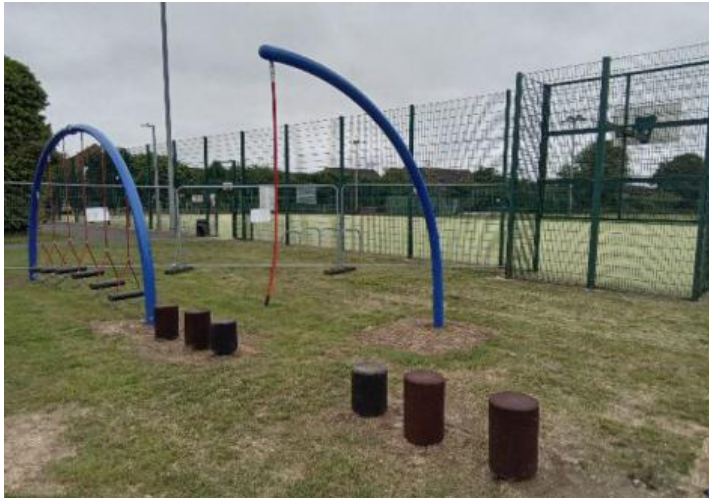
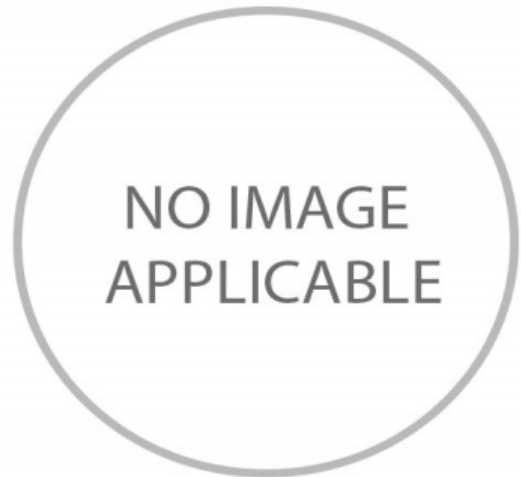
Finding: There is no identification label affixed to the equipment

Action: Provide an identification label

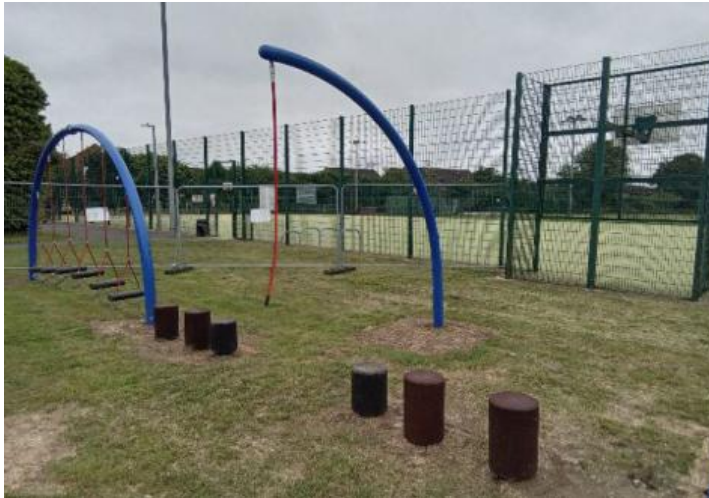
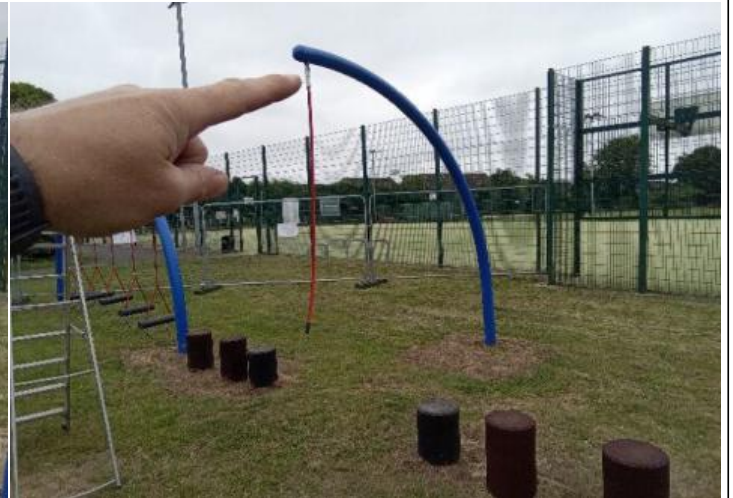
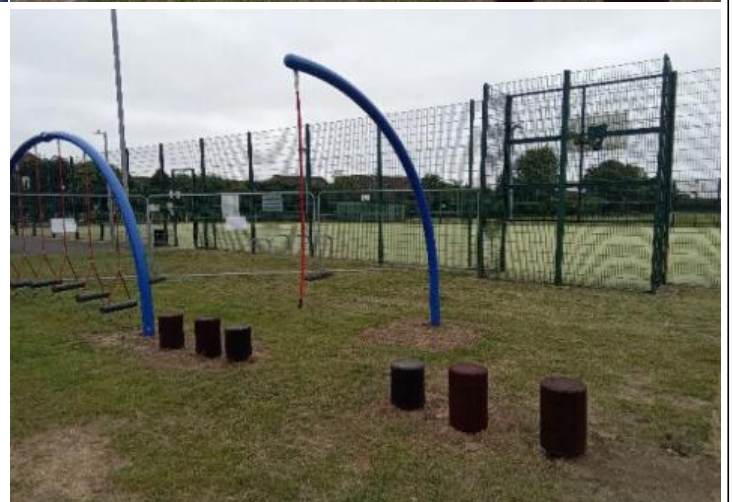
Finding: The item of equipment has a fall height exceeding 1.50 metres (1.70m) and grass has been provided as a safety surface, in contravention of the applicable standard

Action: Refer to the designer

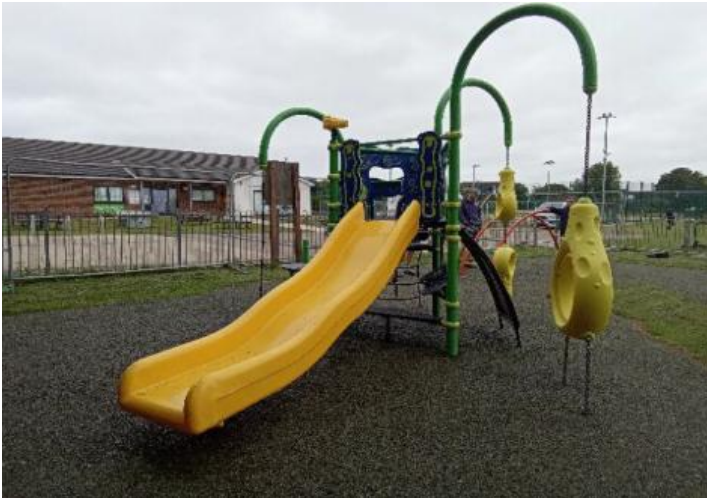
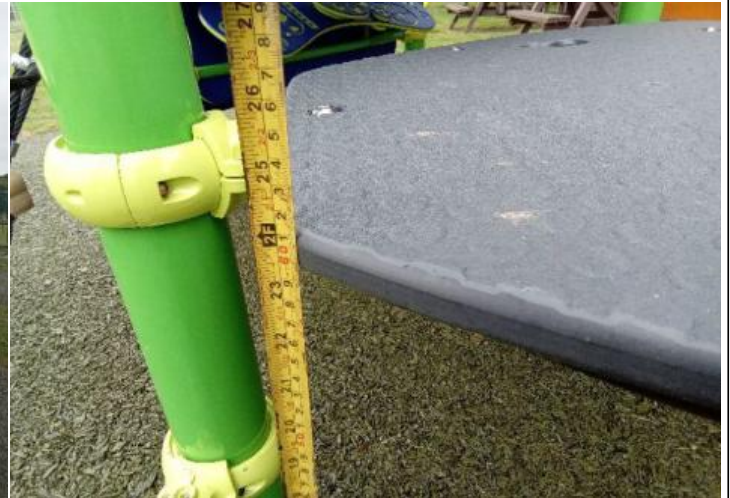
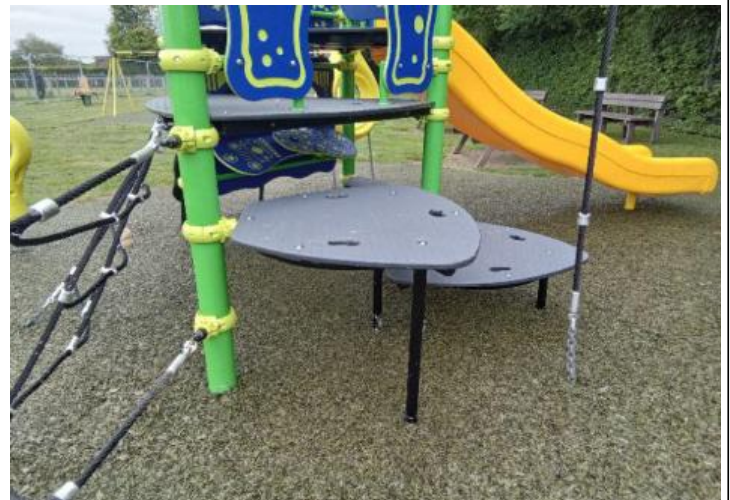
Finding: The item has been installed marginally too high which has resulted in the platform height being in excess of 600mm (615 mm) and technically, barriers are now required to meet the requirements of BS EN 1176 Part 1. This is however a very low risk technicality and no remedial action is recommended

Action: No action given the risk assessment

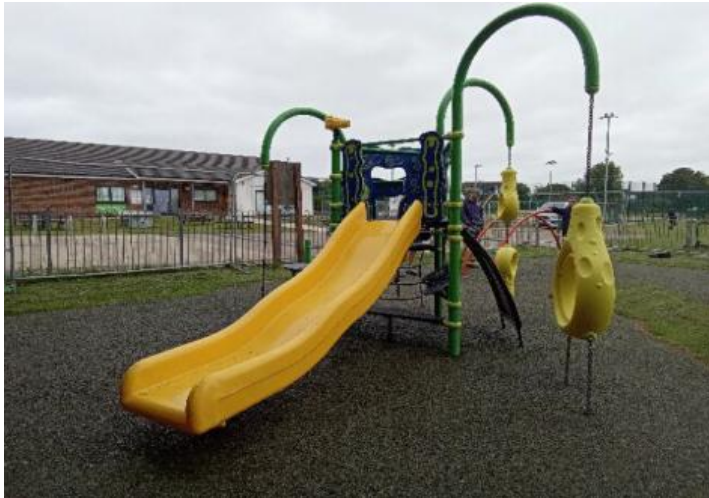
Finding: There is no identification label affixed to the equipment

Action: Provide an identification label

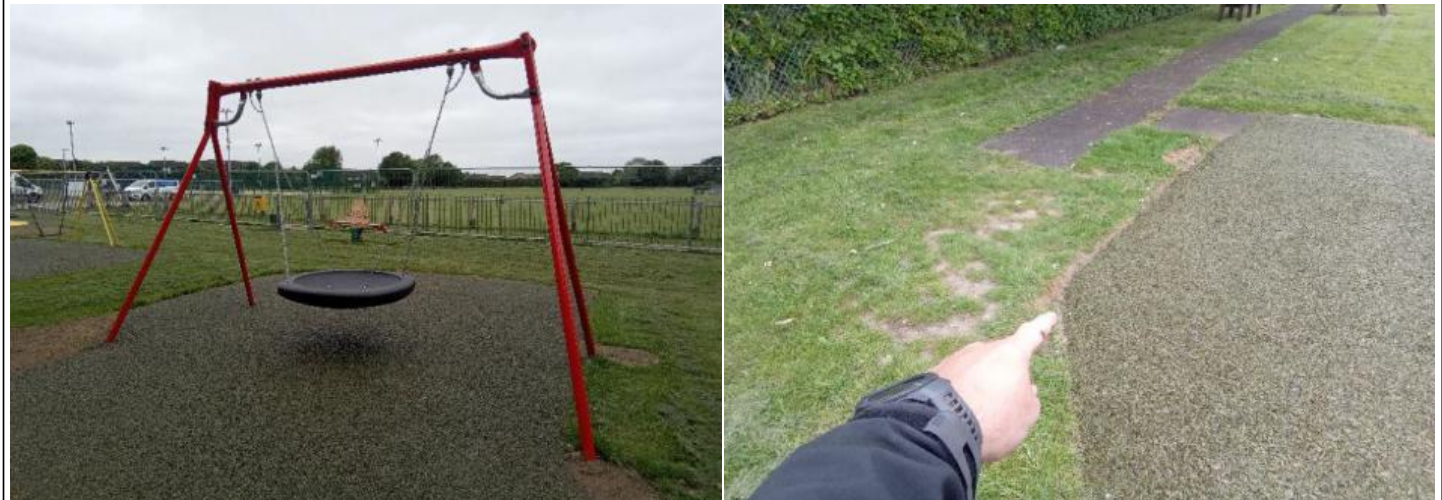
Finding: There are trip hazards at the edges of the surface **Action:** Refer to the contractor

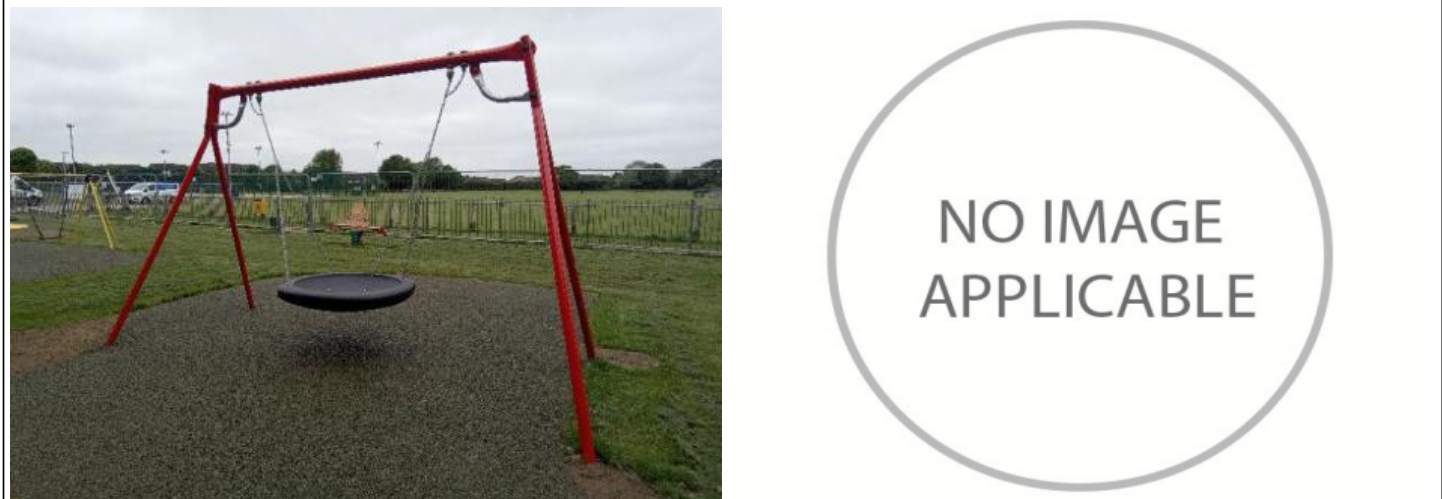
Finding: There is no identification label affixed to the equipment **Action:** Provide an identification label

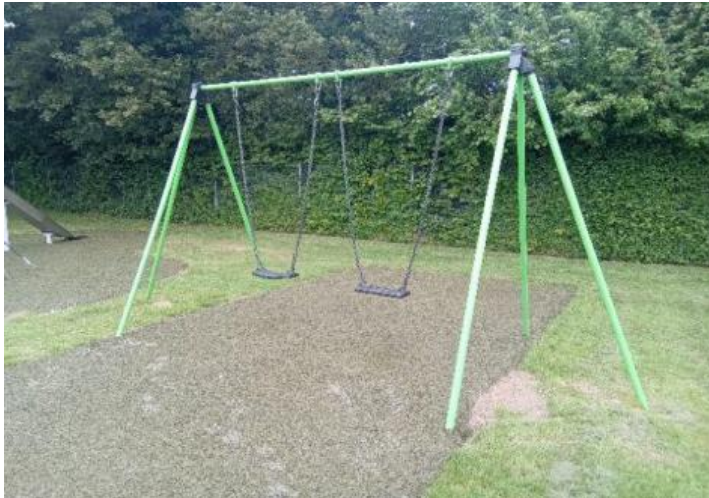
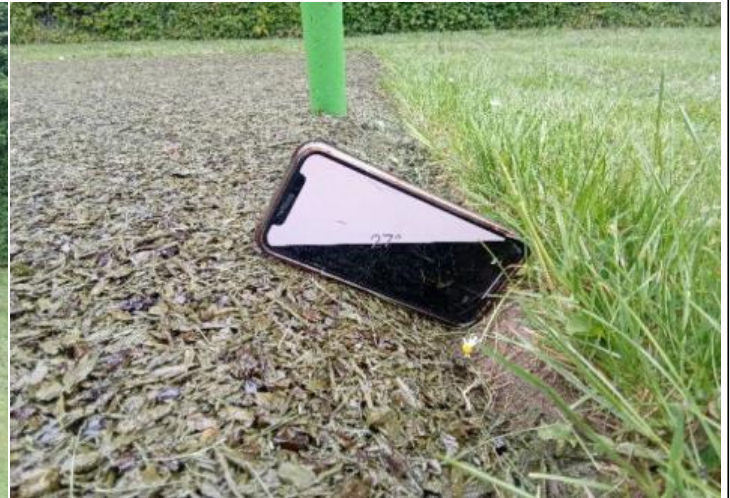
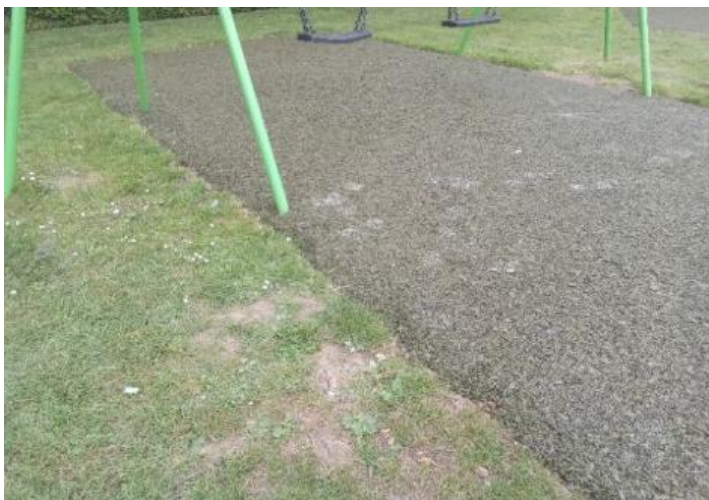
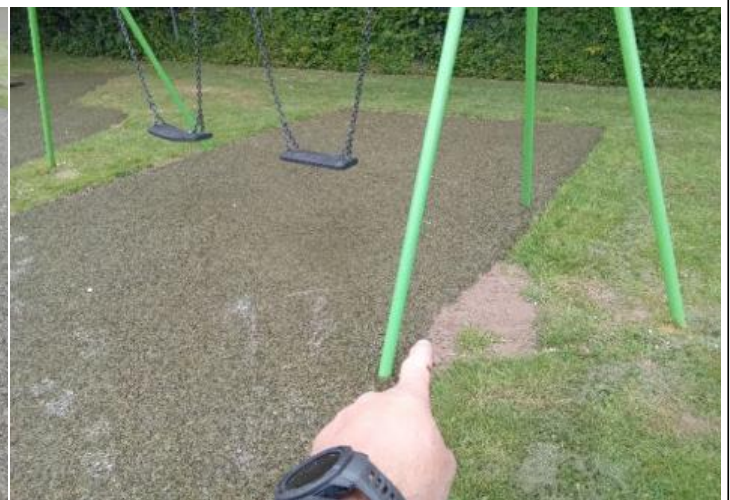
Finding: There is a steep gradient along the edge of the surface that may cause users to trip or roll ankles

Action: Build up ground levels to remove

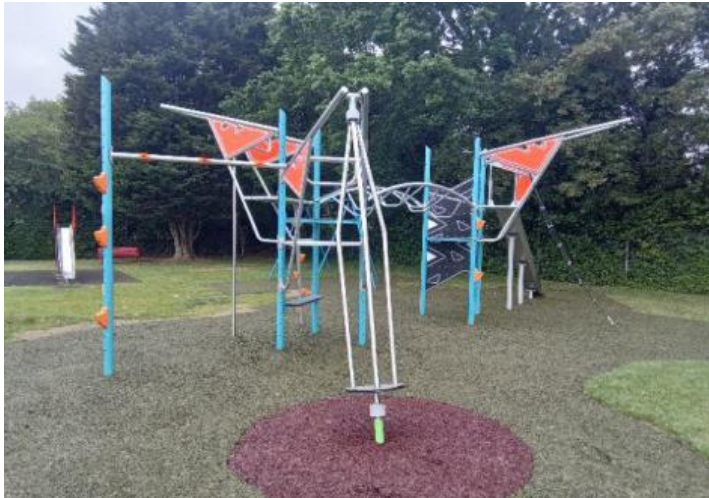
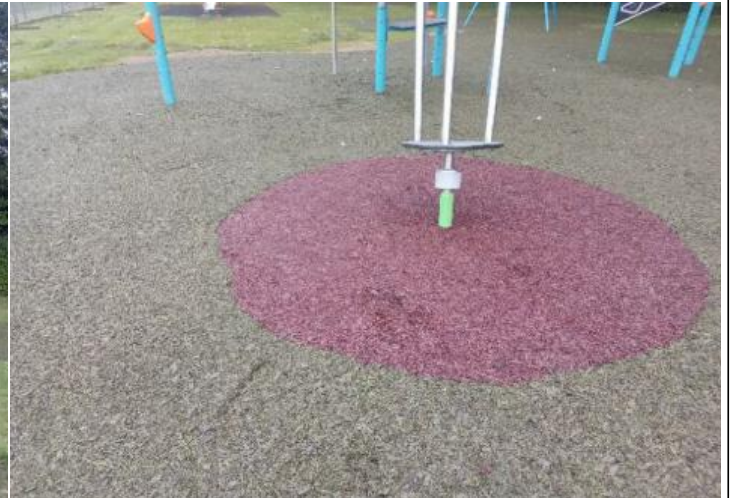
Finding: The surfacing has been damaged during the installation (vandalism)

Action: Refer to the contractor

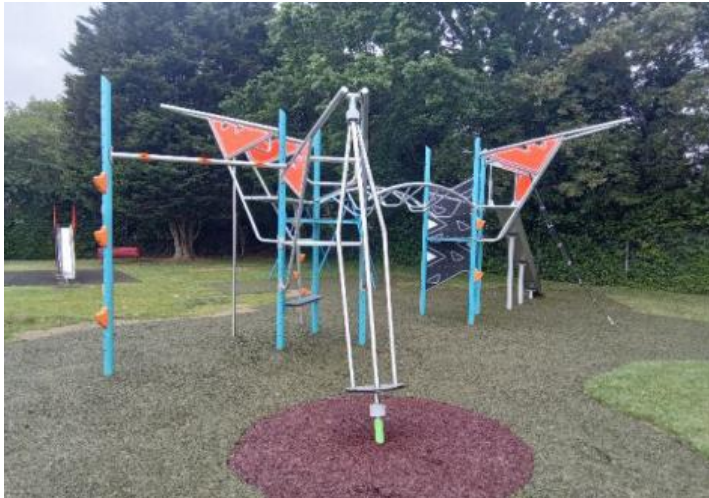
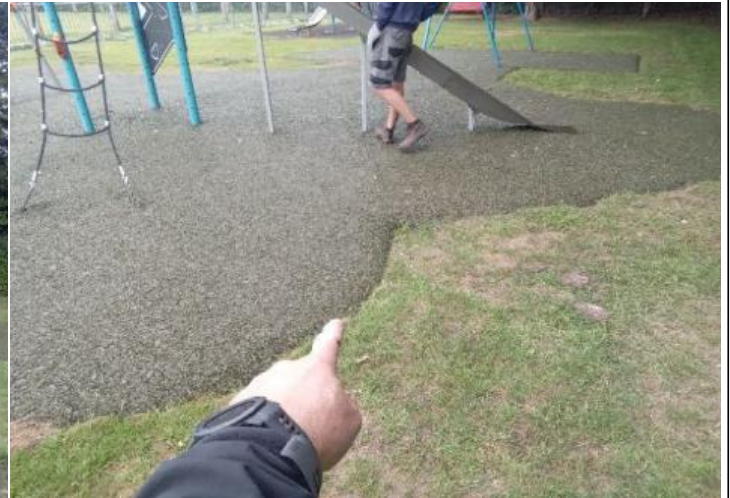
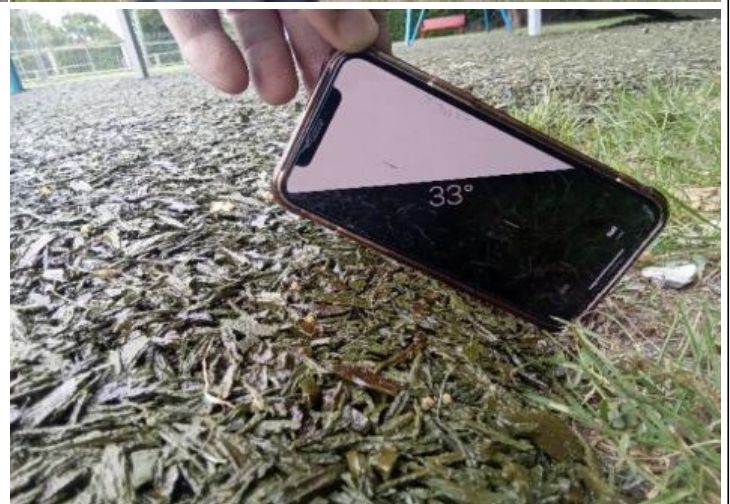
Finding: There is a steep gradient along the edge of the surface that may cause users to trip or roll ankles

Action: Build up ground levels to remove

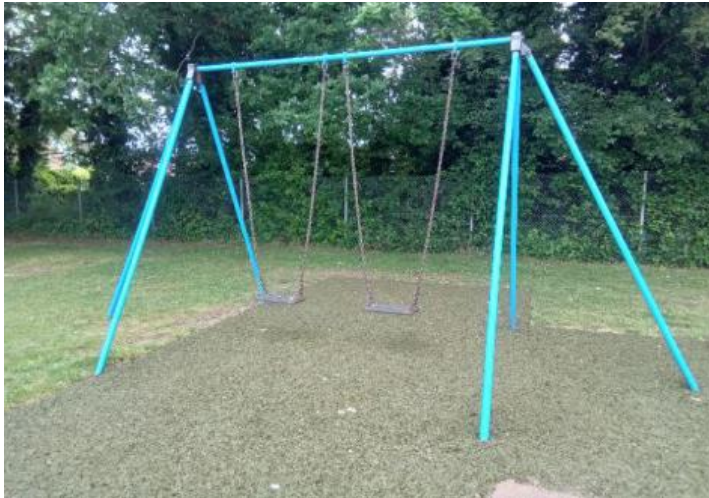
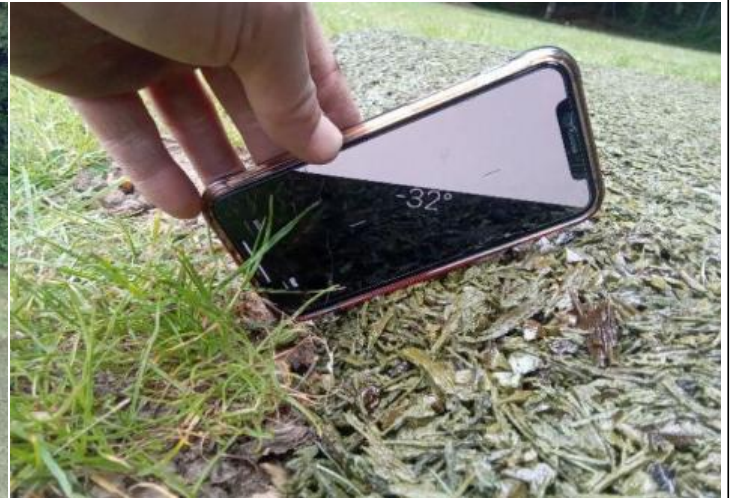
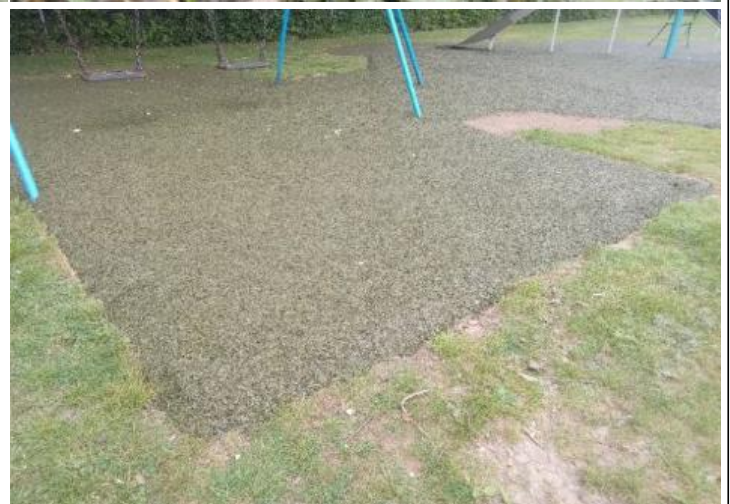
Finding: There is a steep gradient along the edge of the surface that may cause users to trip or roll ankles

Action: Build up ground levels to remove

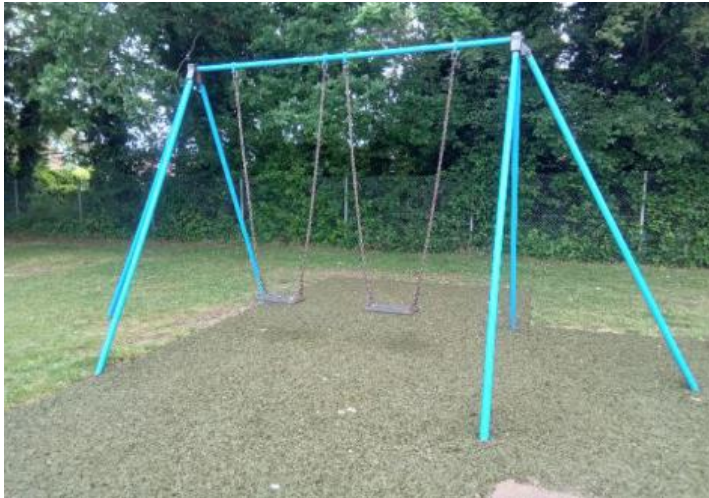
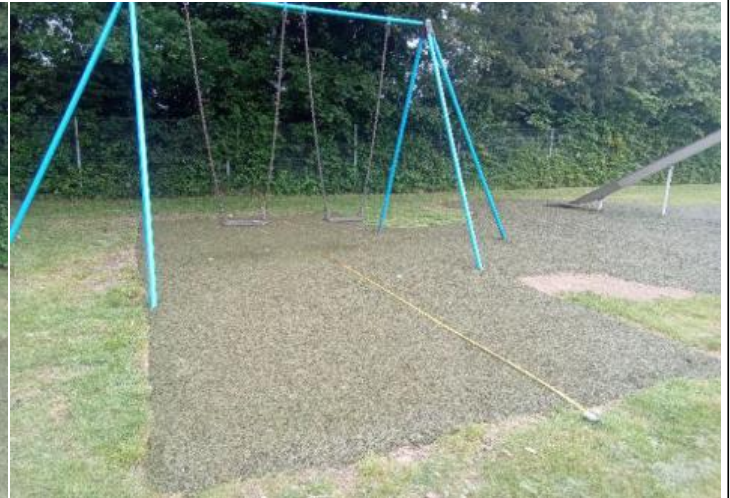
Finding: The surfacing dimensions are short and do not meet with the requirements of the current applicable standard (3.70m required / 3.60 provided). NOTE - Fall height 1.57m

Action: Refer to the designer / contractor

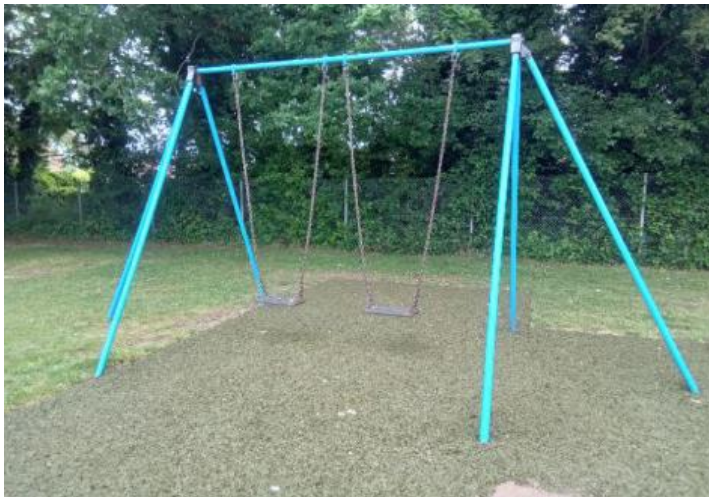
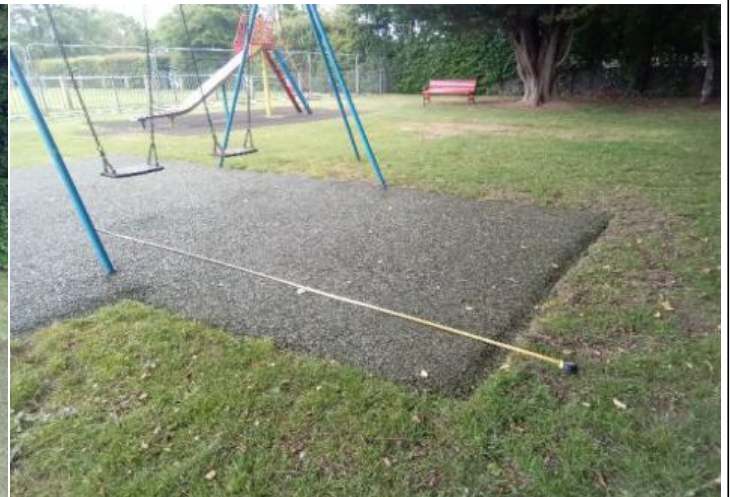
Finding: The surfacing dimensions are short and do not meet with the requirements of the current applicable standard (3.70m required / 3.45m provided). NOTE - Fall height 1.57m

Action: Refer to the designer / contractor
