# the **play inspection** company

## Annual Inspection

Long Stratton Town Council

Manor Road Playing Fields

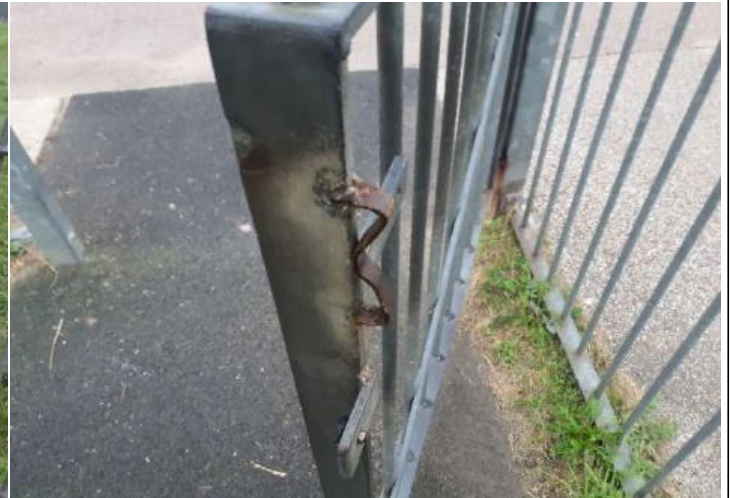
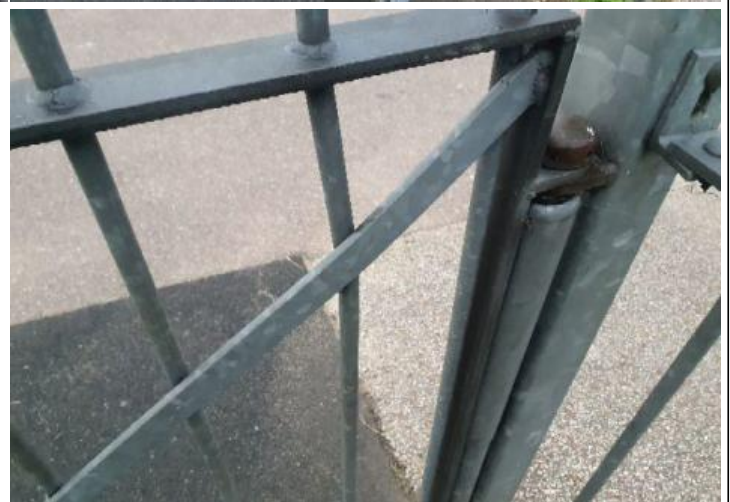
**Finding:** There is some damage to the item

**Action:** Monitor for any further deterioration and repair as required

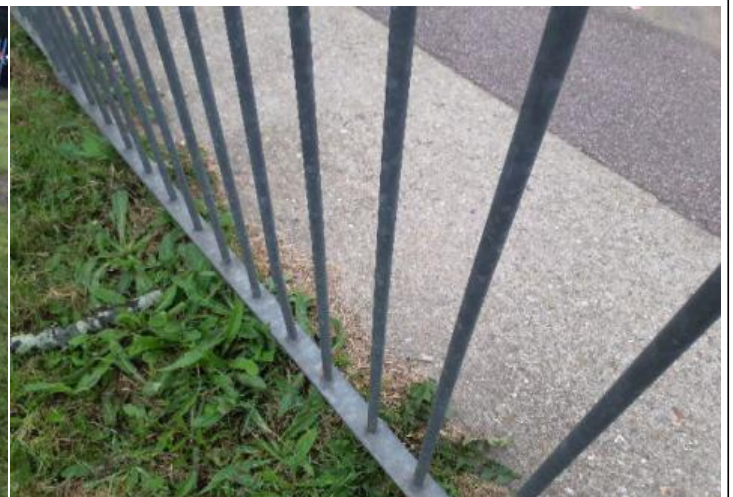
**Finding:** There is some damage to the fence sections

**Action:** Monitor for any further deterioration and repair as required

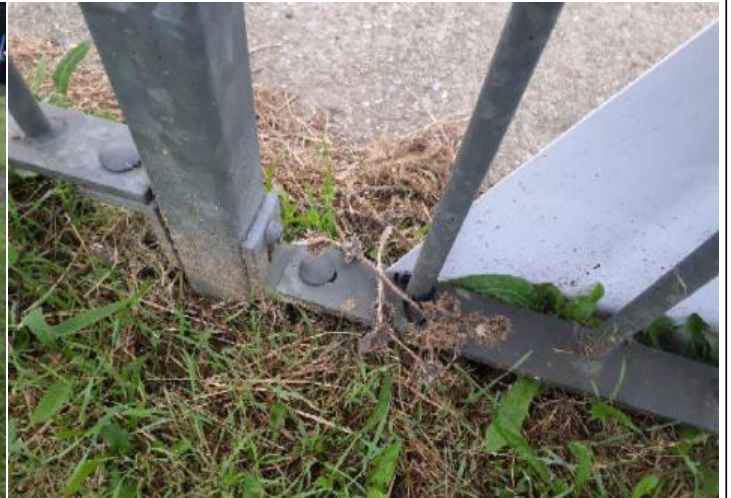
**Finding:** A number of fixing(s) have worked loose

**Action:** Secure all loose fixings

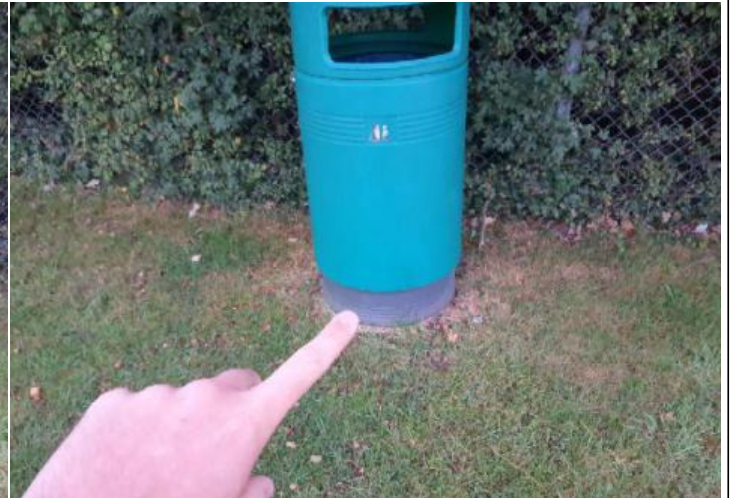
**Finding:** A number of fixing(s) have worked loose

**Action:** Secure all loose fixings

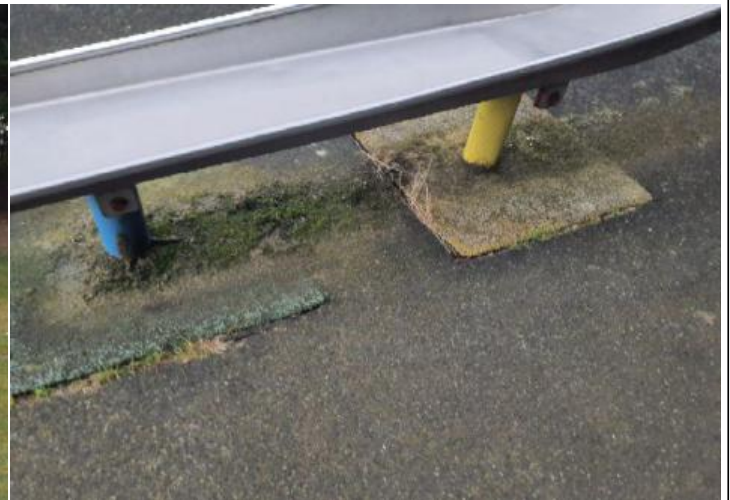
**Finding:** There is algae, silt or moss growth on the surface resulting in slippery conditions  
**Action:** Clean and treat appropriately

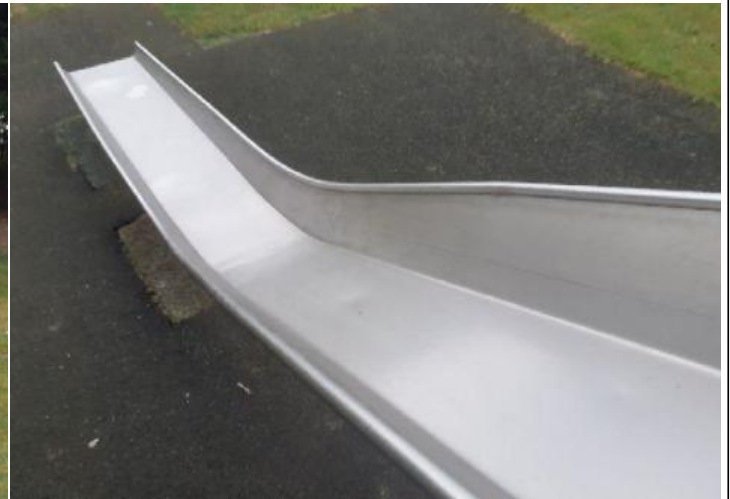
**Finding:** There are a number of dents in the slide surface  
**Action:** Monitor for any further deterioration and repair as required

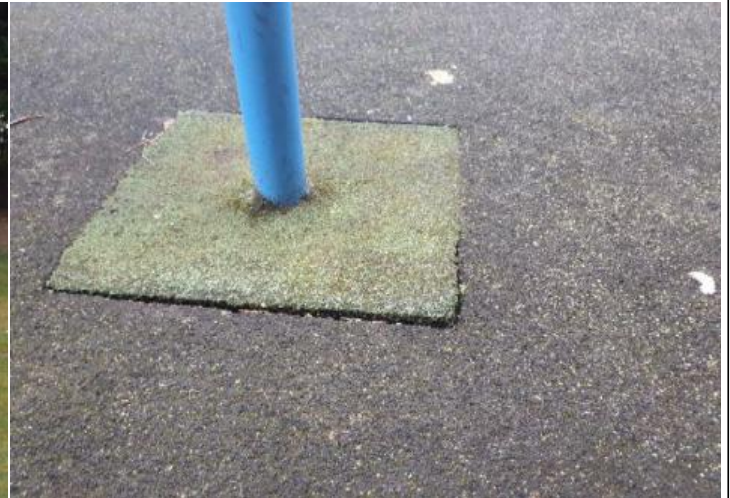
**Finding:** The surface is lifting at the edges and creating trip points  
**Action:** Repair perimeter of surfacing to remove trip points

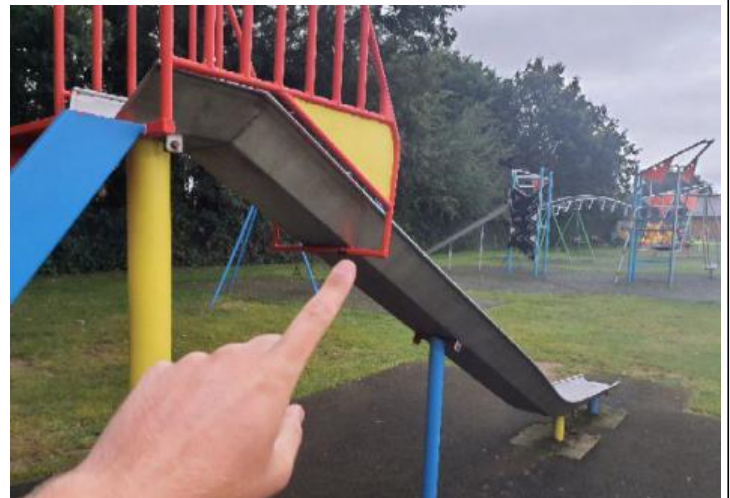
**Finding:** Parts of the steel on this item have corroded excessively and the metal has perforated in places

**Action:** Ensure all affected areas are treated and repaired

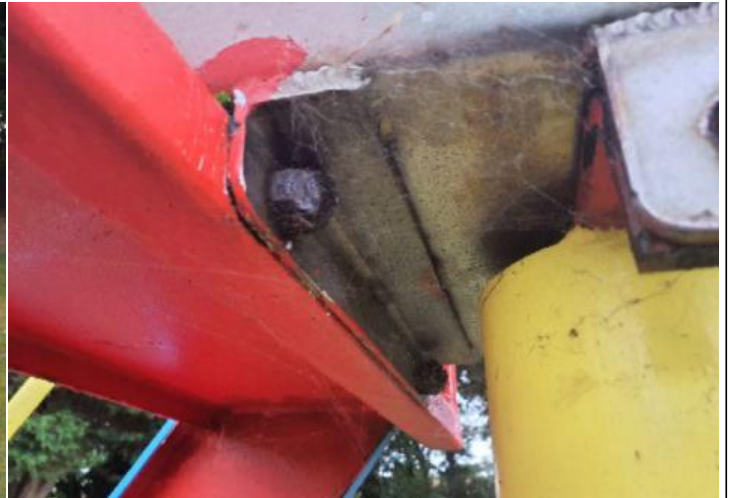
**Finding:** The fixings have corroded excessively

**Action:** Replace all corroded fixings

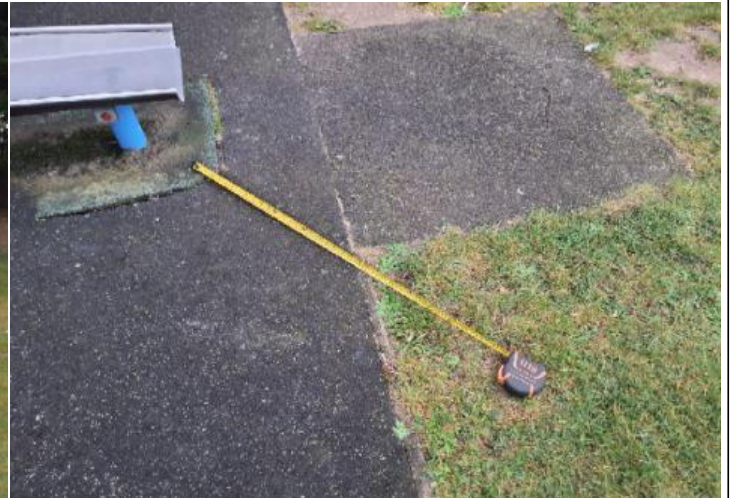
**Finding:** The timber edge forms a hard object within the impact area of the equipment in contravention of the requirements of BS EN 1176 Part 1

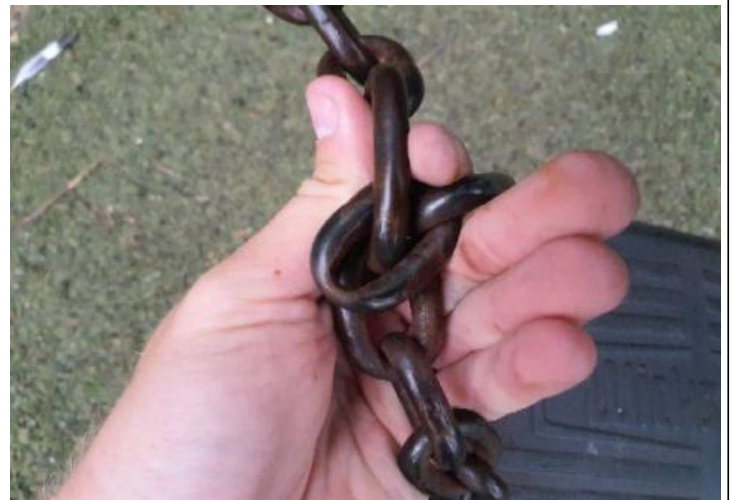
**Finding:** The chain links are worn in excess of 40% and require renewing

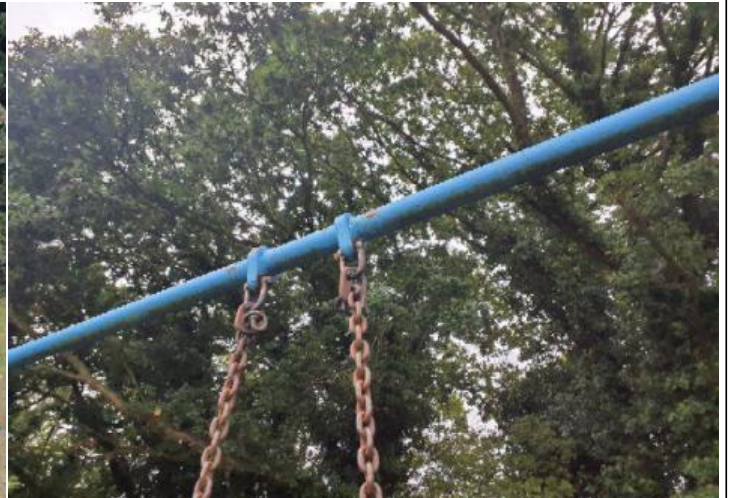
**Finding:** The bushes are worn or missing

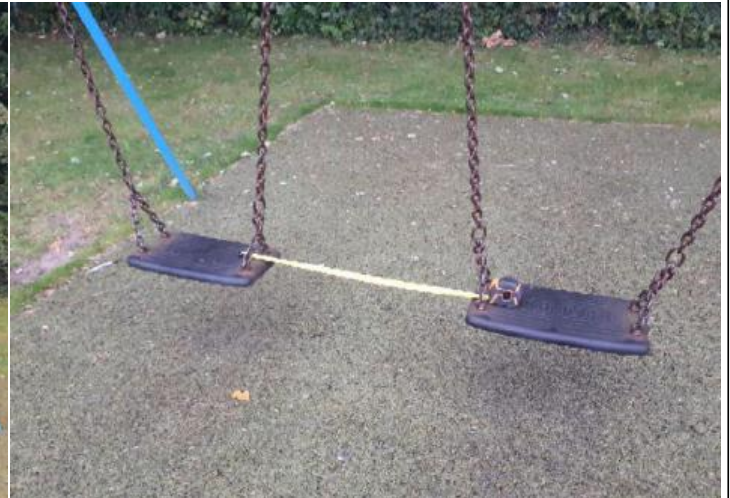
**Finding:** The seats are too close to each other as defined in BS EN 1176 Part 2; this is a low risk failure and no remedial action is required  
**Action:** Monitor - No remedial work recommended

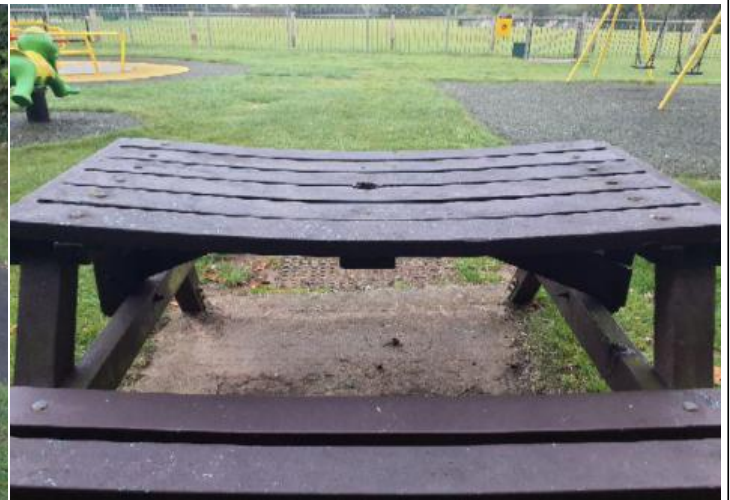
**Finding:** The slats are distorted  
**Action:** Monitor for any further deterioration and replace as required

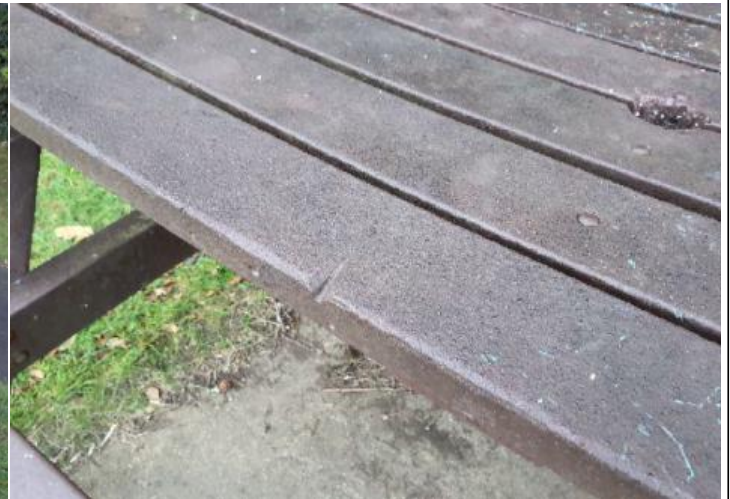
**Finding:** There is some damage to the item  
**Action:** Monitor for any further deterioration and repair as required

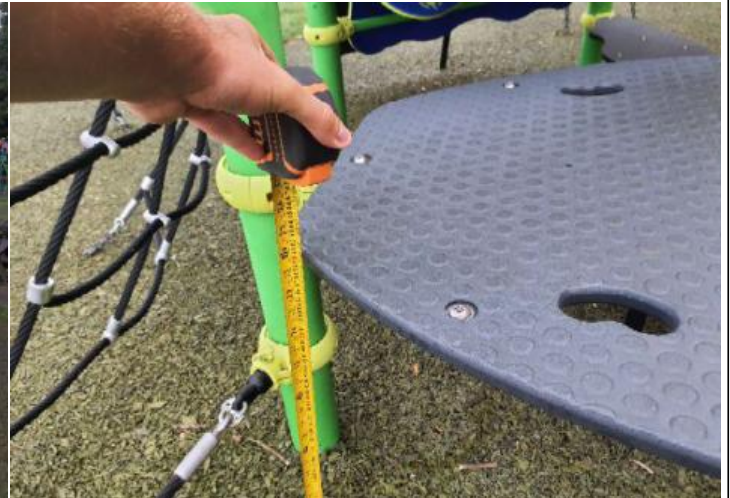
**Finding:** The item has been installed marginally too high which has resulted in the platform height being in excess of 600mm (610 mm) and technically, the height of the barriers are now insufficient to meet the requirements of BS EN 1176 Part 1. This is however a very low risk technicality and no remedial action is recommended as it has not affected the risk assessment of the item

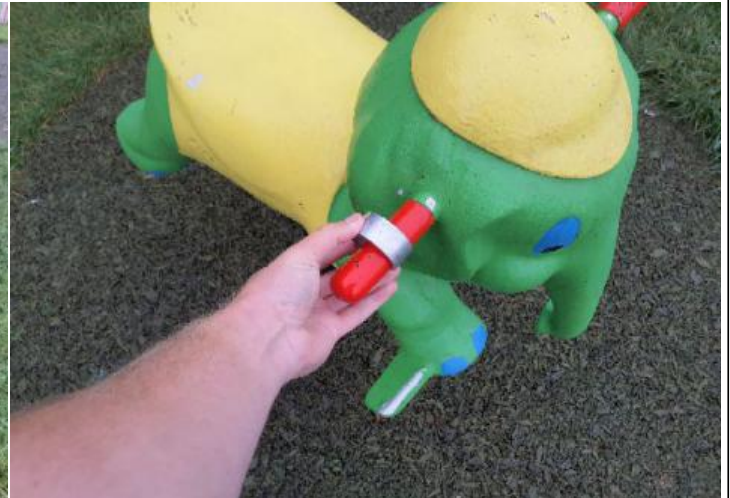
**Finding:** The end of handgrips and/or footrests have a cross section of less than 15cm<sup>2</sup> and fail to meet the requirements of BS EN 1176 Part 6  
**Action:** Monitor - No remedial work recommended

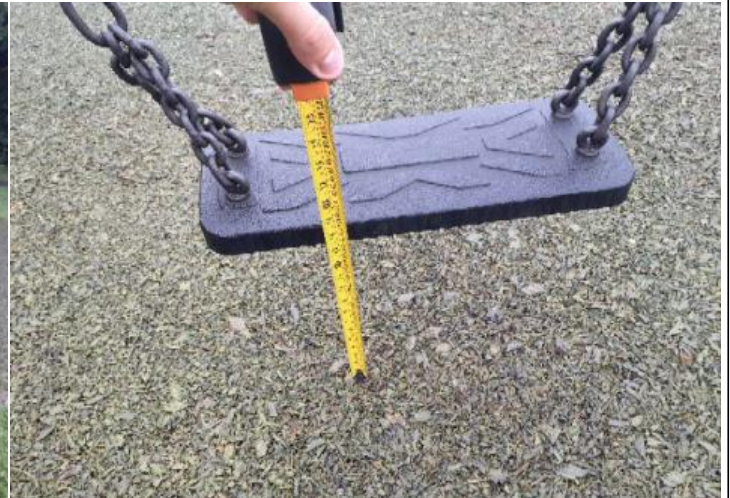
**Finding:** The seat clearance from finished surface level to the underside of the seat is too low and does not meet the requirements of BS EN 1176 Part 2 (350mm minimum clearance required)

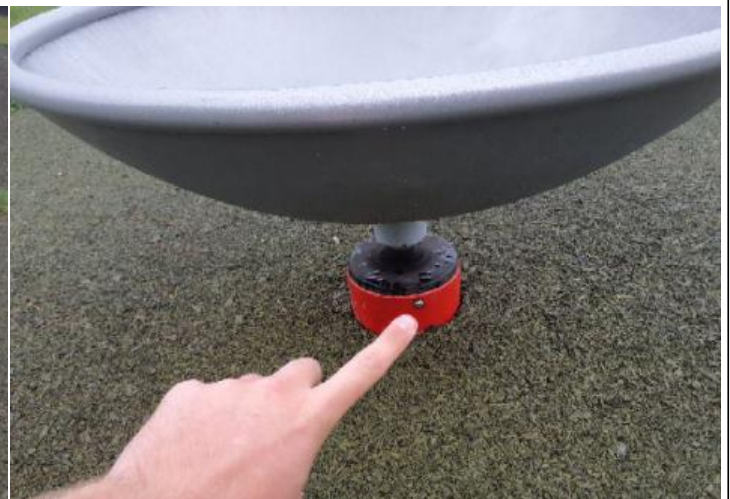
**Finding:** A number of fixing(s) have worked loose

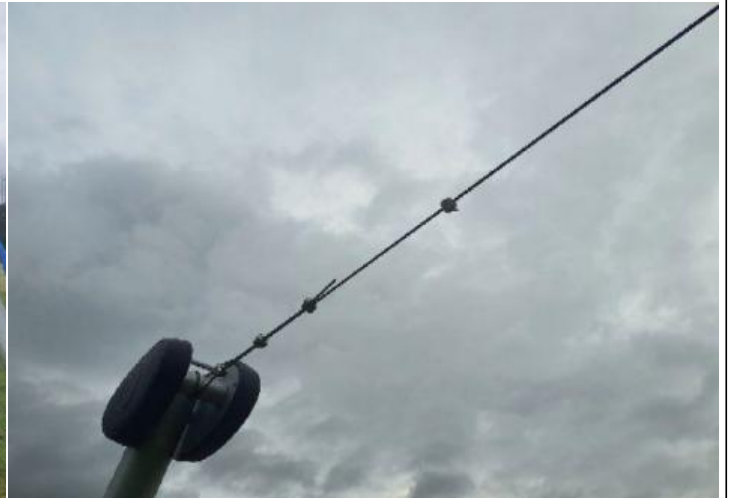
**Finding:** The installation of the cable end does not appear to have been installed in accordance with the manufacturers recommendations

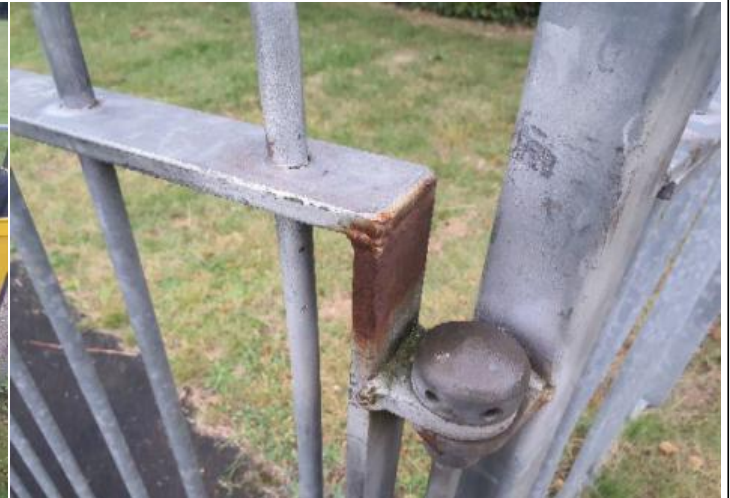
**Finding:** There is surface corrosion / rust present on the item

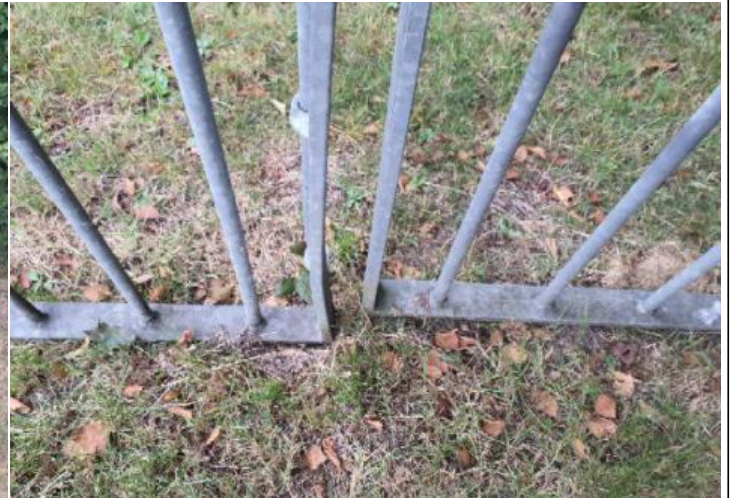
**Finding:** There is some damage to the item

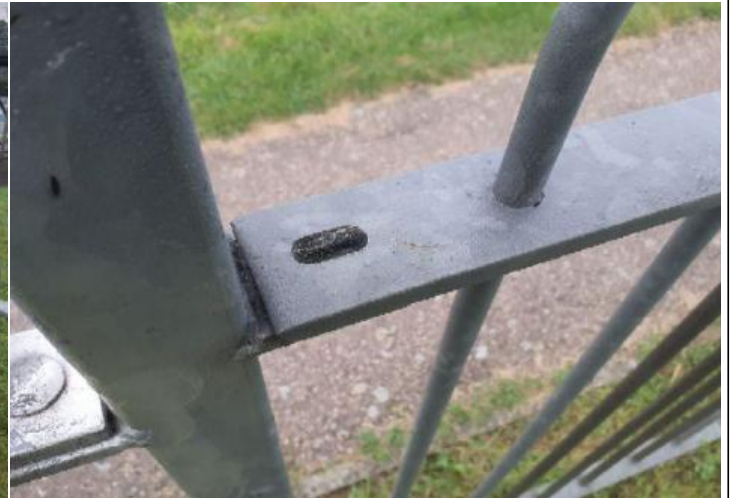
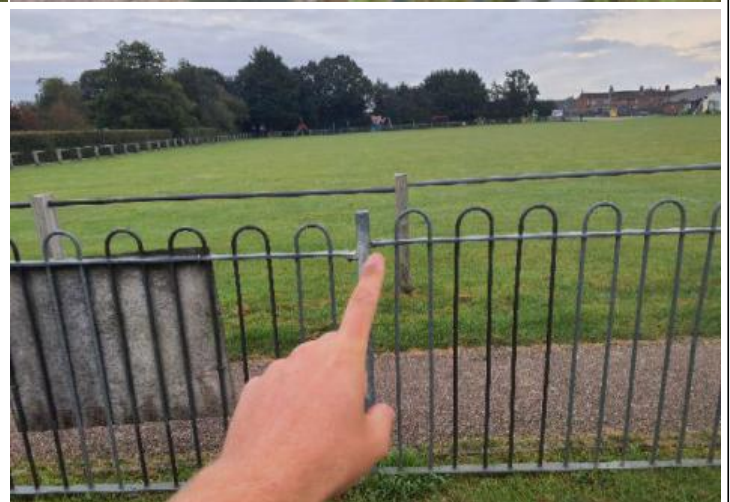
**Finding:** There is or are fixings missing on the item

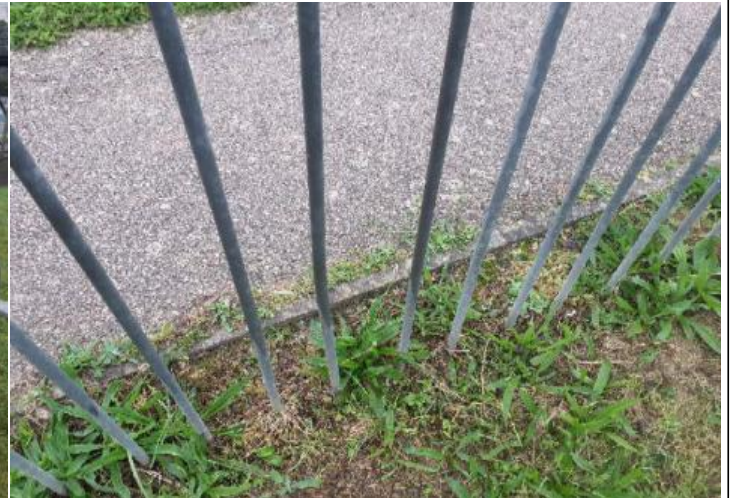
**Finding:** There is some damage to the fence sections  
**Action:** Monitor for any further deterioration and repair as required

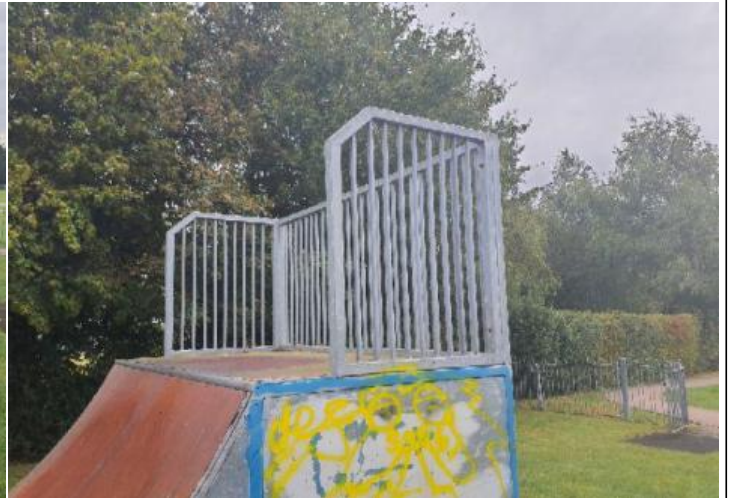
**Finding:** The height of the barrier is less than 1200mm at a distance exceeding 300mm from the front of the barrier and fails the requirements of BS EN 14974

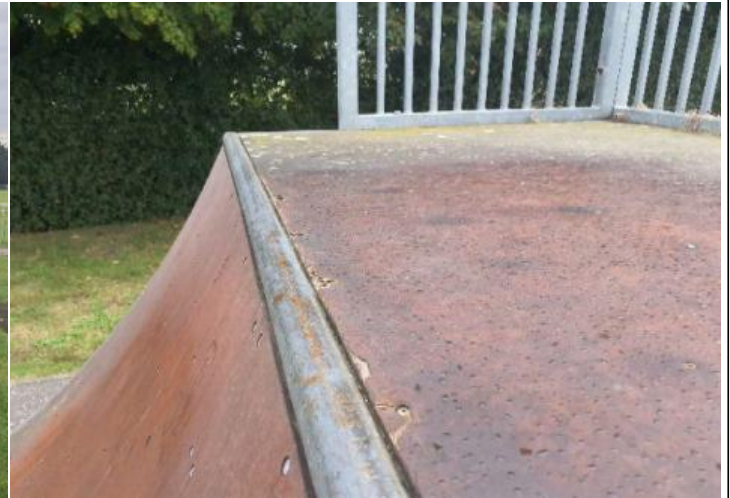
**Finding:** The riding surface of the ramp has some damage apparent

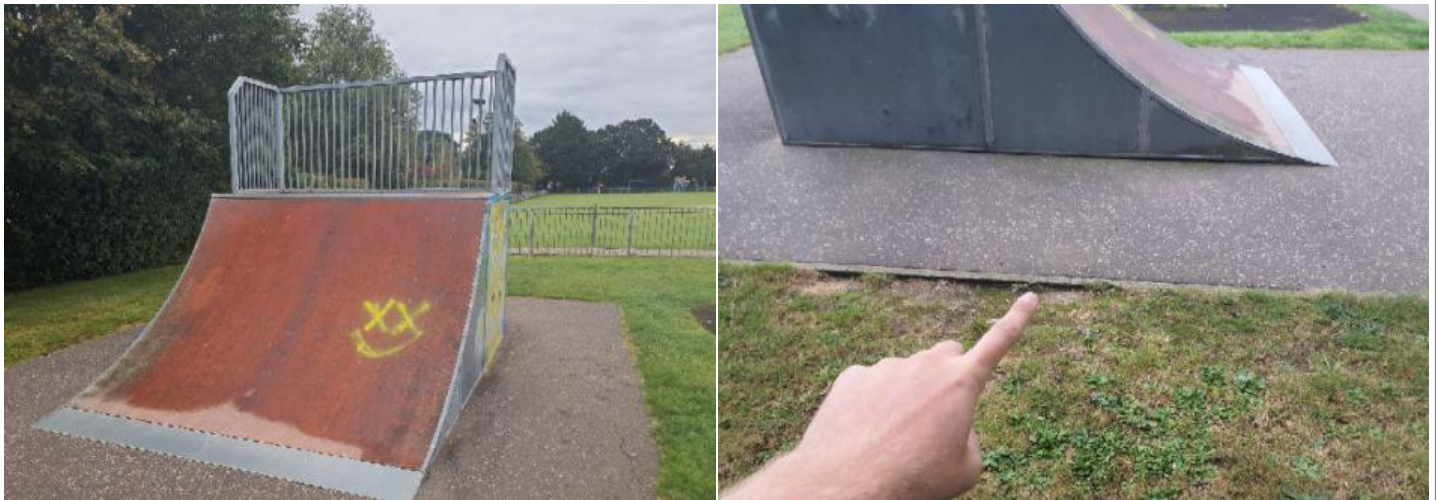
**Finding:** There are trip hazards at the edges of the surface  
**Action:** Reinstate surrounding surface levels to remove the trip points

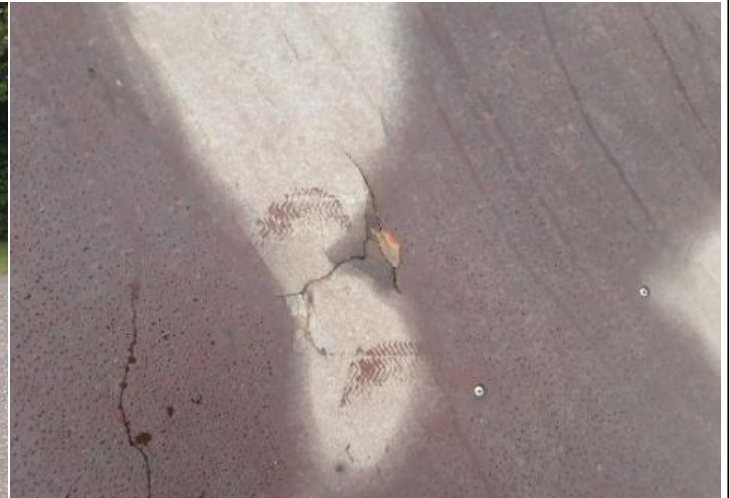
**Finding:** The riding surface of the ramp has some damage apparent

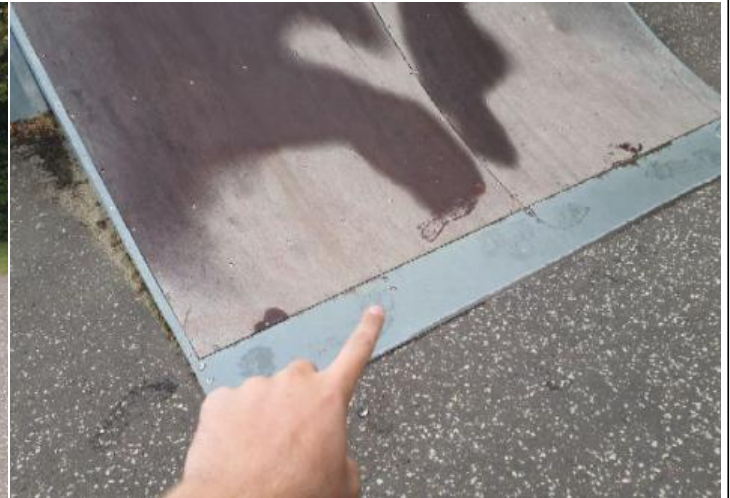
**Finding:** The kicker plate is loose

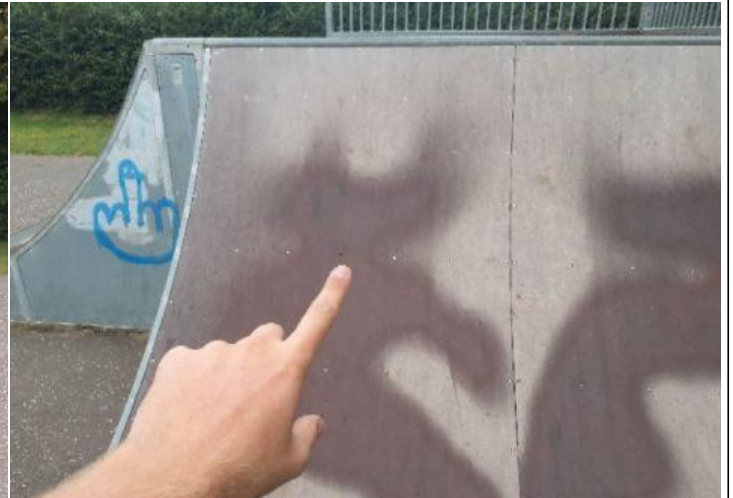
**Finding:** There is or are fixings missing on the item

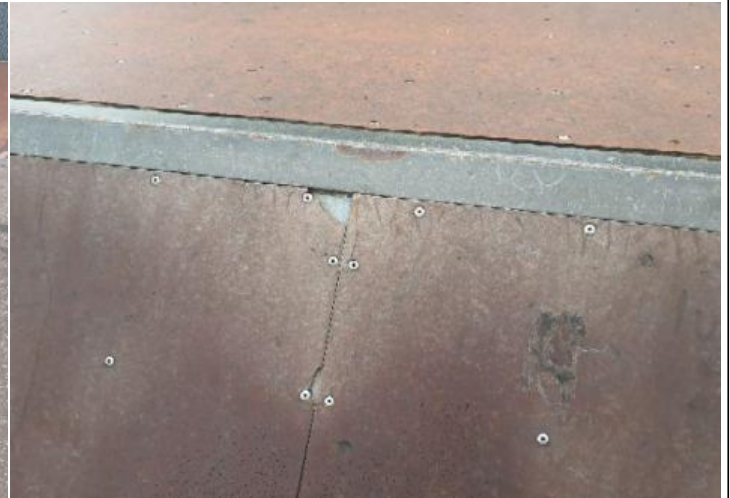
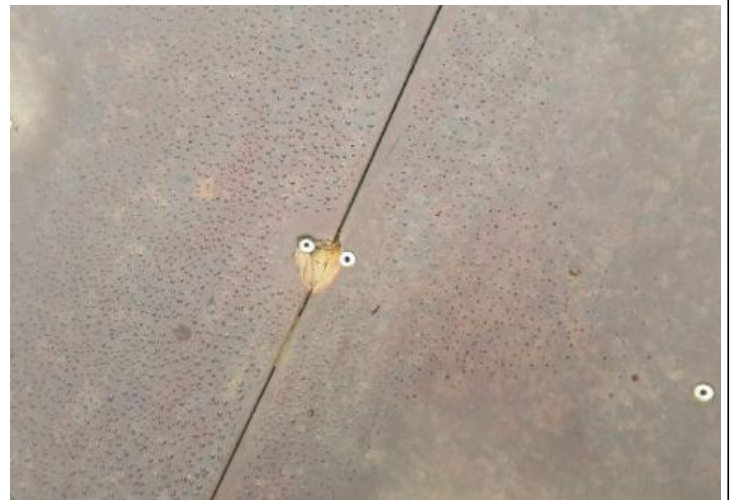
**Finding:** The riding surface of the ramp is damaged

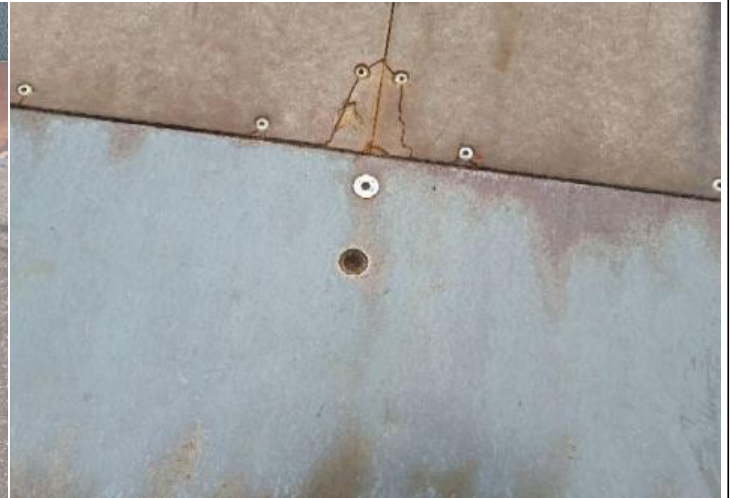
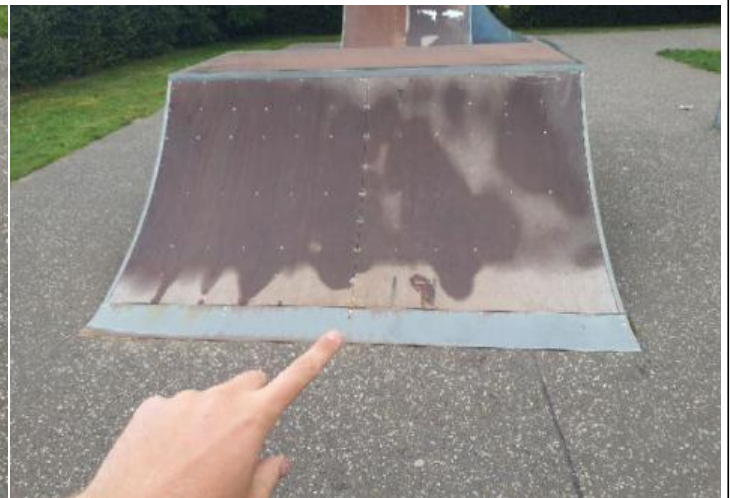
**Finding:** There is or are fixings missing on the item

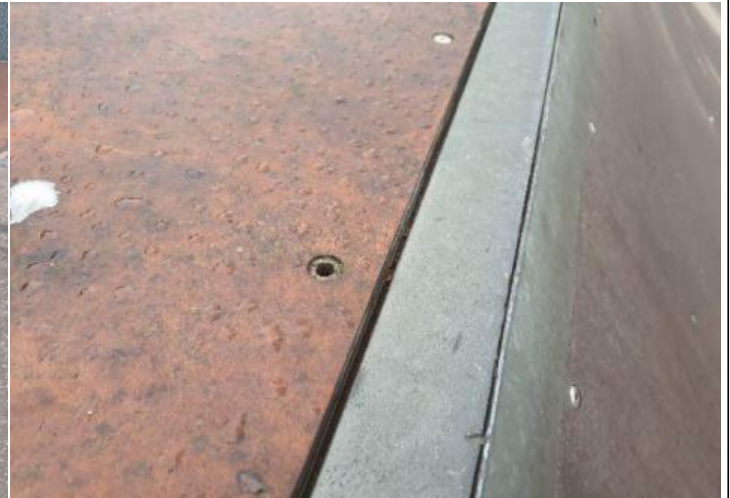
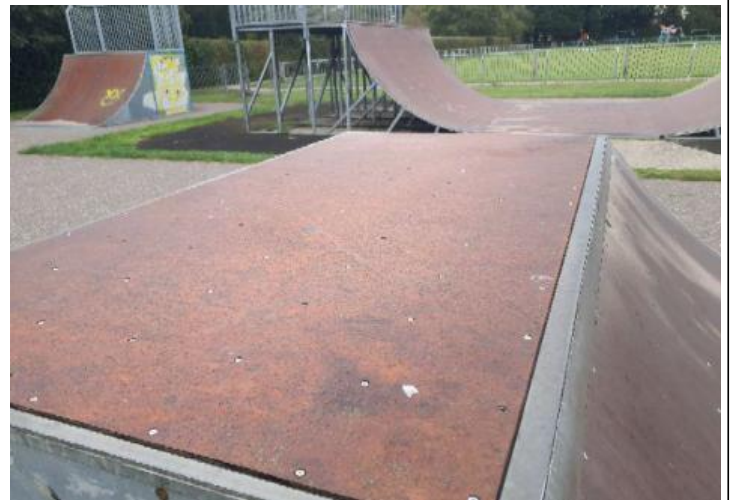
**Finding:** There is or are fixings missing on the item

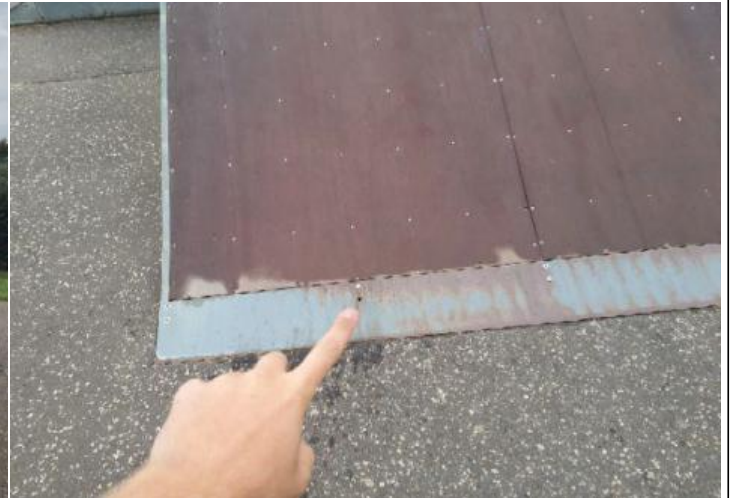
**Finding:** There is or are fixings missing on the item

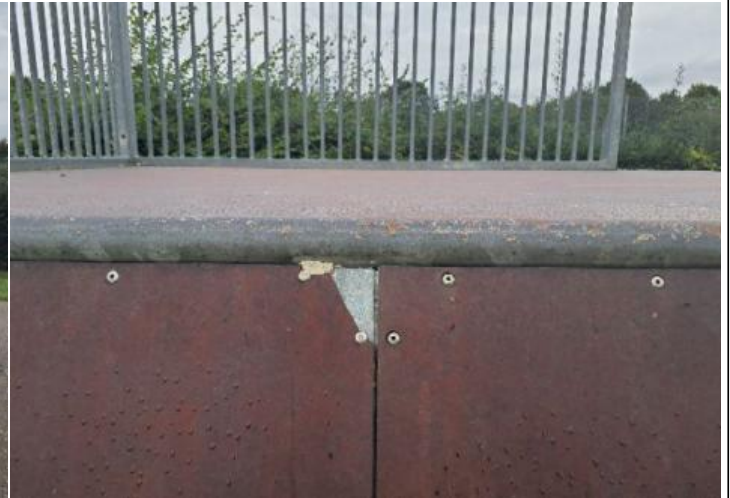
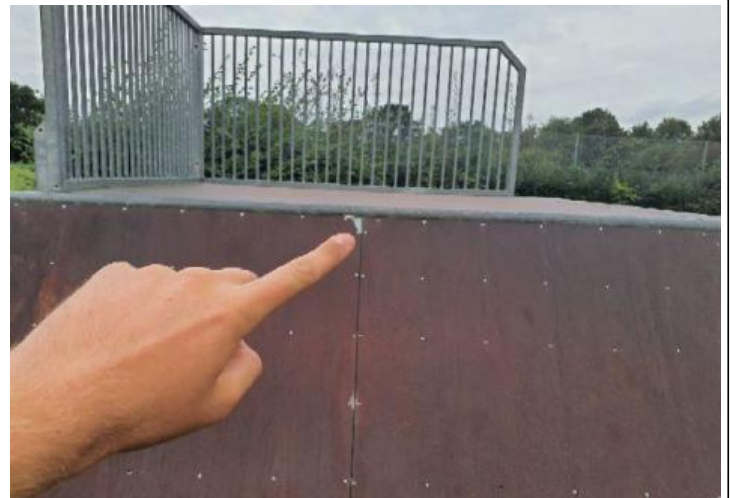
**Finding:** The riding surface of the ramp is damaged

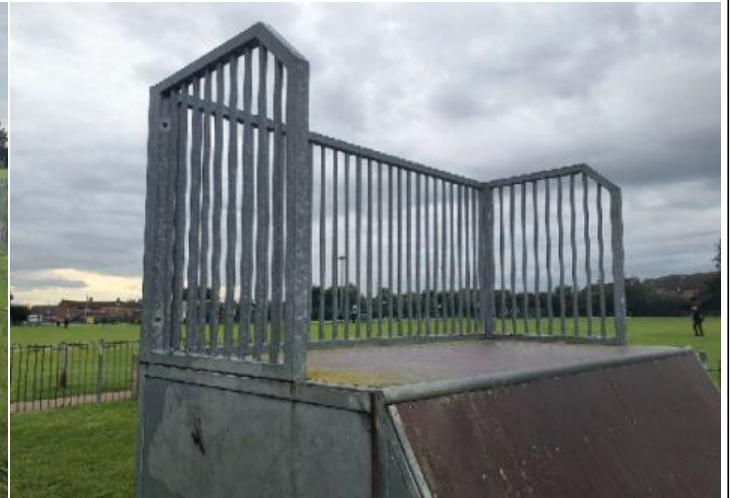
**Finding:** The height of the barrier is less than 1200mm at a distance exceeding 300mm from the front of the barrier and fails the requirements of BS EN 14974

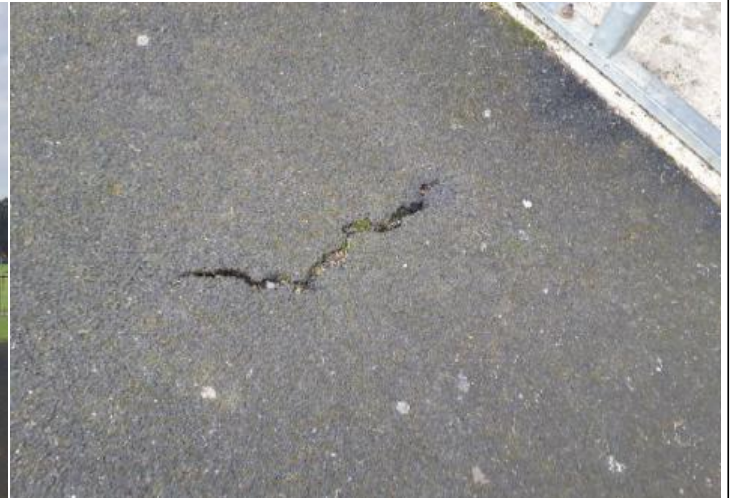
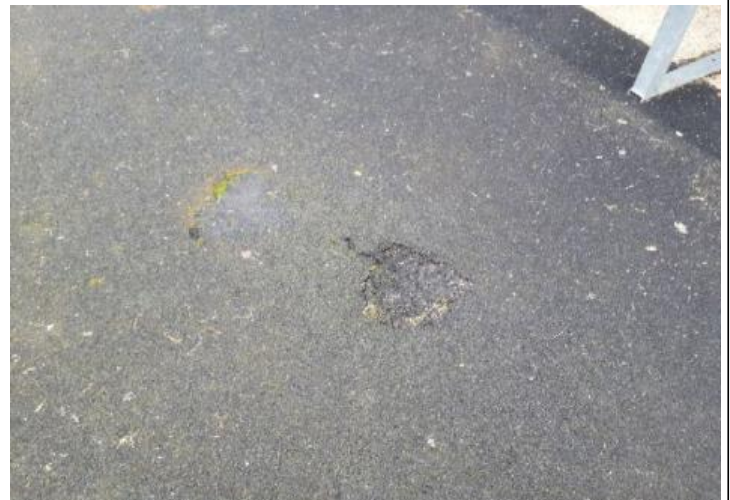
**Finding:** There is moderate damage to the surface

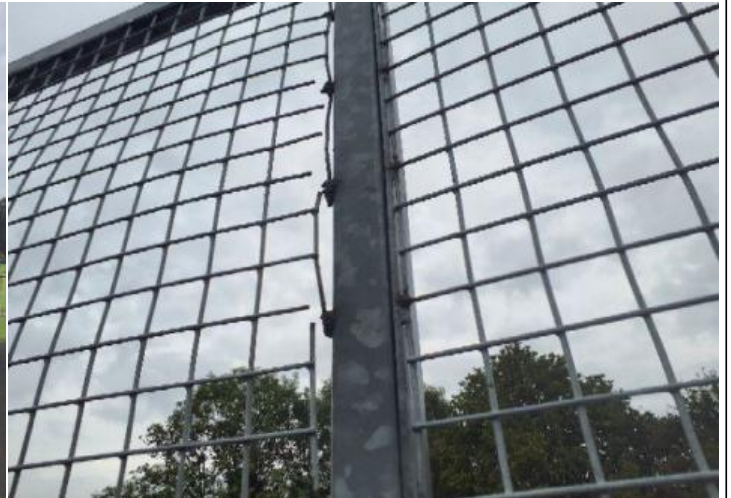
**Finding:** The weld(s) on this item have failed

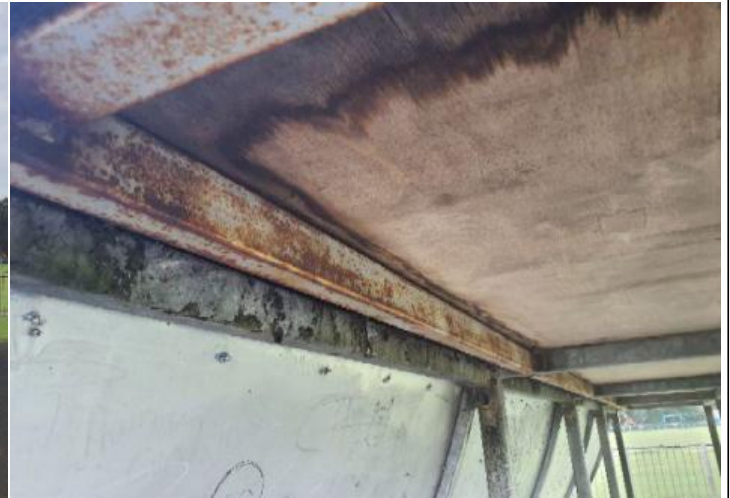
**Finding:** There is surface corrosion / rust present on the item

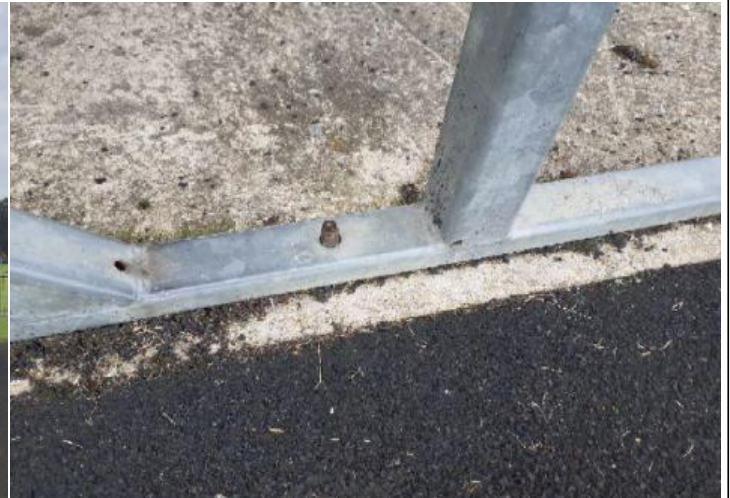
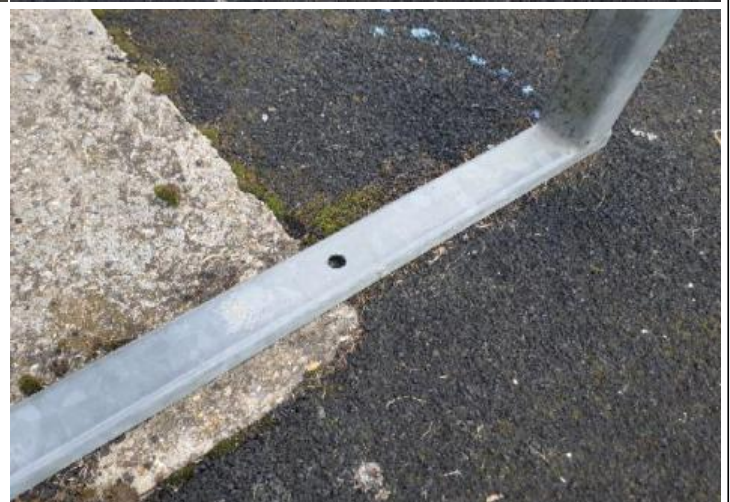
**Finding:** There is or are fixings missing on the item

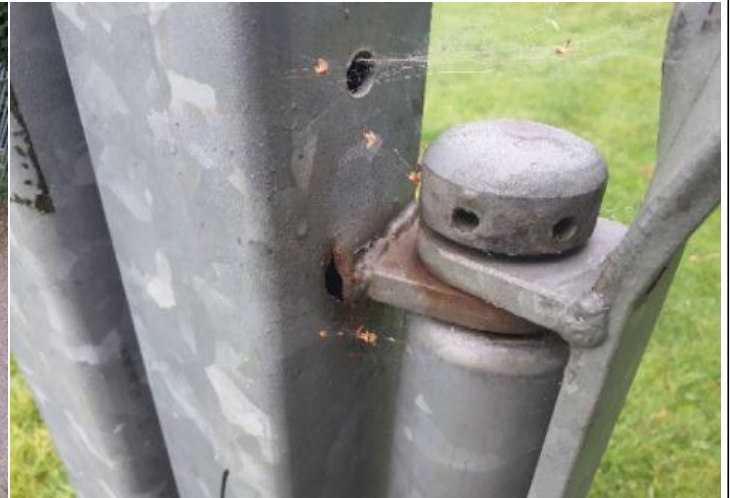
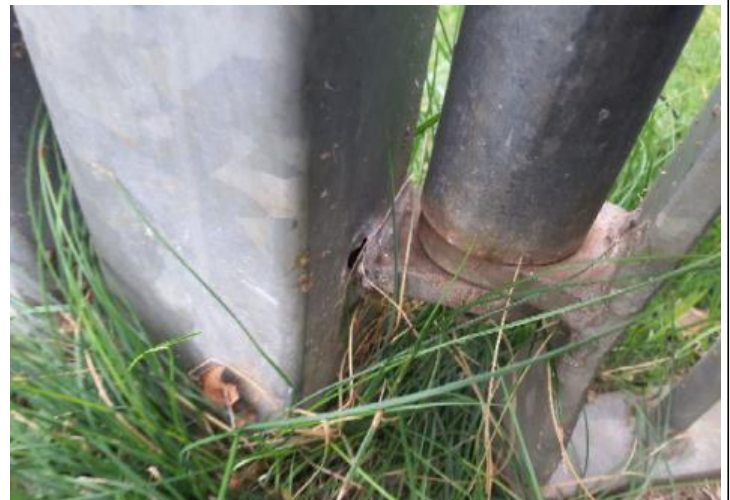
**Finding:** The weld(s) on this item have failed

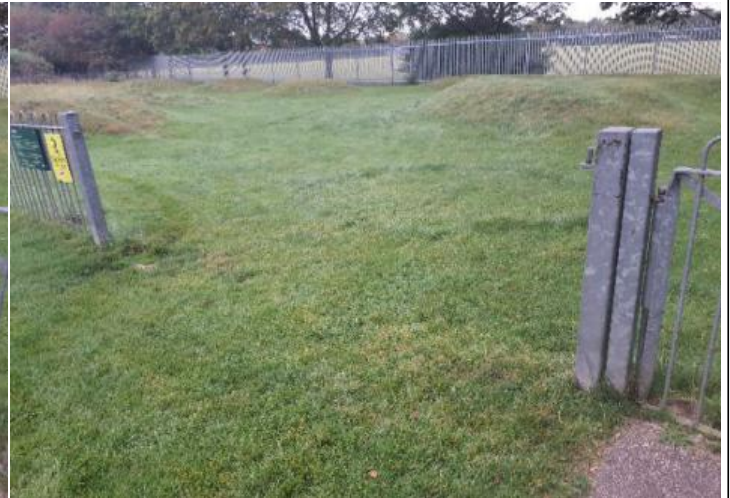
**Finding:** The gate is missing

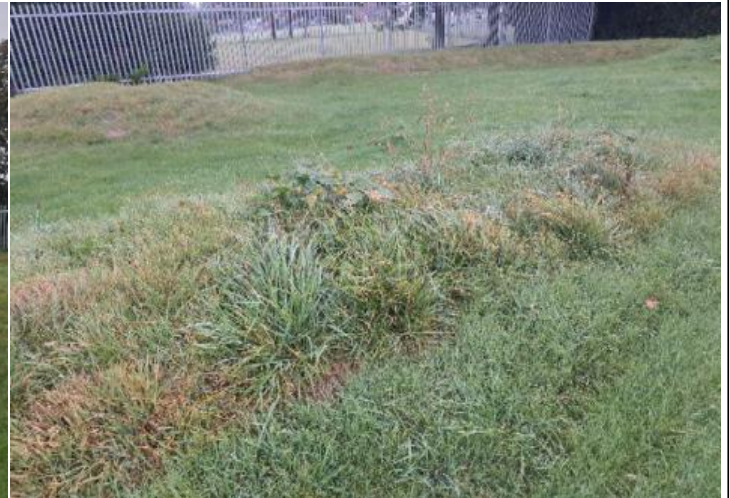
**Finding:** The grass is overgrown within the play area and may hide hazards

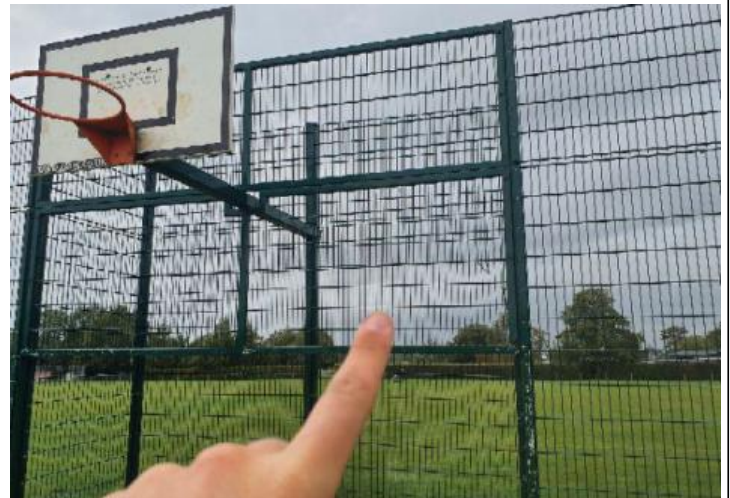
**Finding:** A panel is damaged

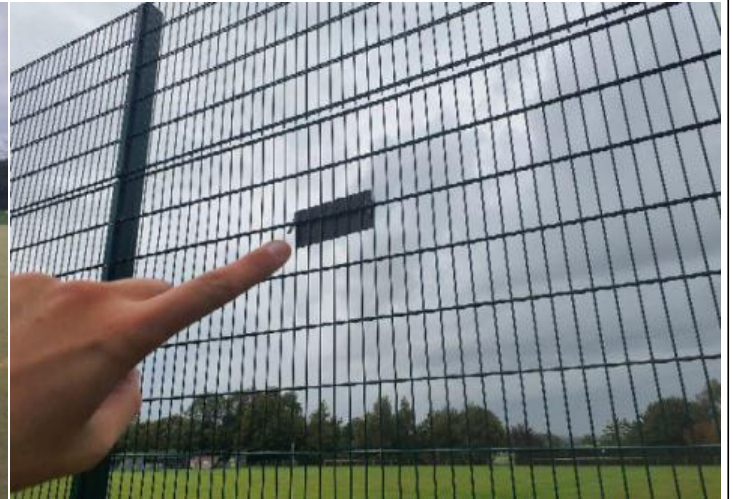
**Finding:** There is or are fixings missing on the item

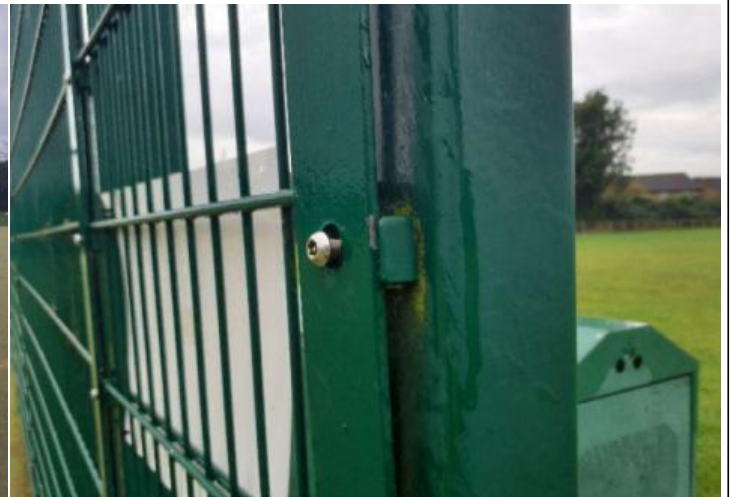
**Finding:** A number of fixing(s) have worked loose on the clamping rails

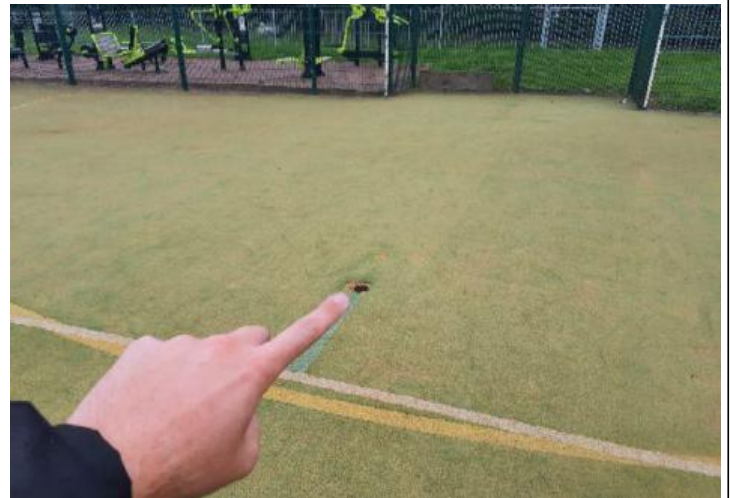
**Finding:** Socket covers are missing creating a foot entrapment

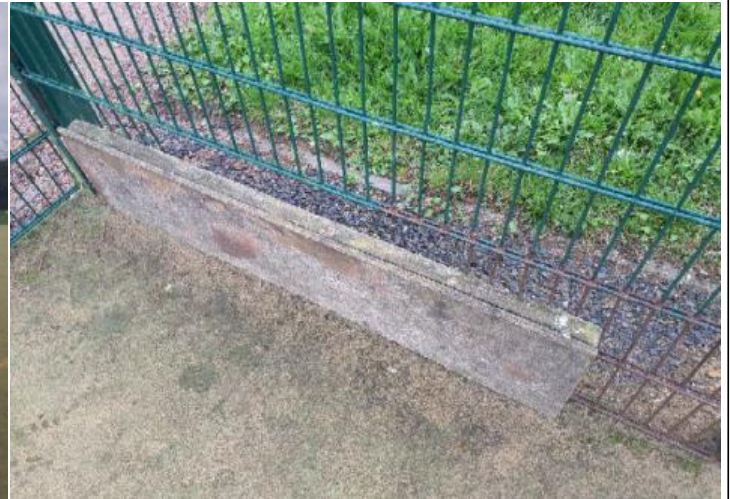
**Finding:** There is moderate damage to the goal panel and a wooden board has been used as a temporary repair  
**Action:** Replace panel

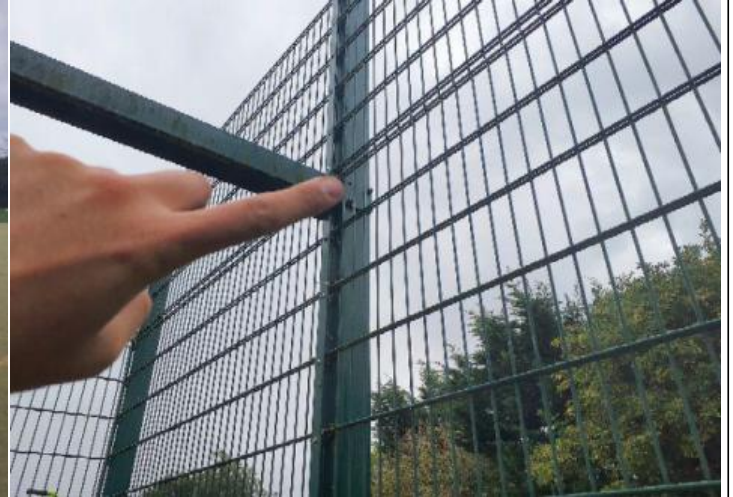
**Finding:** There is or are fixings missing on the item

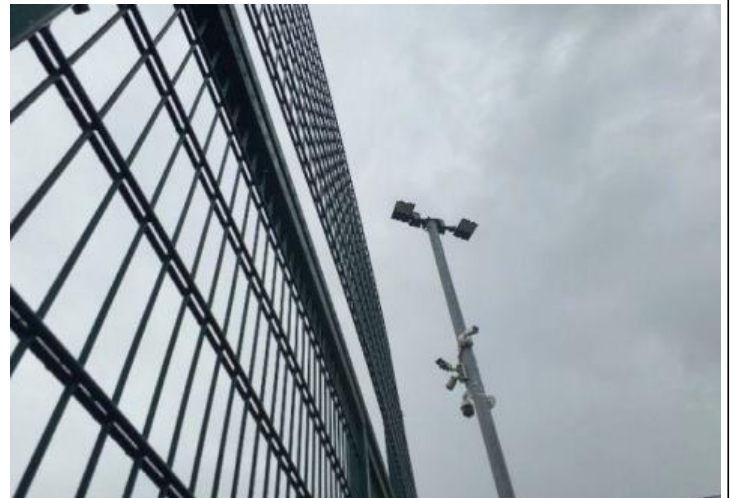
**Finding:** A panel is loose
