# the **play inspection** company

## Annual Inspection

Long Stratton Town Council

Manor Road Playing Fields

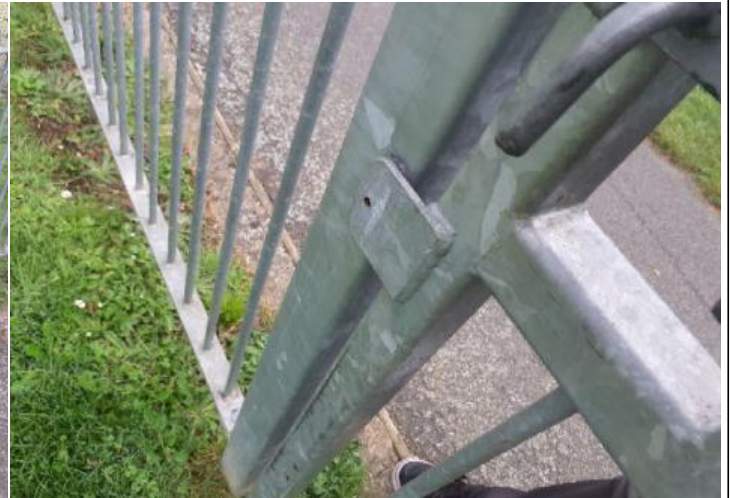
**Finding:** The rubber buffer is missing from the latch plate

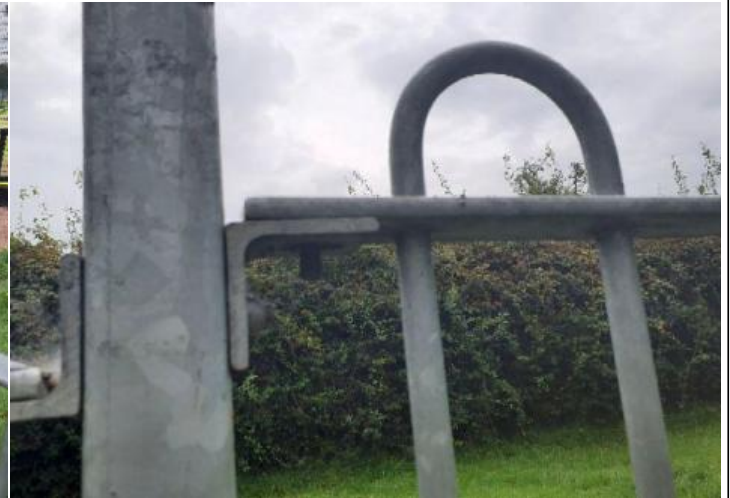
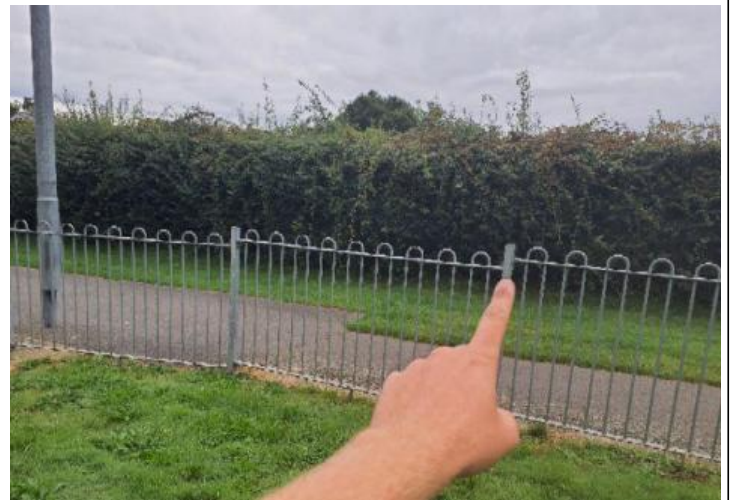
**Finding:** There is or are fixings missing on the item

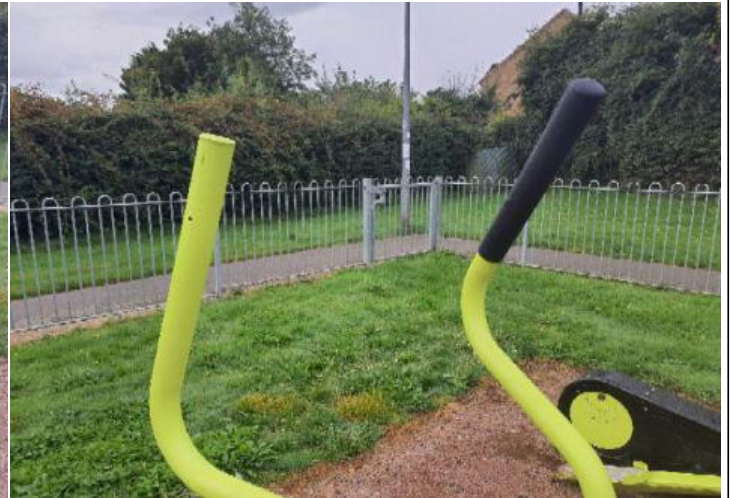
**Finding:** One or more handgrip(s) are damaged or missing. **Action:** Replace missing or damaged handgrips

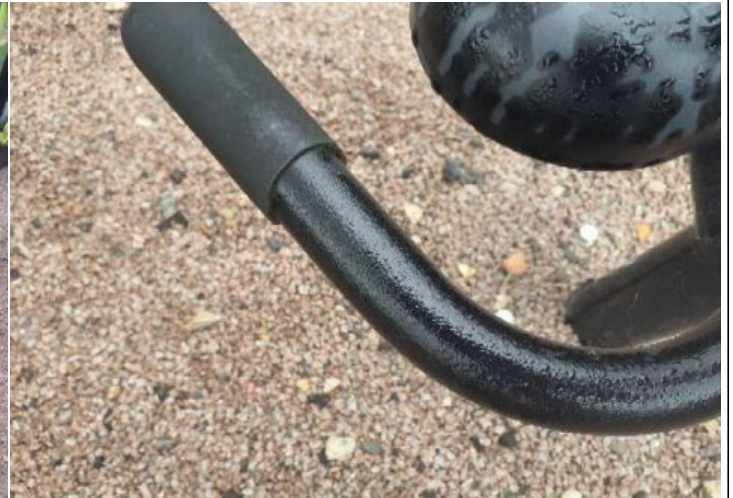
**Finding:** There is some damage to the handgrip

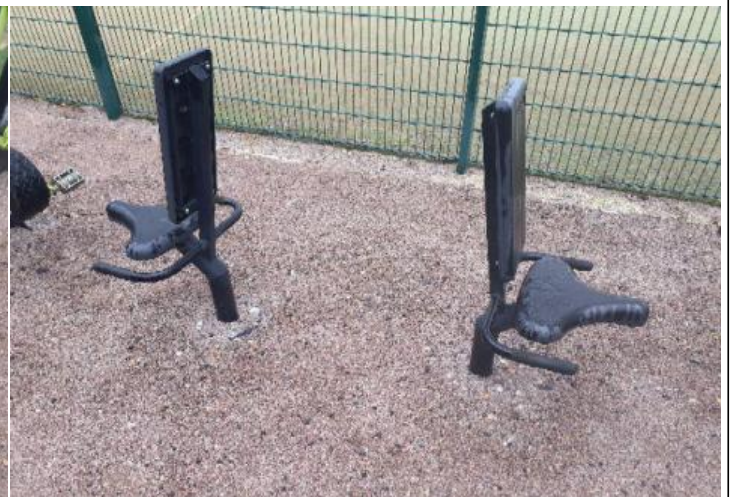
**Finding:** There are obstacles located within the movement space of the item in contravention of the requirements of BS EN 16630

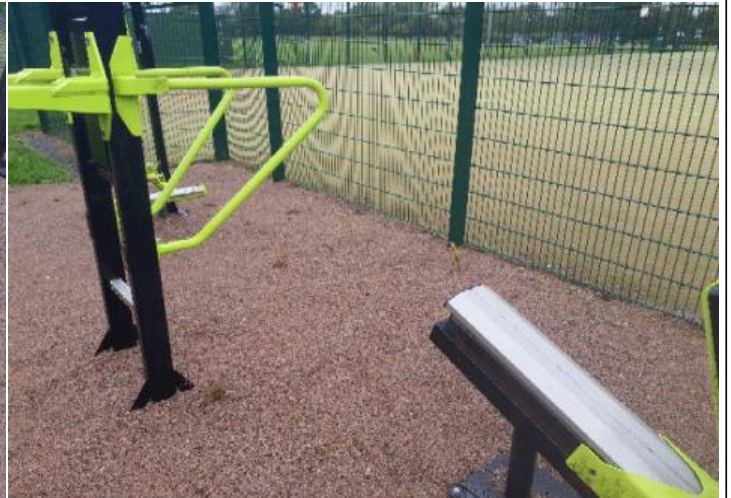
**Finding:** There are obstacles located within the movement space of the item in contravention of the requirements of BS EN 16630

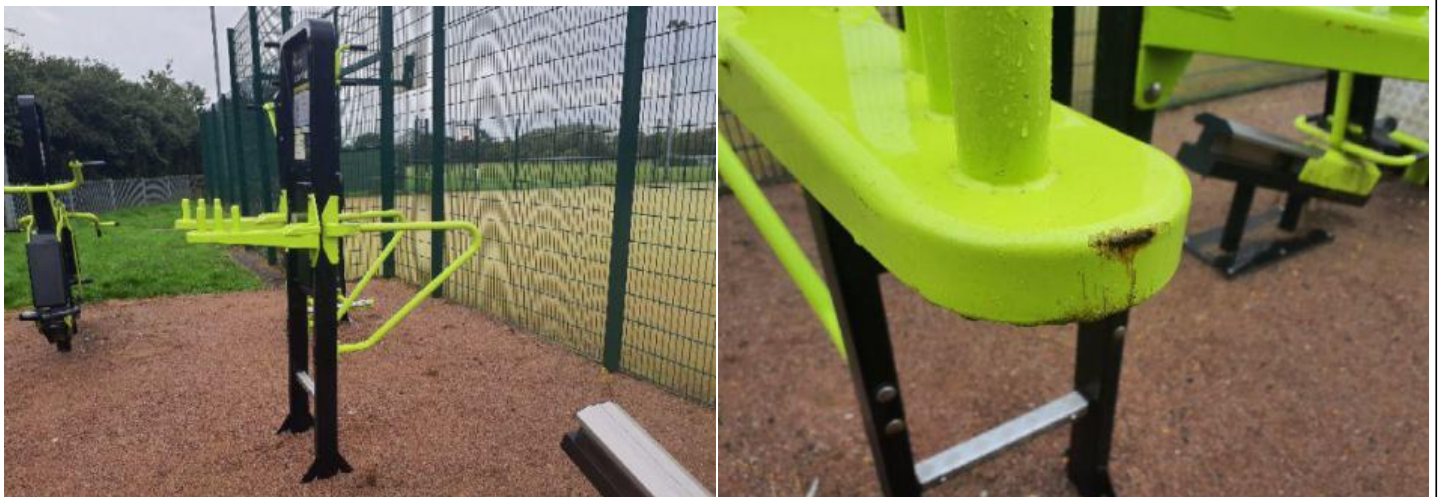
**Finding:** The paintwork on this item has been damaged or worn exposing the metal underneath which is rusting / corroding  
**Action:** Treat affected areas and repaint

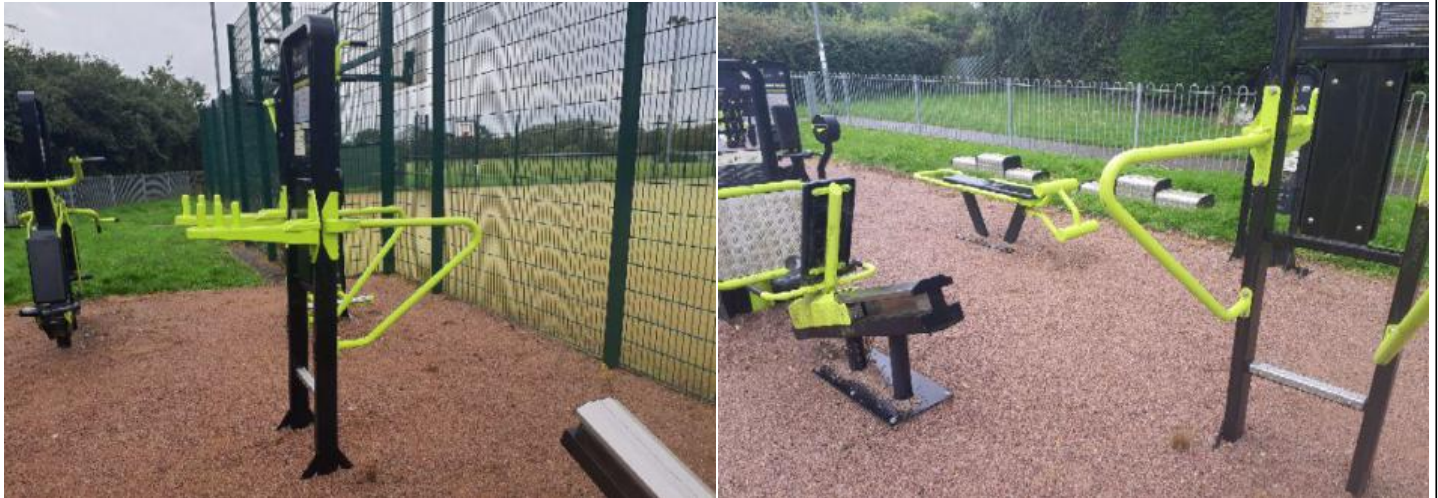
**Finding:** There are obstacles located within the movement space of the item in contravention of the requirements of BS EN 16630  
**Action:** Monitor - No remedial work recommended

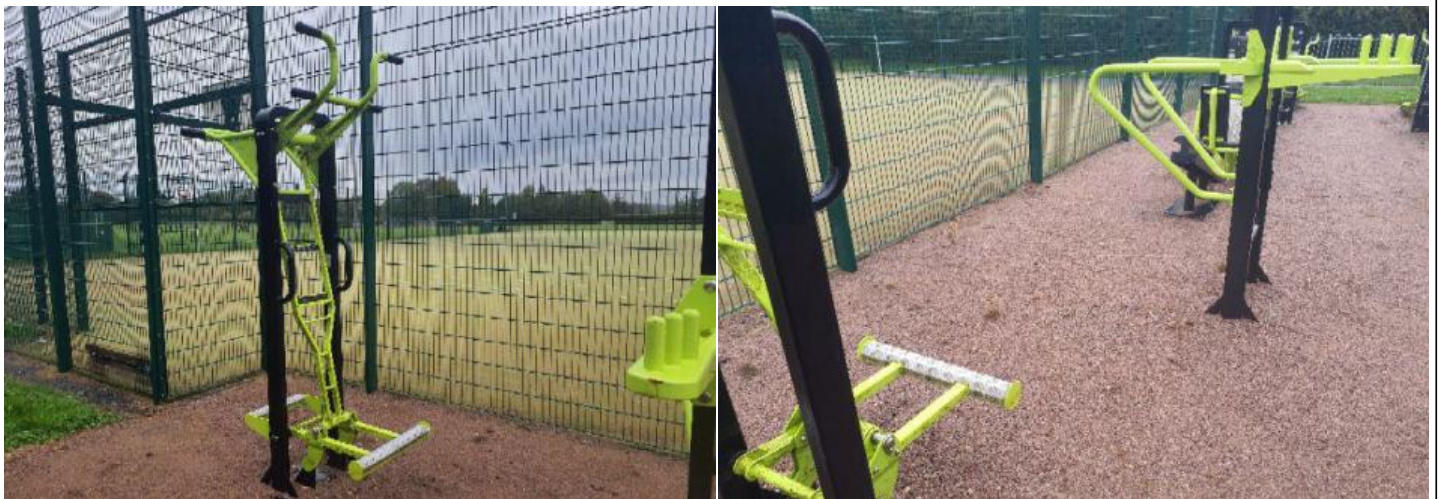
**Finding:** There are obstacles located within the movement space of the item in contravention of the requirements of BS EN 16630  
**Action:** Monitor - No remedial work recommended

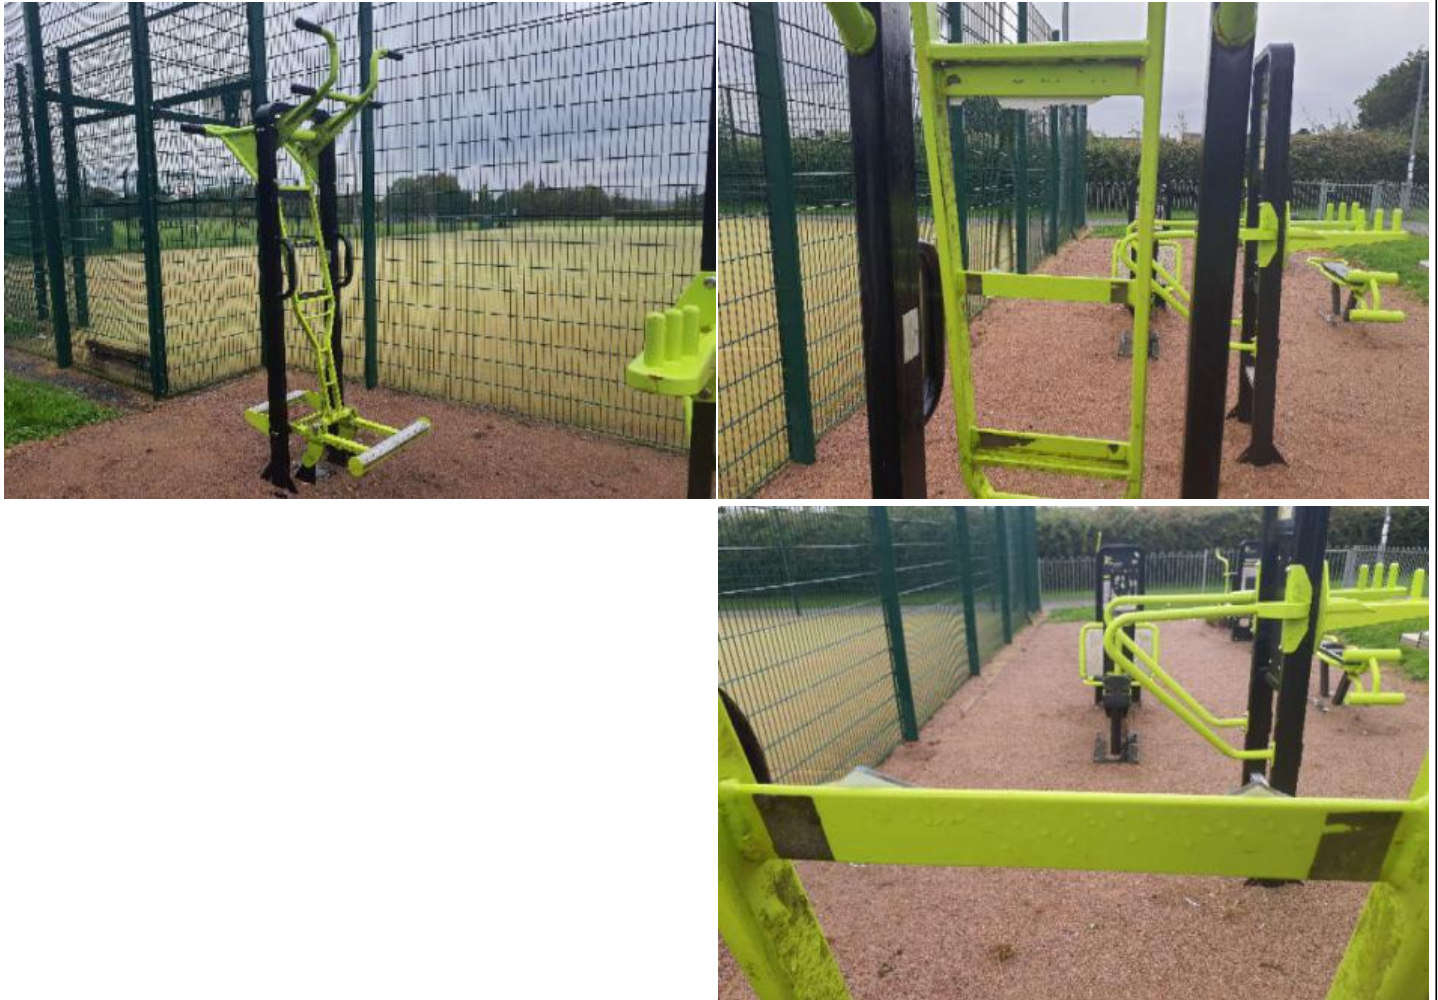
**Finding:** The sign is missing and sharp edges are present **Action:** Replace sign
