Post Installation Report

Long Stratton Town Council

Manor Road, Long Stratton, NR15 2XR

Inspection Ref: 2083314

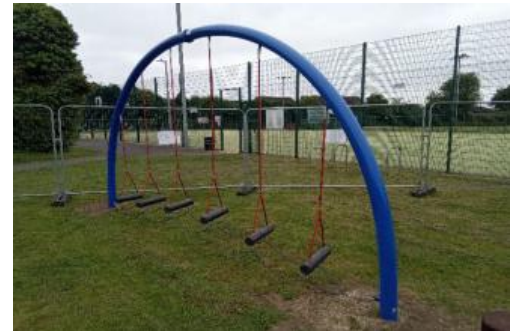
Item: Swinging Steps
Manufacturer: Hags
Surface Type: Grass
Item Quantity: 1
Equipment Compliance: Yes
Surface Area Compliance: Yes

This item is satisfactory - no work required -

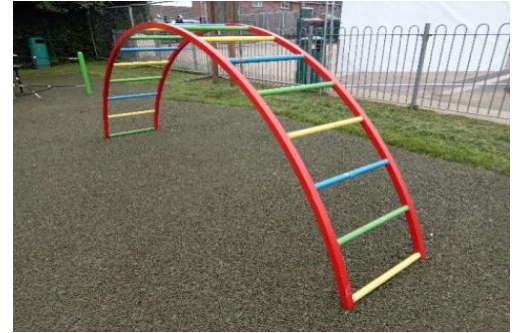
Item:	Climbing Frame
Manufacturer:	Not Identified
Surface Type:	Bonded Rubber Mulch
Surface Nominal Depth:	50mm
Item Quantity:	1
Equipment Compliance:	N/A
Surface Area Compliance:	Yes
Total Findings:	1

NOTE - This is an existing item of equipment that has had a new safer surface installed; the equipment itself was not included within this inspection and only the new surfacing and any related findings (such as equipment ground clearances) were assessed. The surface was found to be satisfactory - no work required. -

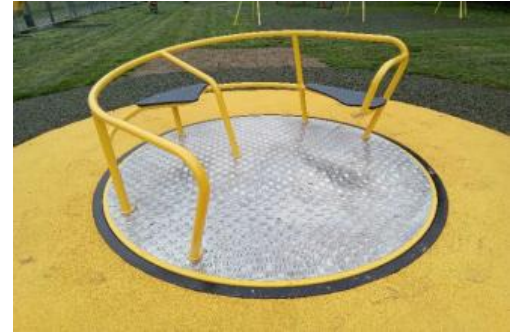
Item: Inclusive Roundabout
Manufacturer: Hags
Surface Type: Mixed Surface
Surface Nominal Depth: 40mm
Item Quantity: 1
Equipment Compliance: Yes
Surface Area Compliance: Yes
Total Findings: 1

This item is satisfactory - no work required -

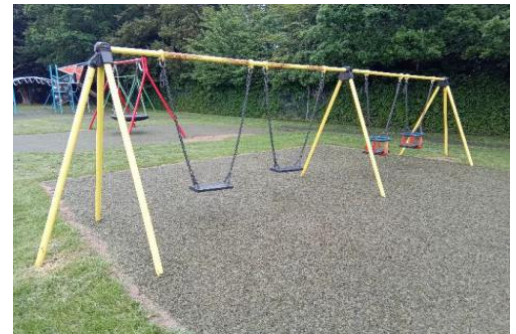
Item: 2 Bay (2 Flat, 2 Cradle)
Manufacturer: Wicksteed Playgrounds
Surface Type: Bonded Rubber Mulch
Surface Nominal Depth: 50mm
Item Quantity: 1
Equipment Compliance: N/A
Surface Area Compliance: Yes
Total Findings: 1

NOTE - This is an existing item of equipment that has had a new safer surface installed; the equipment itself was not included within this inspection and only the new surfacing and any related findings (such as equipment ground clearances) were assessed. The surface was found to be satisfactory - no work required. -

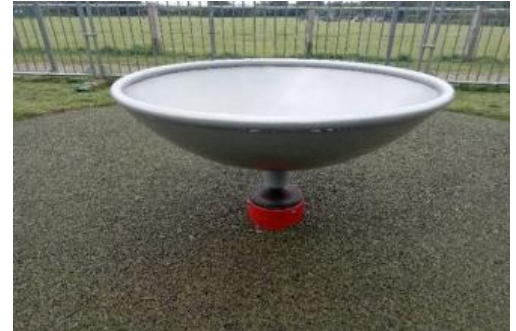
Item: Dish Roundabout
Manufacturer: Hags
Surface Type: Bonded Rubber Mulch
Surface Nominal Depth: 50mm
Item Quantity: 1
Equipment Compliance: Yes
Surface Area Compliance: Yes
Total Findings: 1

This item is satisfactory - no work required -

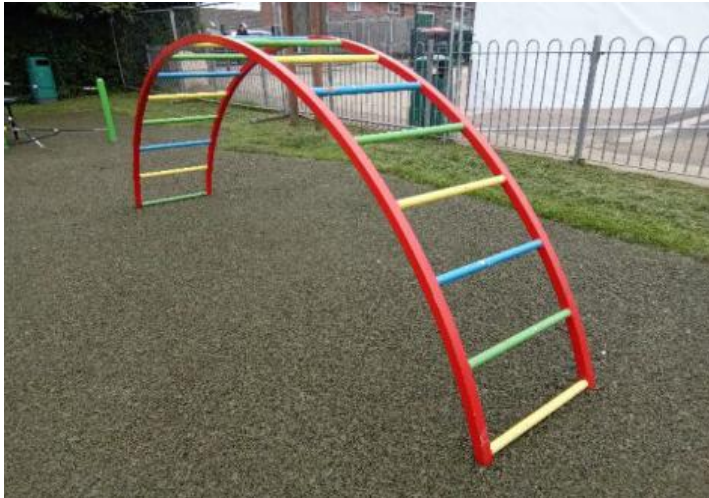
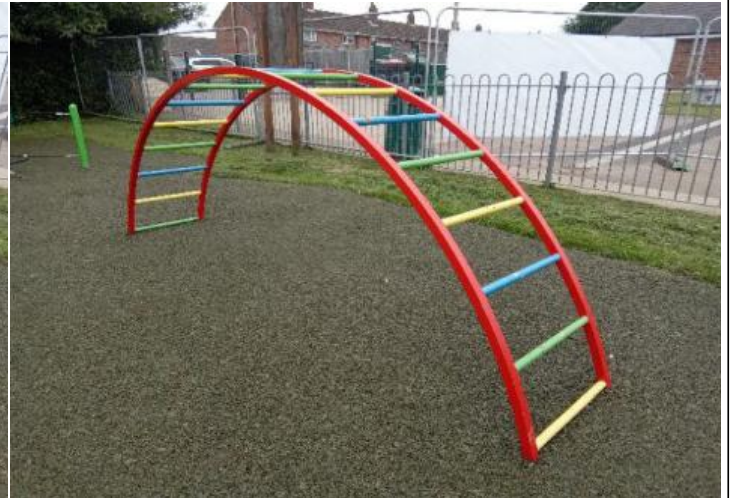
Item: Activity Equipment - Climbing Frame
Manufacturer: Not Identified

Finding: NOTE - This is an existing item of equipment that has had a new safer surface installed; the equipment itself was not included within this inspection and only the new surfacing and any related findings (such as equipment ground clearances) were assessed. The surface was found to be satisfactory - no work required.

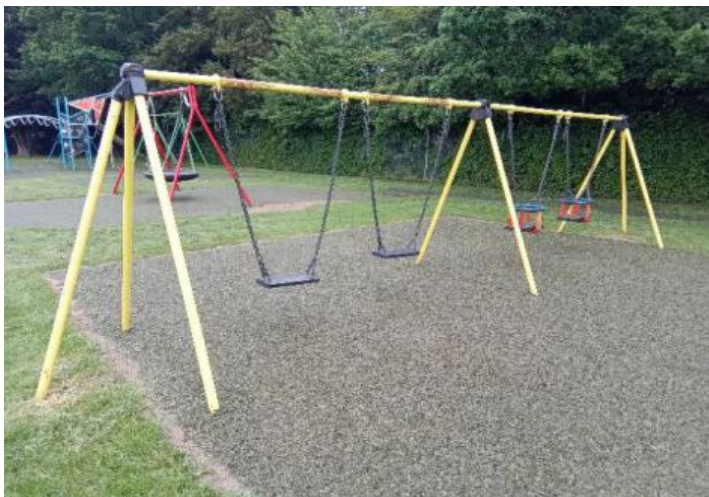
Item: Swings - 2 Bay (2 Flat, 2 Cradle)
Manufacturer: Wicksteed Playgrounds

Finding: NOTE - This is an existing item of equipment that has had a new safer surface installed; the equipment itself was not included within this inspection and only the new surfacing and any related findings (such as equipment ground clearances) were assessed. The surface was found to be satisfactory - no work required.

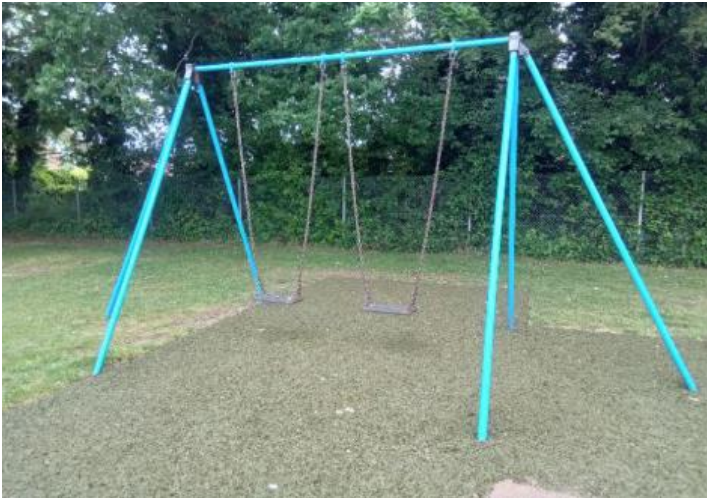
Item: Swings - 1 Bay 2 Seat (Flat)
Manufacturer: Wicksteed Playgrounds

Finding: NOTE - This is an existing item of equipment that has had a new safer surface installed; the equipment itself was not included within this inspection and only the new surfacing and any related findings (such as equipment ground clearances) were assessed. **Action:**
