# the **play inspection** company

## Annual Inspection

Long Stratton Town Council

Manor Road Playing Fields

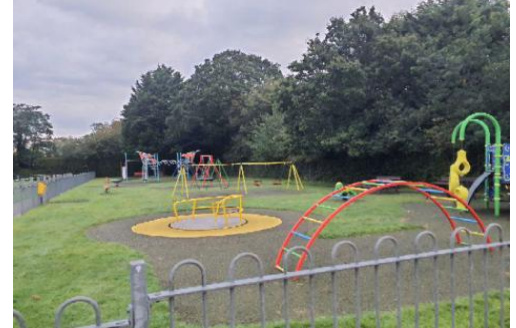
**Item:** Site General  
**Manufacturer:** Owner/Operator  
**Surface Type:** N/A  
**Item Quantity:** 1  
**Equipment Compliance:** N/A  
**Surface Area Compliance:** N/A

A section of pathway edging is damaged - Replace

The grass is overgrown within the fitness area and may hide hazards - Reduce the length of grass to an acceptable height and maintain

There are redundant concrete foundations in the fitness area - Remove

There are cracks in the rolling surface of the skate area - Monitor for any further deterioration and repair as required

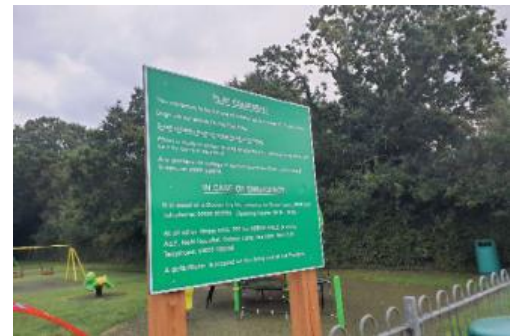
**Item:** Sign  
**Manufacturer:** Owner/Operator  
**Surface Type:** Grass  
**Item Quantity:** 1  
**Equipment Compliance:** N/A  
**Surface Area Compliance:** N/A

This item is satisfactory - no work required -

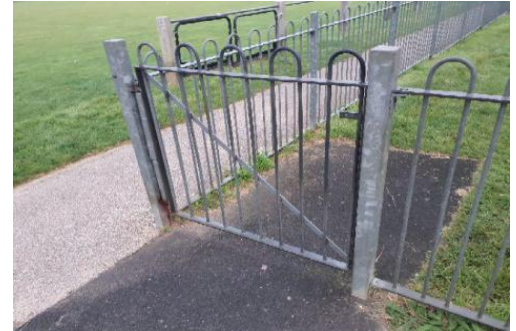
**Item:** Gate - Self Closing  
**Manufacturer:** Not Identified  
**Surface Type:** Wet Pour  
**Item Quantity:** 1  
**Equipment Compliance:** N/A  
**Surface Area Compliance:** N/A

The rubber buffer is damaged - Replace rubber buffer

There is some damage to the item - Monitor for any further deterioration and repair as required

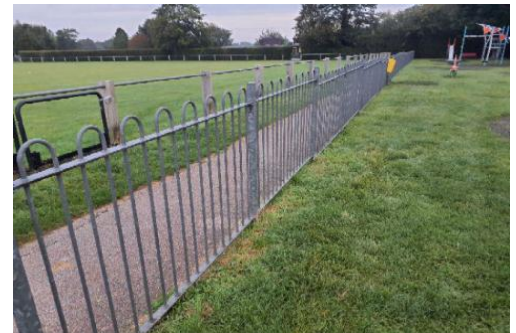
**Item:** Fence - Bow Top  
**Manufacturer:** Owner/Operator  
**Surface Type:** Grass  
**Item Quantity:** 1  
**Equipment Compliance:** N/A  
**Surface Area Compliance:** N/A

There is some damage to the fence sections - Monitor for any further deterioration and repair as required

A number of fixing(s) have worked loose - Secure all loose fixings

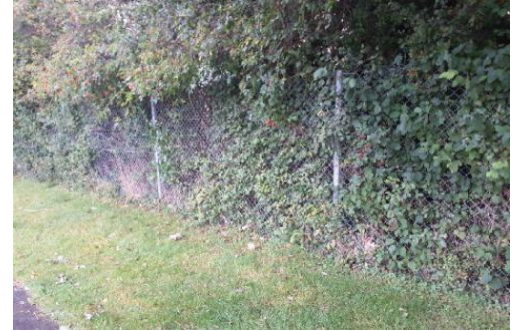
**Item:** Fence - Chainlink  
**Manufacturer:** Not Identified  
**Surface Type:** Grass  
**Item Quantity:** 1  
**Equipment Compliance:** N/A  
**Surface Area Compliance:** N/A

The fence is severely damaged in places - Repair or replace all affected sections

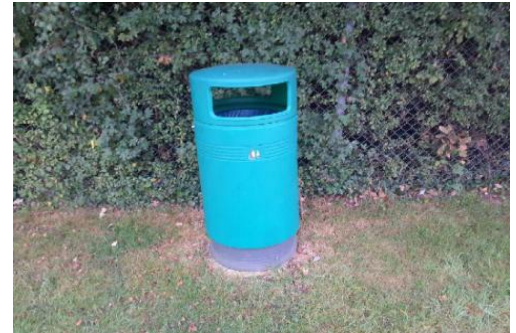
**Item:** Litter Bin  
**Manufacturer:** Not Identified  
**Surface Type:** Grass  
**Item Quantity:** 1  
**Equipment Compliance:** N/A  
**Surface Area Compliance:** N/A

A number of fixing(s) have worked loose - Secure all loose fixings

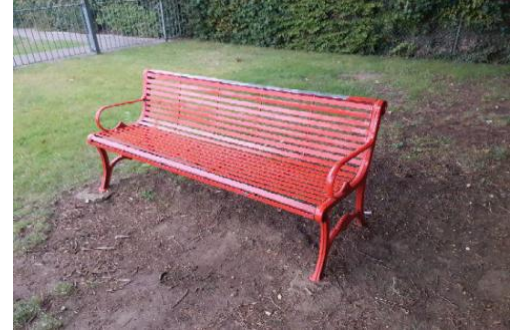
**Item:** Bench  
**Manufacturer:** Not Identified  
**Surface Type:** Grass  
**Item Quantity:** 1  
**Equipment Compliance:** N/A  
**Surface Area Compliance:** N/A

The surface has eroded in some areas and may be slippery in wet conditions - Reinstate the surface

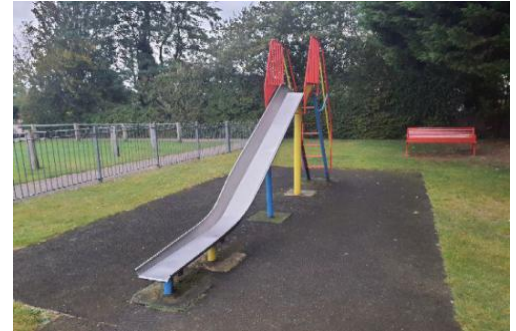
**Item:** Free Standing Slide  
**Manufacturer:** Not Identified  
**Surface Type:** Wet Pour  
**Item Quantity:** 1  
**Equipment Compliance:** No  
**Surface Area Compliance:** No

There are trip hazards at the edges of the surface - Reinstate surrounding surface levels to remove the trip points

There are a number of dents in the slide surface - Monitor for any further deterioration and repair as required

There are gaps opening between the surfacing and the edging surround or between the joints in the surfacing - Monitor for any further deterioration and repair as required

The fixings have corroded excessively - Replace all corroded fixings

The item fails to meet the requirements of BS EN 1176 Part 1 4.2.7.2 for head and neck entrapment in the frame - Monitor - No remedial work recommended

The timber edge forms a hard object within the impact area of the equipment in contravention of the requirements of BS EN 1176 Part 1 - Monitor - No remedial work recommended

There is algae, silt or moss growth on the surface resulting in slippery conditions - Clean and treat appropriately

The surface is lifting at the edges and creating trip points - Repair perimeter of surfacing to remove trip points

Parts of the steel on this item have corroded excessively and the metal has perforated in places - Ensure all affected areas are treated and repaired

There is some minor damage to the surface - Monitor for any further deterioration and repair as required

The slide is predominately south facing and will catch the majority of the sun's heat during the day. Slide surfaces can become very warm during periods of sustained sunny weather - Monitor - No remedial work recommended

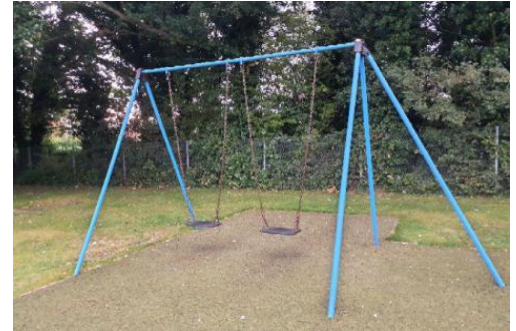
**Item:** 1 Bay 2 Seat (Flat)  
**Manufacturer:** Wicksteed Playgrounds  
**Surface Type:** Bonded Rubber Mulch  
**Item Quantity:** 1  
**Equipment Compliance:** No  
**Surface Area Compliance:** No

The chain openings are in excess of 8.6mm and do not meet the recommendations of BS EN 1176 Part 1 - Monitor - No remedial work recommended

There is some notable evidence of chain wear - Monitor for any further deterioration and replace when 40% worn

The chain links are worn in excess of 40% and require renewing - Replace worn chains

The bushes are worn or missing - Replace worn or missing bushes

There is some wear to the shackles - Monitor for any further deterioration and replace when 40% worn

The seats are too close to each other as defined in BS EN 1176 Part 2; this is a low risk failure and no remedial action is required - Monitor - No remedial work recommended

The surfacing dimensions are short and do not meet with the requirements of the current applicable standard - Monitor - no remedial action recommended

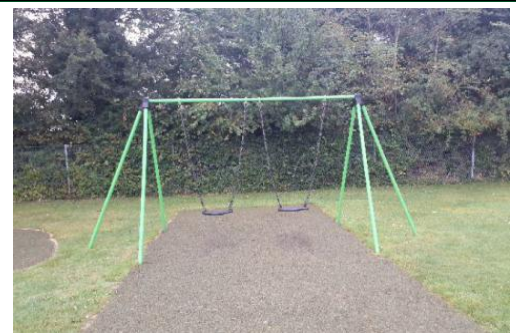
**Item:** 1 Bay 2 Seat (Flat)  
**Manufacturer:** Wicksteed Playgrounds  
**Surface Type:** Bonded Rubber Mulch  
**Item Quantity:** 1  
**Equipment Compliance:** Yes  
**Surface Area Compliance:** Yes

The seat has minor damage or wear - Monitor for any further deterioration and replace as required

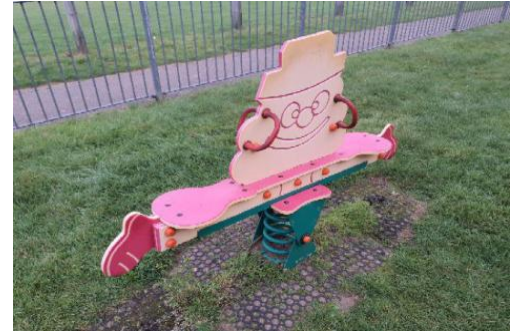
**Item:** Spring See-Saw  
**Manufacturer:** Not Identified  
**Surface Type:** Grass Matrix Tiles  
**Item Quantity:** 1  
**Equipment Compliance:** Yes  
**Surface Area Compliance:** Yes

There is moderate damage to the surface - Repair the damaged areas of surfacing

There is movement within the pivot point - Monitor for any further deterioration and repair as required

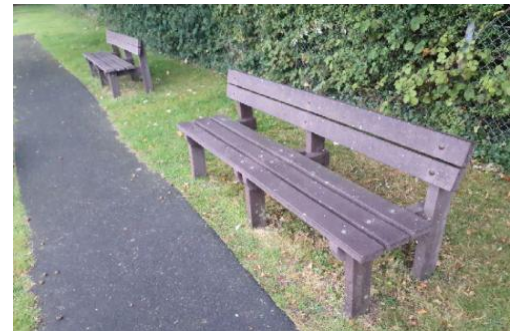
**Item:** Bench  
**Manufacturer:** Not Identified  
**Surface Type:** Grass  
**Item Quantity:** 2  
**Equipment Compliance:** N/A  
**Surface Area Compliance:** N/A

There is some damage to the item - Monitor for any further deterioration and repair as required

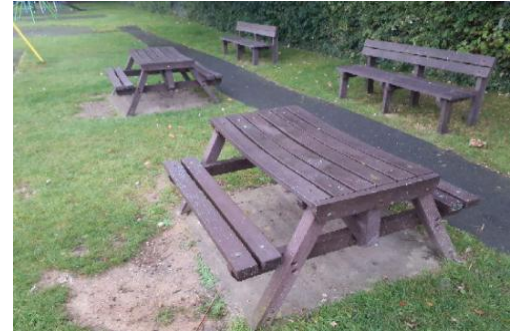
**Item:** Picnic Table  
**Manufacturer:** Not Identified  
**Surface Type:** Grass  
**Item Quantity:** 1  
**Equipment Compliance:** N/A  
**Surface Area Compliance:** N/A

The surface has eroded in some areas and may be slippery in wet conditions - Reinstate the surface

The slats are distorted - Monitor for any further deterioration and replace as required

There is some damage to the item - Monitor for any further deterioration and repair as required

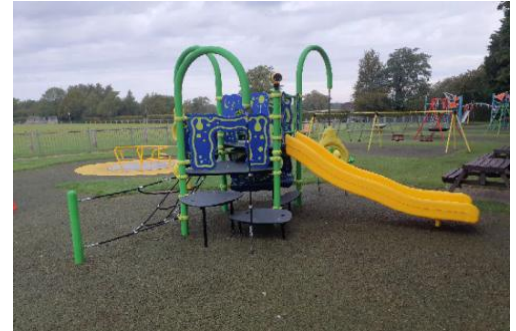
**Item:** Multi Play (Junior)  
**Manufacturer:** Hags  
**Surface Type:** Bonded Rubber Mulch  
**Item Quantity:** 1  
**Equipment Compliance:** No  
**Surface Area Compliance:** Yes

The item has been installed marginally too high which has resulted in the platform height being in excess of 600mm (610 mm) and technically, the height of the barriers are now insufficient to meet the requirements of BS EN 1176 Part 1. This is however a very low risk technicality and no remedial action is recommended as it has not affected the risk assessment of the item - No action given the risk assessment

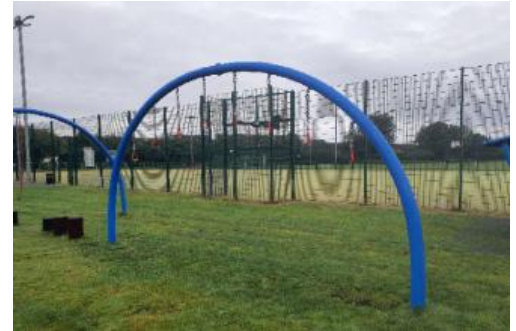
**Item:** Rope Traverse  
**Manufacturer:** Hags  
**Surface Type:** Grass Matrix Tiles  
**Item Quantity:** 1  
**Equipment Compliance:** Yes  
**Surface Area Compliance:** Yes

This item is satisfactory - no work required -

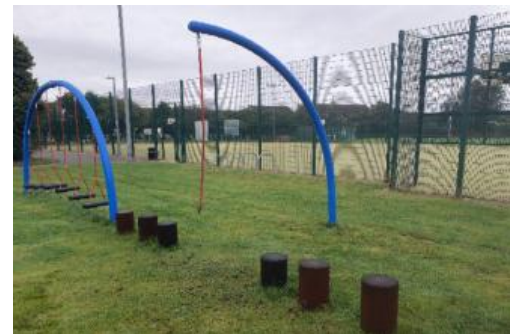
**Item:** Rope Traverse  
**Manufacturer:** Hags  
**Surface Type:** Grass Matrix Tiles  
**Item Quantity:** 1  
**Equipment Compliance:** Yes  
**Surface Area Compliance:** Yes

This item is satisfactory - no work required -

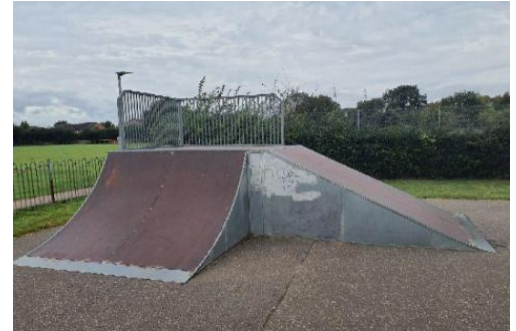
**Item:** Start Ramp  
**Manufacturer:** StreetSkapes  
**Surface Type:** Bitmac  
**Item Quantity:** 1  
**Equipment Compliance:** No  
**Surface Area Compliance:** Yes

There is or are fixings missing on the item - Replace all missing fixings

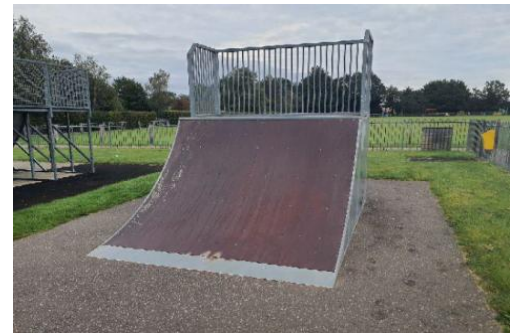
**Item:** Quarter Pipe  
**Manufacturer:** StreetSkapes  
**Surface Type:** Bitmac  
**Item Quantity:** 1  
**Equipment Compliance:** No  
**Surface Area Compliance:** Yes

The riding surface of the ramp has some damage apparent - Monitor for any further deterioration and repair as required

The height of the barrier is less than 1200mm at a distance exceeding 300mm from the front of the barrier and fails the requirements of BS EN 14974 - Monitor - No remedial work recommended

The identification label is damaged - Remove the label

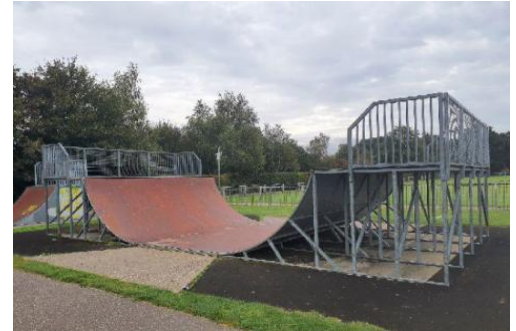
**Item:** Half Pipe  
**Manufacturer:** StreetSkapes  
**Surface Type:** Mixed Surface  
**Item Quantity:** 1  
**Equipment Compliance:** No  
**Surface Area Compliance:** Yes

There are significant gaps (over 30mm) between the surface and the edging or between the joints in the surface; these are large enough for a small foot to enter - Repair surfacing

There is moderate damage to the surface - Repair the damaged areas of surfacing

The weld(s) on this item have failed - Repair item

There are post / end caps missing from the item - Replace missing post caps

There is surface corrosion / rust present on the item - Consider treating the item

There is or are fixings missing on the item - Replace all missing fixings

The height of the barrier is less than 1200mm and fails the requirements of BS EN 14974 - Monitor - No remedial work recommended

The riding surface of the ramp has some damage apparent - Monitor for any further deterioration and repair as required

There is a change in the level of the rolling surface in excess of 3mm and the item fails the requirements of BS EN 14974 Clause 5.1.2.3 - Monitor - No remedial work recommended

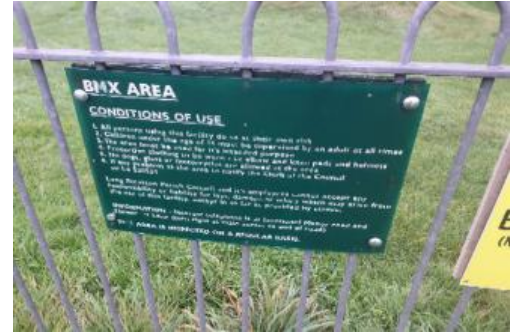
**Item:** Sign  
**Manufacturer:** Owner/Operator  
**Surface Type:** N/A  
**Item Quantity:** 1  
**Equipment Compliance:** N/A  
**Surface Area Compliance:** N/A

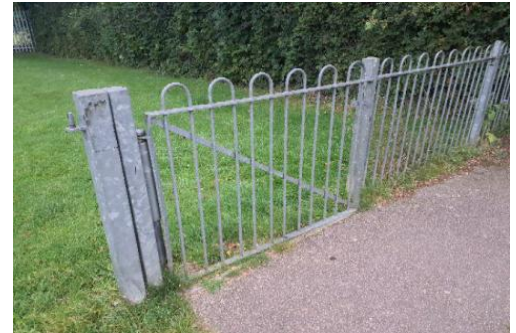
**Item:** Gate - Self Closing  
**Manufacturer:** Not Identified  
**Surface Type:** Grass  
**Item Quantity:** 1  
**Equipment Compliance:** N/A  
**Surface Area Compliance:** N/A

There are trip hazards at the edges of the surface - Reinststate surrounding surface levels to remove the trip points

The weld(s) on this item have failed - Repair item

There is some damage to the item - Monitor for any further deterioration and repair as required

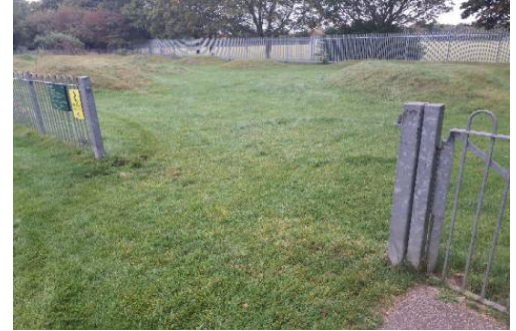
**Item:** Maintenance Gate  
**Manufacturer:** Not Identified  
**Surface Type:** Grass  
**Item Quantity:** 1  
**Equipment Compliance:** N/A  
**Surface Area Compliance:** N/A

The gate is missing - Replace the gate

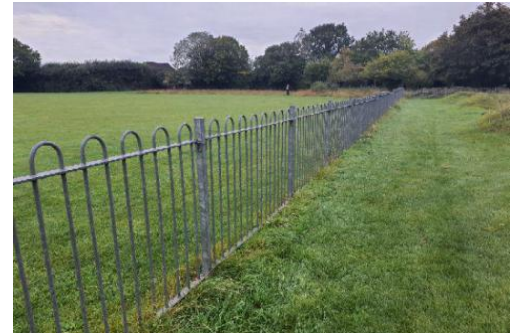
**Item:** Fence - Bow Top  
**Manufacturer:** Not Identified  
**Surface Type:** Grass  
**Item Quantity:** 1  
**Equipment Compliance:** N/A  
**Surface Area Compliance:** N/A

There is some damage to the fence sections - Monitor for any further deterioration and repair as required

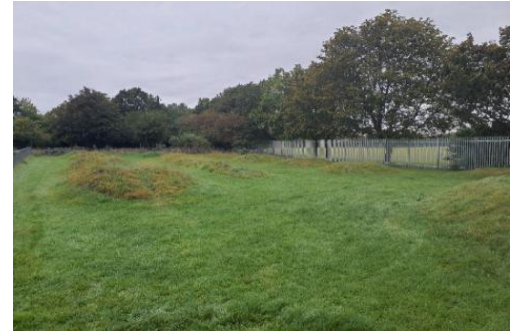
**Item:** BMX Track  
**Manufacturer:** Not Identified  
**Surface Type:** Grass  
**Item Quantity:** 1  
**Equipment Compliance:** N/A  
**Surface Area Compliance:** N/A

BMX tracks are not currently covered by any British or European Standard; comments made in the report are based on the application of our knowledge and understanding of the Wheeled Sports Standard (BS EN 14974) and their maintenance and the area has been risk assessed accordingly - Monitor use and review risk assessment regularly

The grass is overgrown within the play area and may hide hazards - Reduce the length of grass to an acceptable height and maintain

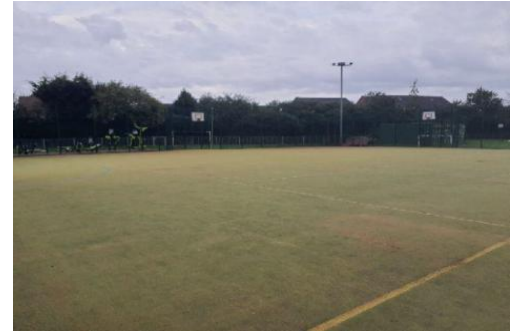
**Item:** Multi Use Games Area (MUGA)  
**Manufacturer:** Not Identified  
**Surface Type:** Carpet System  
**Item Quantity:** 1  
**Equipment Compliance:** N/A  
**Surface Area Compliance:** N/A

There is/are finger entrapments in the frame due to missing fixings and the item fails to meet the requirements of BS EN 15312 Clause 4.4.2.2 Entrapment of fingers - Provide missing fixings to remove entrapment

A panel is damaged - Repair or replace as required

A number of fixing(s) have worked loose on the clamping rails - Secure all loose fixings

There is moderate damage to the surface - Repair the damaged areas of surfacing

There is moderate damage to the goal panel and a wooden board has been used as a temporary repair - Replace panel

There is or are fixings missing on the item - Replace all missing fixings

There is or are numerous fixings missing on the clamping rails - Replace all missing fixings

There is/are finger entrapments in the frame and the item fails to meet the requirements of BS EN 15312 Clause 4.4.2.2 Entrapment of fingers - Monitor - No remedial work recommended

There is some damage to the goal panel - Repair or replace as required

There is algae or moss growth on the surface resulting in slippery conditions - Clean and treat appropriately

Socket covers are missing creating a foot entrapment - Replace the cover

A panel is loose - Secure

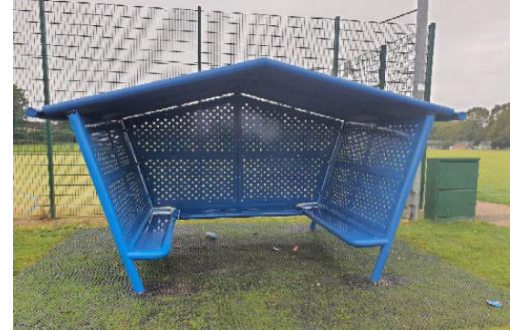
**Item:** Shelter  
**Manufacturer:** Caloo  
**Surface Type:** Grass Matrix Tiles  
**Item Quantity:** 1  
**Equipment Compliance:** N/A  
**Surface Area Compliance:** N/A

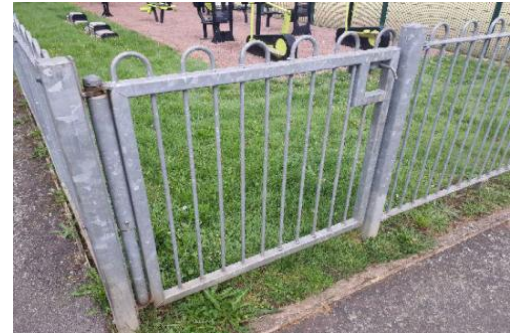
**Item:** Gate - Self Closing  
**Manufacturer:** Not Identified  
**Surface Type:** Grass  
**Item Quantity:** 1  
**Equipment Compliance:** N/A  
**Surface Area Compliance:** N/A

The rubber buffer is missing from the latch plate - Replace rubber buffer

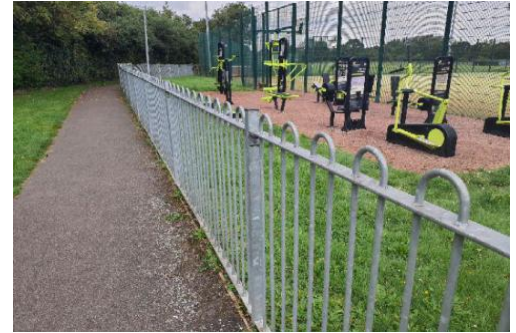
**Item:** Fence - Bow Top  
**Manufacturer:** Not Identified  
**Surface Type:** Grass  
**Item Quantity:** 1  
**Equipment Compliance:** N/A  
**Surface Area Compliance:** N/A

There is or are fixings missing on the item - Replace all missing fixings

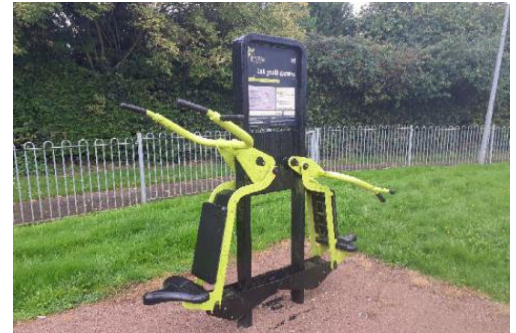
**Item:** Shoulder Press  
**Manufacturer:** The Great Outdoor Gym Company  
**Surface Type:** Crushed Stone  
**Item Quantity:** 1  
**Equipment Compliance:** Yes  
**Surface Area Compliance:** Yes

There is or are fixings missing on the item - Replace all missing fixings

One or more handgrip(s) are damaged or missing. - Replace missing or damaged handgrips

The paintwork on this item has been damaged or worn exposing the metal underneath which is rusting / corroding - Treat affected areas and repaint

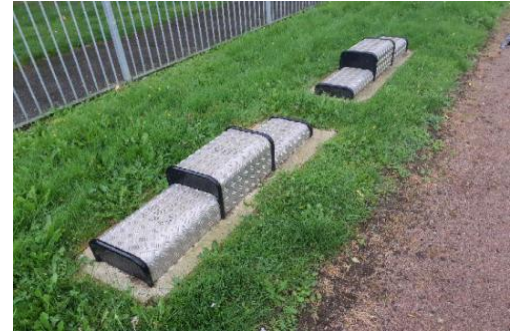
**Item:** Step Up Station  
**Manufacturer:** The Great Outdoor Gym Company  
**Surface Type:** Grass  
**Item Quantity:** 1  
**Equipment Compliance:** No  
**Surface Area Compliance:** Yes

There are obstacles located within the movement space of the item in contravention of the requirements of BS EN 16630 - Monitor - No remedial work recommended

There are trip hazards at the edges of the surface - Reinstate surrounding surface levels to remove the trip points

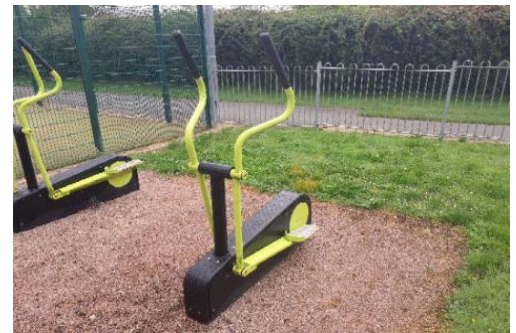
**Item:** Cross Trainer  
**Manufacturer:** The Great Outdoor Gym Company  
**Surface Type:** Crushed Stone  
**Item Quantity:** 1  
**Equipment Compliance:** No  
**Surface Area Compliance:** Yes

The tread surface does not have a 10mm high safeguard that extends around the front of the surface and at least 75% of the sides of the surface as required by BS EN 16630 - Monitor - No remedial work recommended

The cross trainer foot has become unattached - Repair item

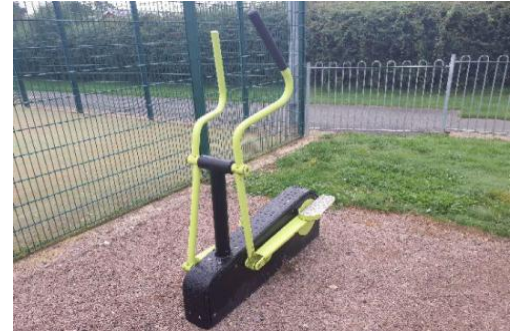
**Item:** Cross Trainer  
**Manufacturer:** The Great Outdoor Gym Company  
**Surface Type:** Crushed Stone  
**Item Quantity:** 1  
**Equipment Compliance:** No  
**Surface Area Compliance:** Yes

One or more handgrip(s) are damaged or missing. - Replace missing or damaged handgrips

The tread surface does not have a 10mm high safeguard that extends around the front of the surface and at least 75% of the sides of the surface as required by BS EN 16630 - Monitor - No remedial work recommended

There are gaps between 8 and 60mm creating a potential crush/shear point in contravention of the requirements of BS EN 16630 - Monitor - No remedial work recommended

There is some damage to the sign - Monitor for any further deterioration and repair as required

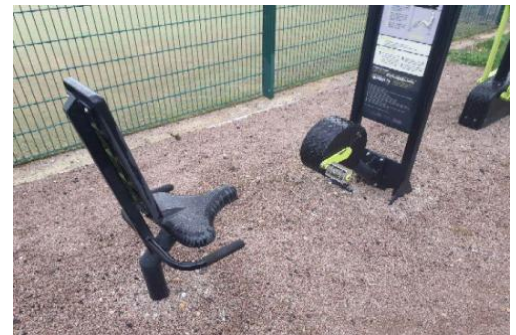
**Item:** Cycle  
**Manufacturer:** The Great Outdoor Gym Company  
**Surface Type:** Crushed Stone  
**Item Quantity:** 1  
**Equipment Compliance:** No  
**Surface Area Compliance:** Yes

There is some damage to the sign - Replace sign

The paintwork on this item has been damaged or worn exposing the metal underneath which is rusting / corroding - Treat affected areas and repaint

There is some damage to the handgrip - Monitor for any further deterioration and repair as required

There are obstacles located within the movement space of the item in contravention of the requirements of BS EN 16630 - Monitor - No remedial work recommended

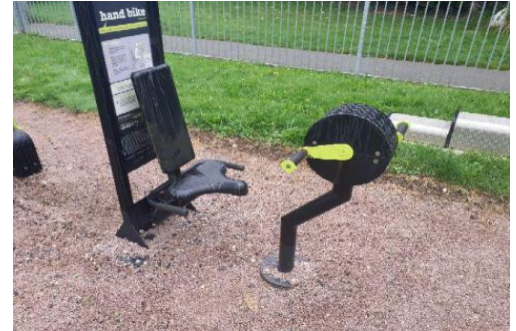
**Item:** Hand Bike  
**Manufacturer:** The Great Outdoor Gym Company  
**Surface Type:** Crushed Stone  
**Item Quantity:** 1  
**Equipment Compliance:** Yes  
**Surface Area Compliance:** Yes

There is some damage to the handgrip - Monitor for any further deterioration and repair as required

The paintwork on this item has been damaged or worn exposing the metal underneath which is rusting / corroding - Treat affected areas and repaint

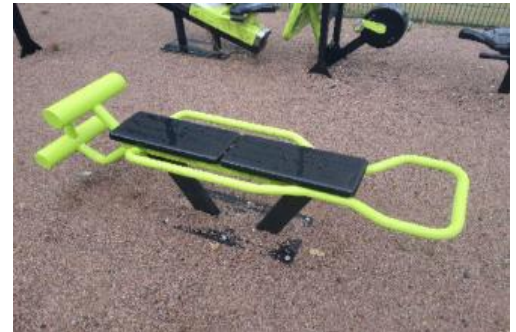
**Item:** Ab Station  
**Manufacturer:** The Great Outdoor Gym Company  
**Surface Type:** Crushed Stone  
**Item Quantity:** 1  
**Equipment Compliance:** Yes  
**Surface Area Compliance:** Yes

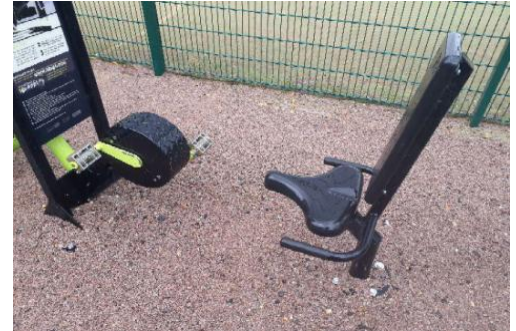
**Item:** Cycle  
**Manufacturer:** The Great Outdoor Gym Company  
**Surface Type:** Crushed Stone  
**Item Quantity:** 1  
**Equipment Compliance:** No  
**Surface Area Compliance:** Yes

There are obstacles located within the movement space of the item in contravention of the requirements of BS EN 16630 - Monitor - No remedial work recommended

There is some damage to the sign - Replace

There is some damage to the item - Monitor for any further deterioration and repair as required

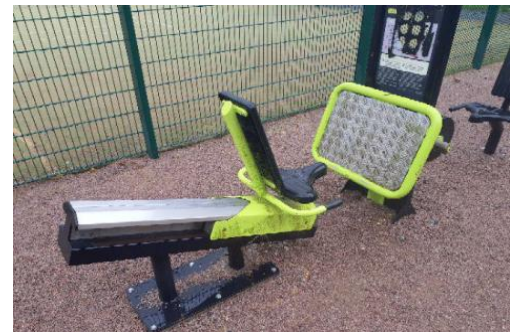
**Item:** Leg Press  
**Manufacturer:** The Great Outdoor Gym Company  
**Surface Type:** Crushed Stone  
**Item Quantity:** 1  
**Equipment Compliance:** No  
**Surface Area Compliance:** Yes

There is some damage to the sign - Replace

There are obstacles located within the movement space of the item in contravention of the requirements of BS EN 16630 - Monitor - No remedial work recommended

The item has missing component(s) - Consider replacing missing components

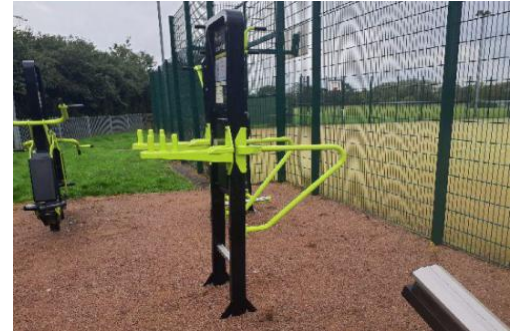
**Item:** Dip Station  
**Manufacturer:** The Great Outdoor Gym Company  
**Surface Type:** Crushed Stone  
**Item Quantity:** 1  
**Equipment Compliance:** No  
**Surface Area Compliance:** Yes

The paintwork on this item has been damaged or worn exposing the metal underneath which is rusting / corroding - Treat affected areas and repaint

There are obstacles located within the movement space of the item in contravention of the requirements of BS EN 16630 - Monitor - No remedial work recommended

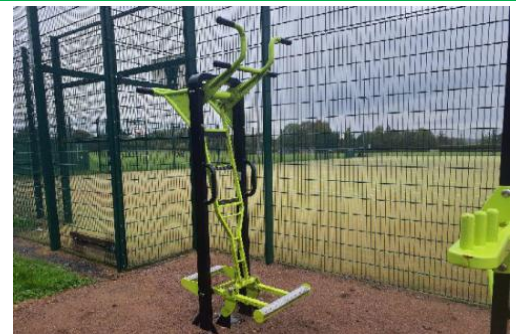
**Item:** Pull Up Station  
**Manufacturer:** The Great Outdoor Gym Company  
**Surface Type:** Crushed Stone  
**Item Quantity:** 1  
**Equipment Compliance:** No  
**Surface Area Compliance:** Yes

There are obstacles located within the movement space of the item in contravention of the requirements of BS EN 16630 - Monitor - No remedial work recommended

The sign is missing and sharp edges are present - Replace sign

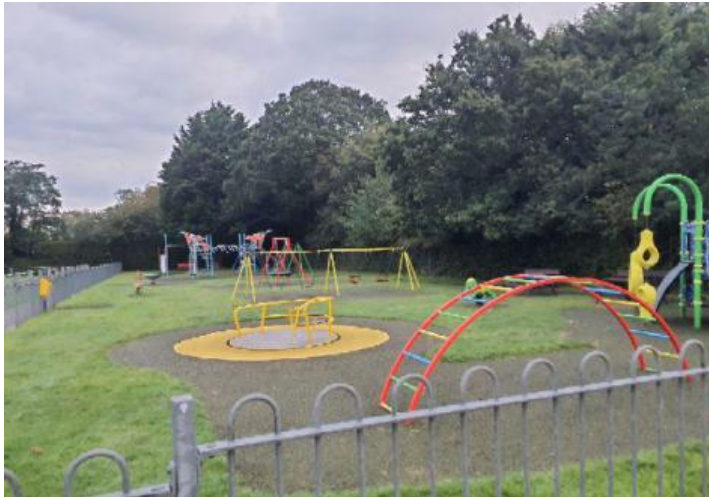
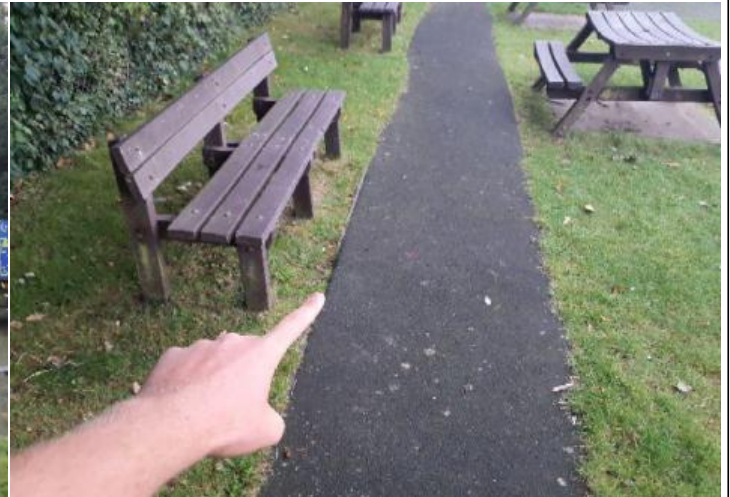
**Finding:** A section of pathway edging is damaged

**Action:** Replace

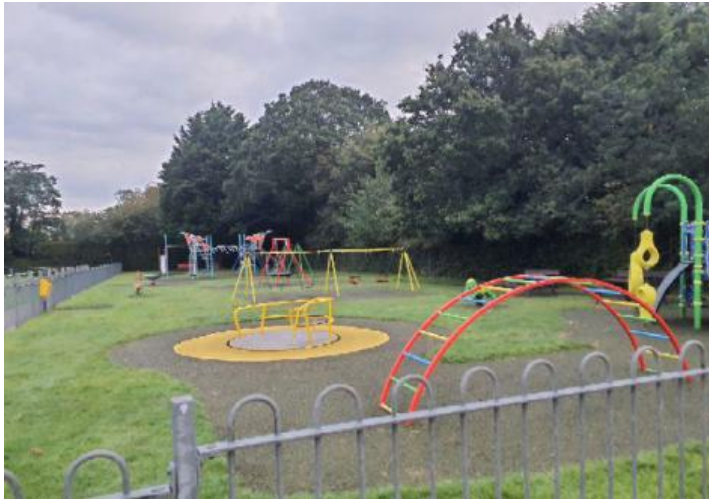
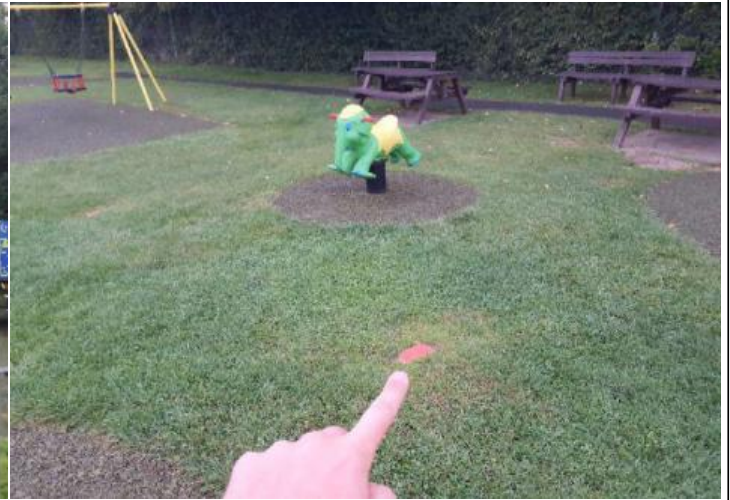
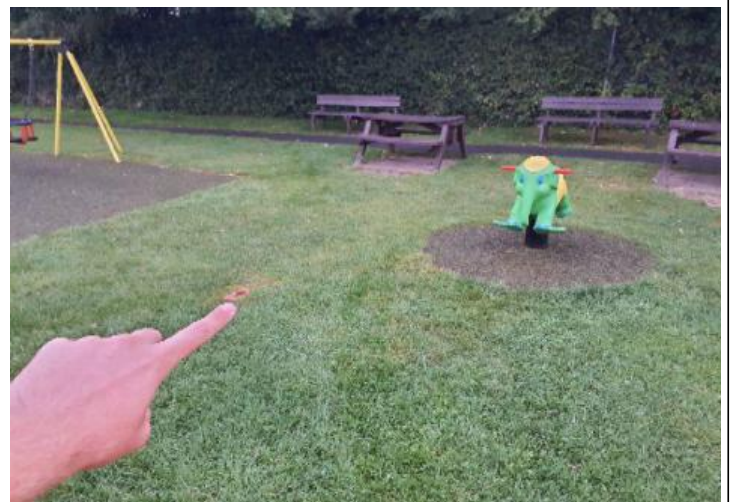
**Finding:** There is a redundant spring base in the area

**Action:** Remove or reinstate the surface

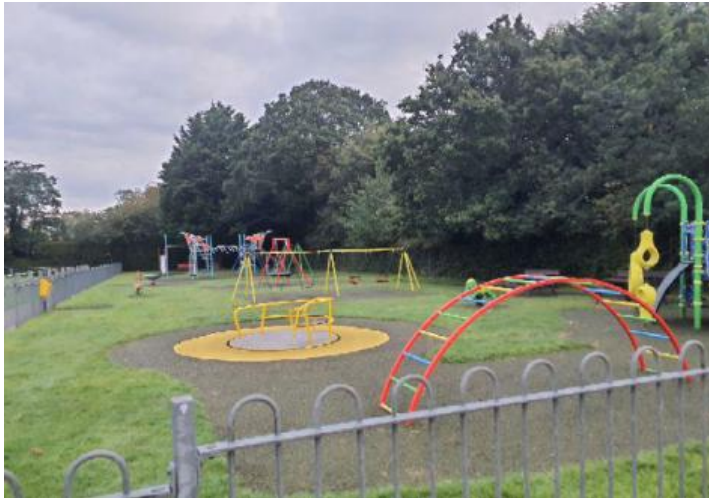
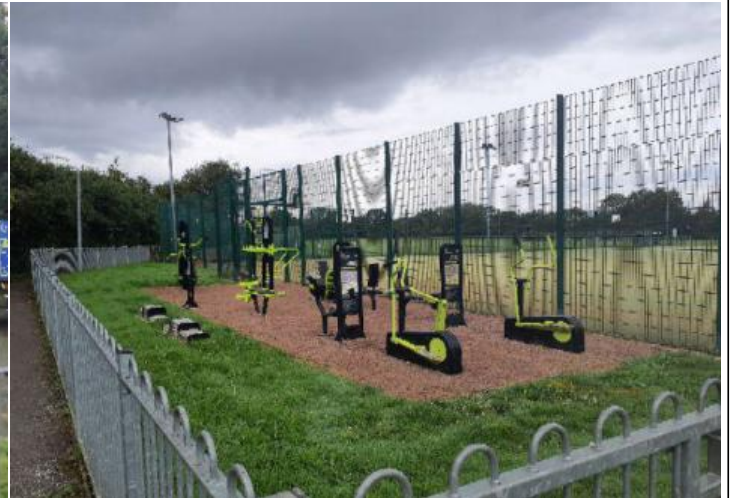
**Finding:** Signage should be provided for the outdoor fitness equipment in accordance with the requirements of BS EN 16630, key requirements of the sign include, but are not limited to, intended users, medical safety and emergency contact details  
**Action:** Provide appropriate signage

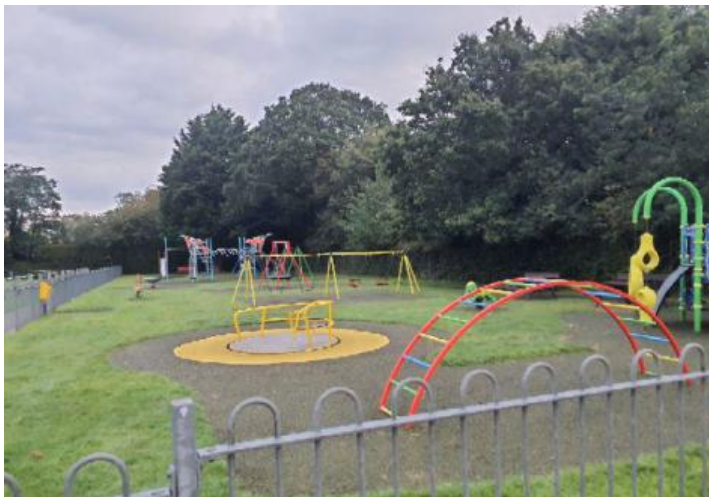
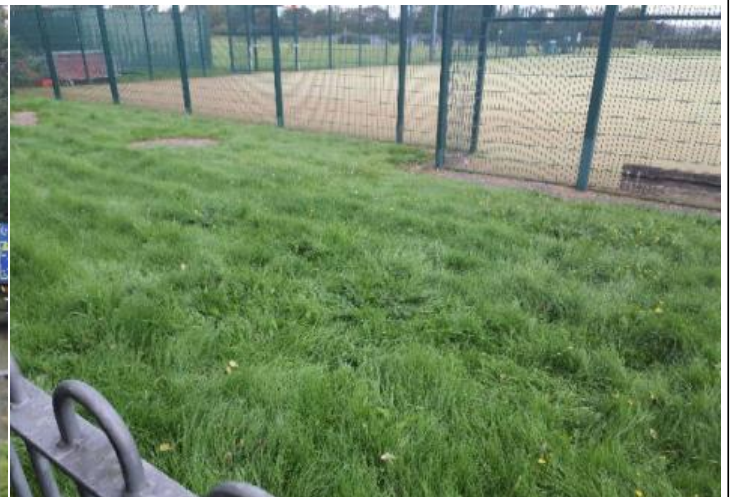
**Finding:** The grass is overgrown within the fitness area and may hide hazards  
**Action:** Reduce the length of grass to an acceptable height and maintain

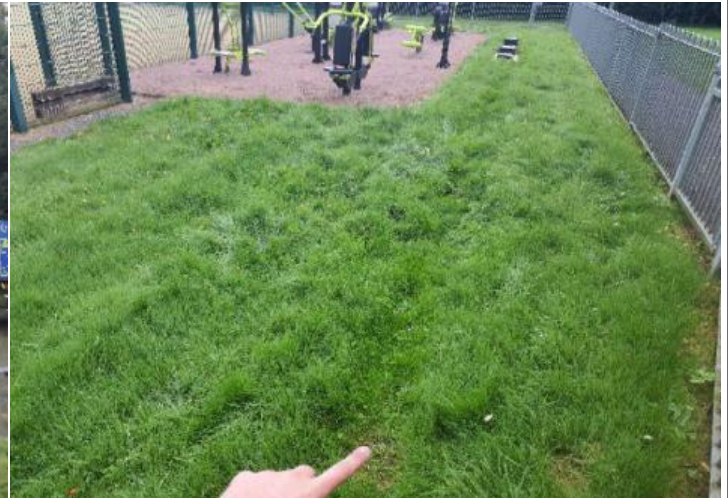
**Finding:** There are redundant concrete foundations in the fitness area  
**Action:** Remove

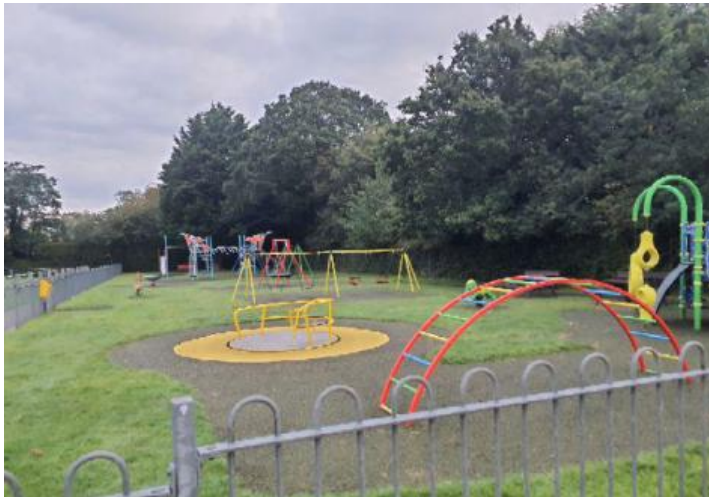
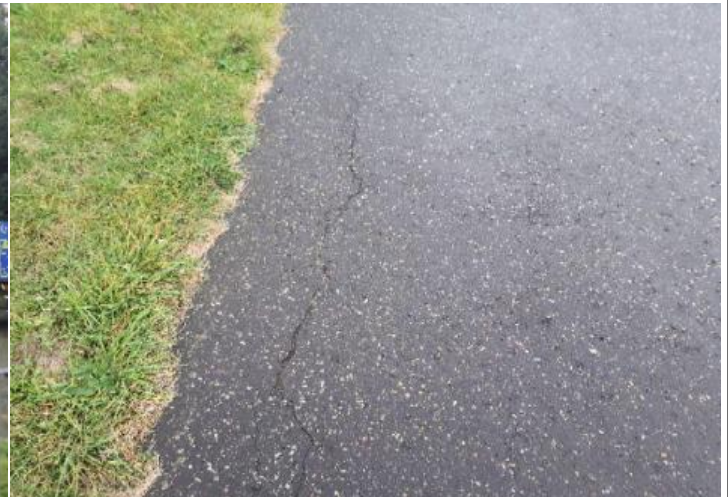
**Finding:** There are cracks in the rolling surface of the skate area  
**Action:** Monitor for any further deterioration and repair as required

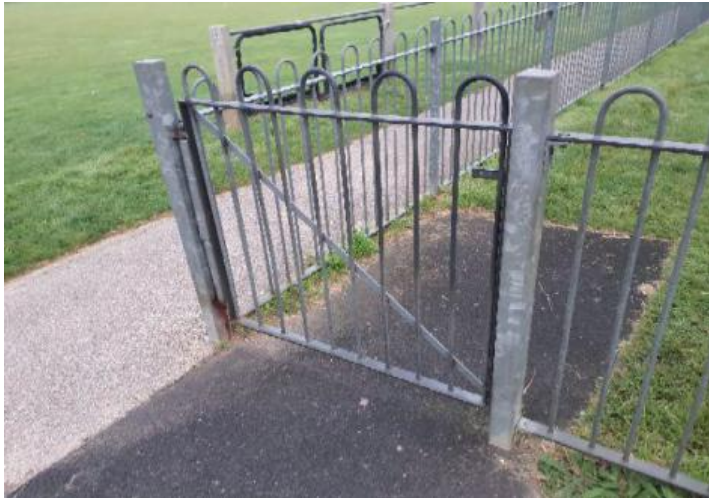
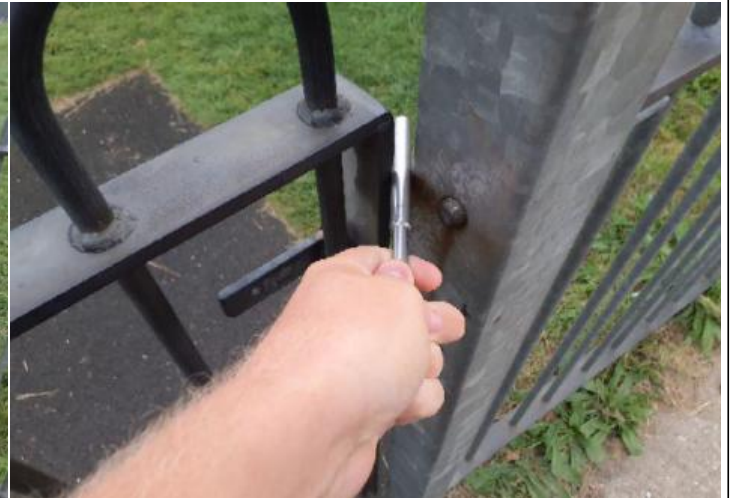
**Finding:** There are openings that are less than 12mm that could trap or crush fingers

**Action:** Provide a 12mm gap throughout full range of motion at both sides of gate

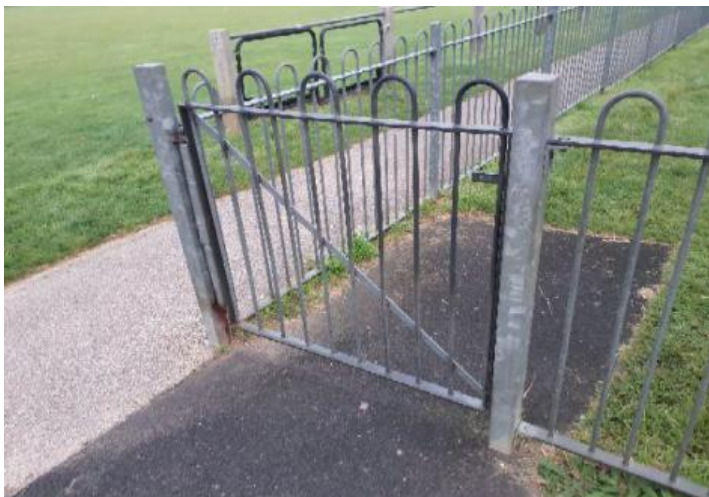
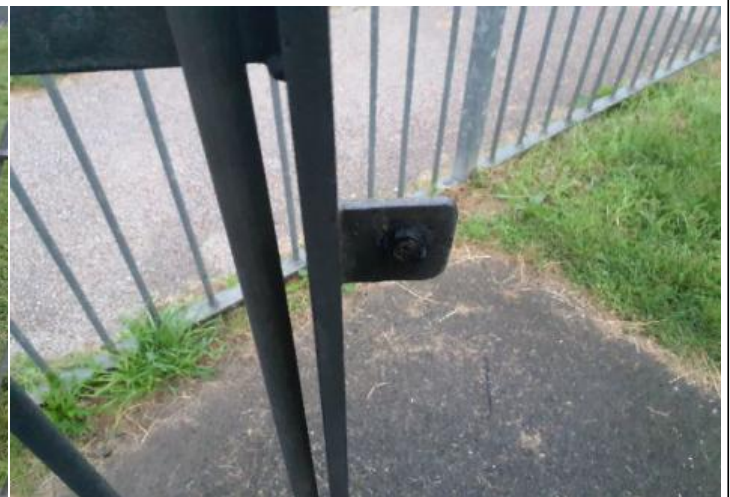
**Finding:** The rubber buffer is damaged

**Action:** Replace rubber buffer

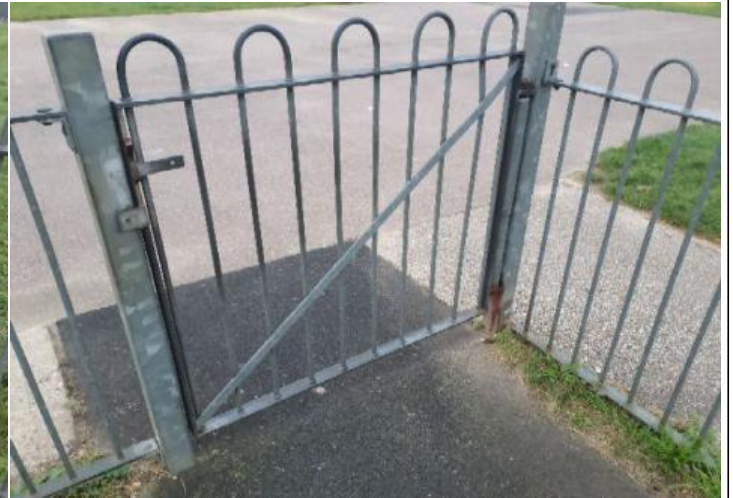
**Finding:** The gate is closing too quickly (less than 4 seconds)

**Action:** Take corrective action to ensure that the gate closes in 4-8 seconds

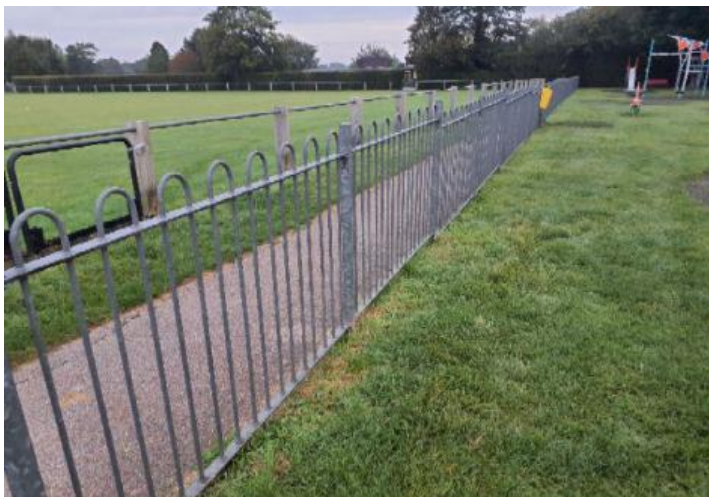
**Finding:** There is some damage to the fence sections

**Action:** Monitor for any further deterioration and repair as required

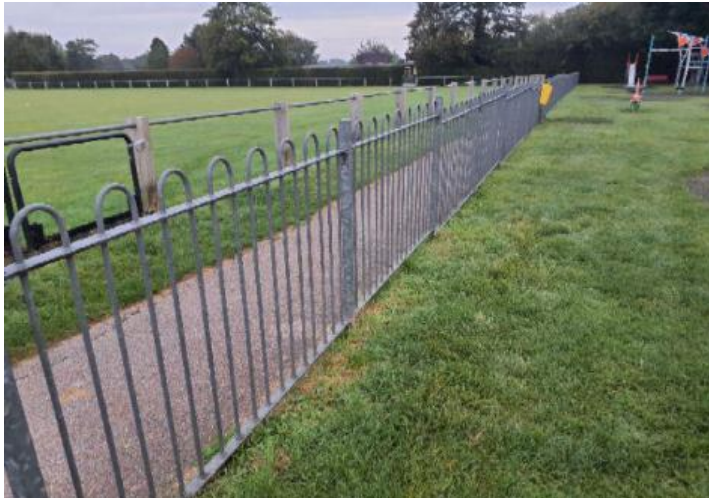
**Item:** Fences - Fence - Bow Top  
**Manufacturer:** Owner/Operator

**Finding:** A number of fixing(s) have worked loose

**Action:** Secure all loose fixings

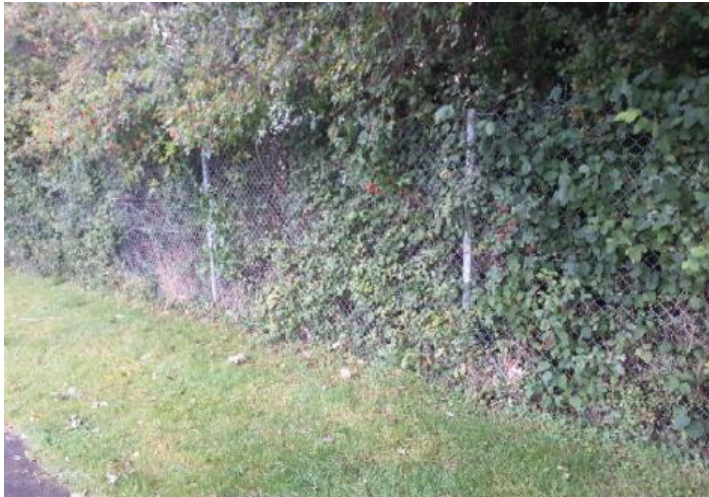
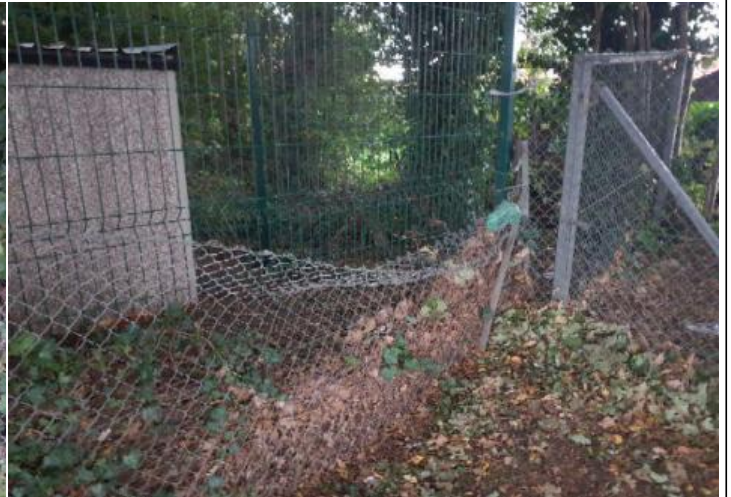
**Item:** Fences - Fence - Chainlink  
**Manufacturer:** Not Identified

**Finding:** The fence is severely damaged in places

**Action:** Repair or replace all affected sections

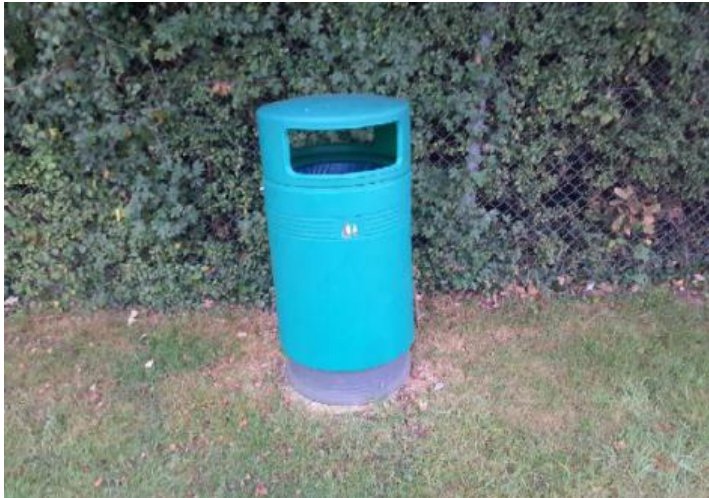
**Item:** Ancillary Items - Litter Bin  
**Manufacturer:** Not Identified

**Finding:** A number of fixing(s) have worked loose

**Action:** Secure all loose fixings

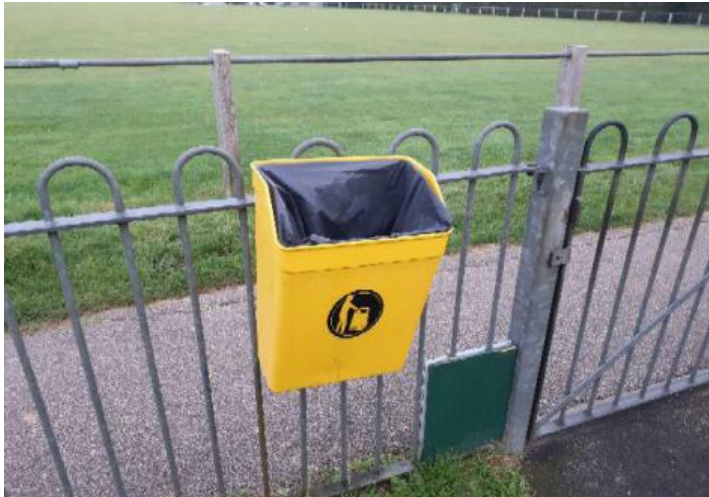
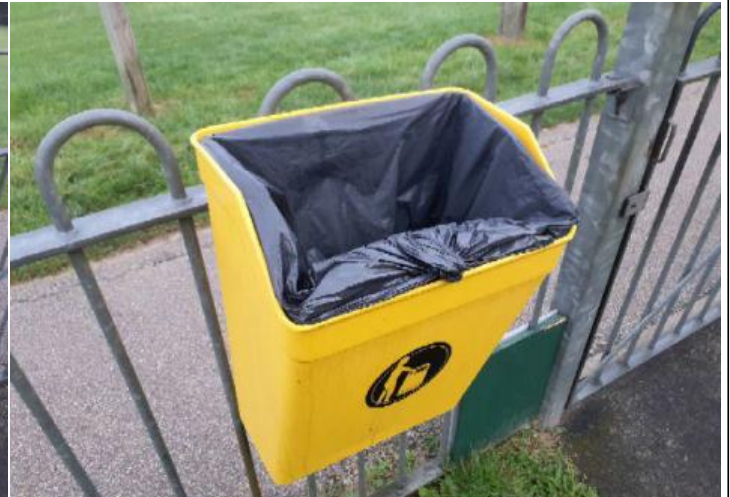
**Item:** Ancillary Items - Litter Bin  
**Manufacturer:** Not Identified

**Finding:** The liner of the litter bin is not secured

**Action:** Ensure the lid/door is kept locked and the liner secured

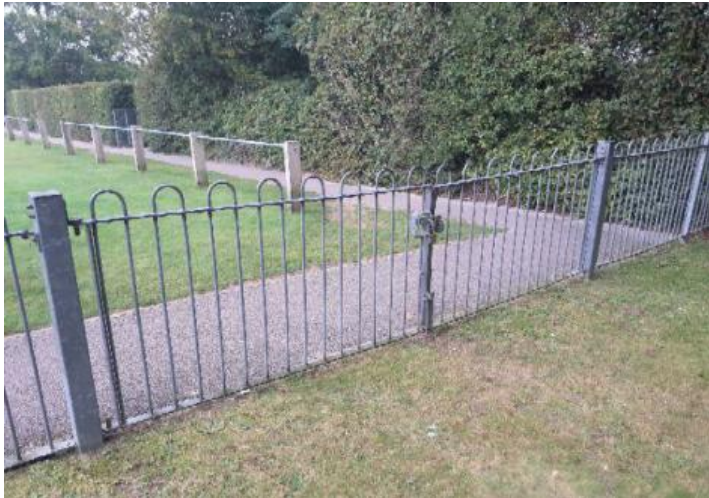
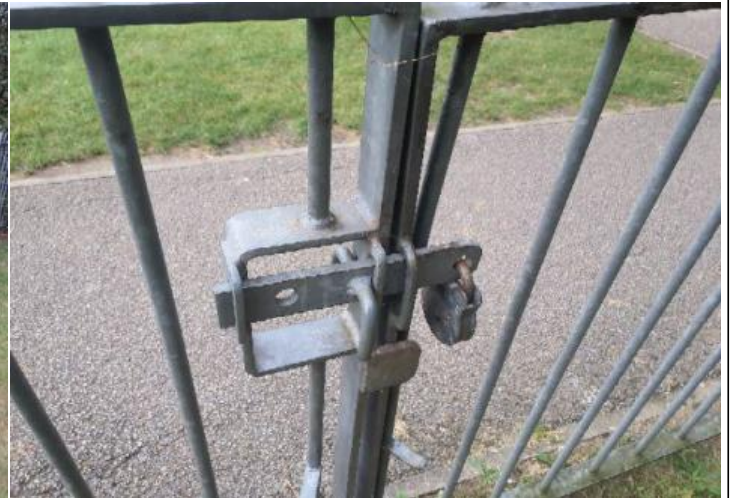
**Item:** Gates - Gate - Maintenance  
**Manufacturer:** Not Identified

**Finding:** The maintenance gate was correctly padlocked at the time of inspection, however this means that the inspector was unable to fully assess the gate

**Action:** Ensure that there are 12mm gaps throughout the full range of motion on gate/s and between leaves where relevant

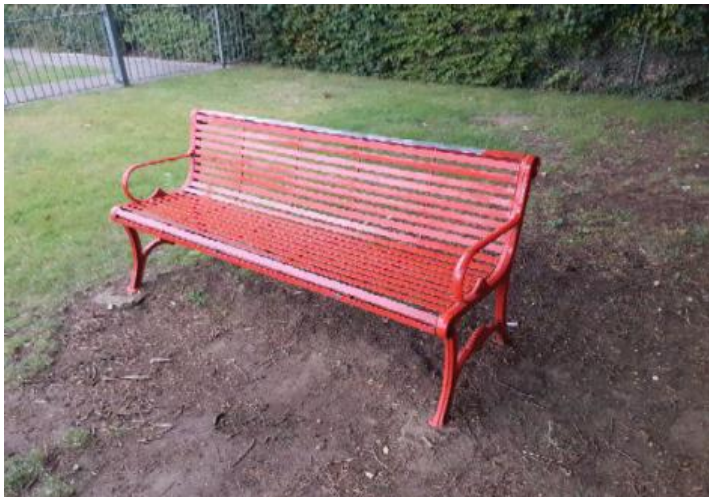
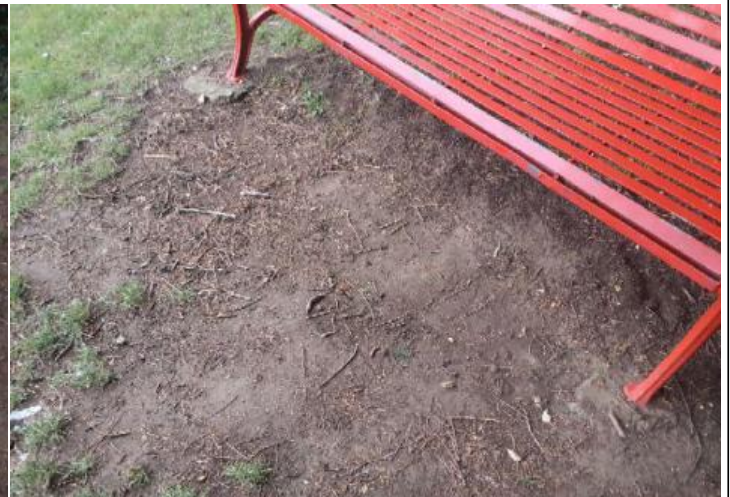
**Item:** Ancillary Items - Bench  
**Manufacturer:** Not Identified

**Finding:** The surface has eroded in some areas and may be slippery in wet conditions

**Action:** Reinststate the surface
