# the **play inspection** company

## Annual Inspection

Long Stratton Town Council

Manor Road Playing Fields

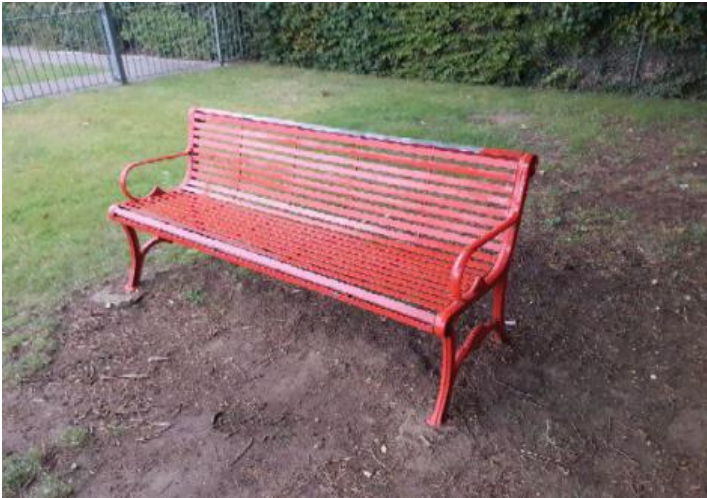
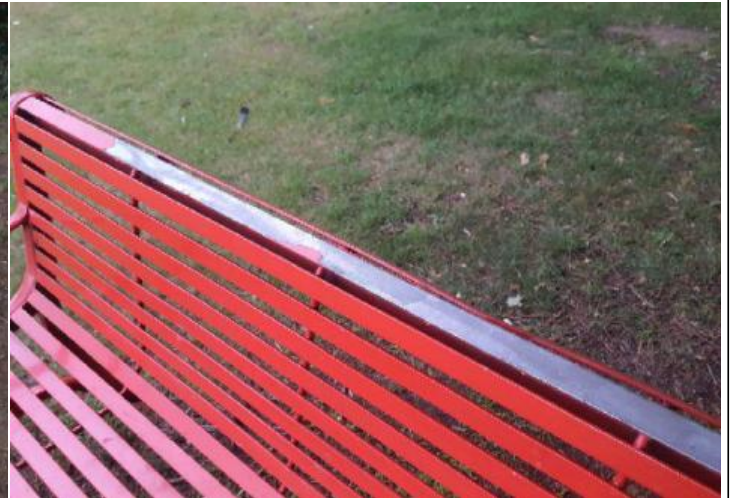
**Item:** Ancillary Items - Bench  
**Manufacturer:** Not Identified

**Finding:** The paint is flaking off the metalwork

**Action:** Rub down and re-paint

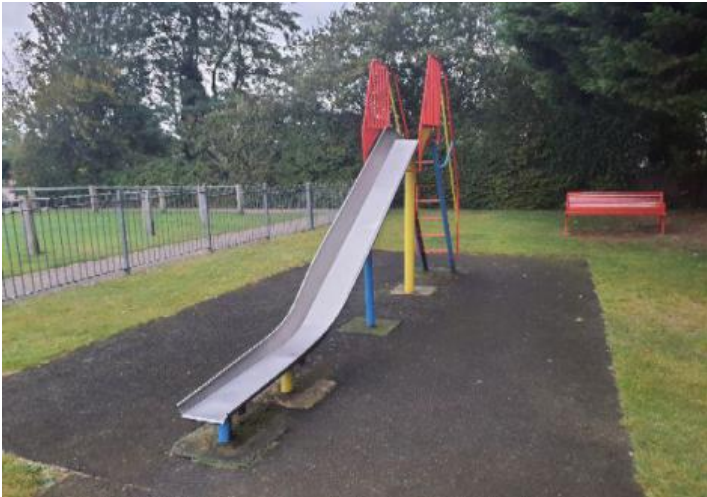
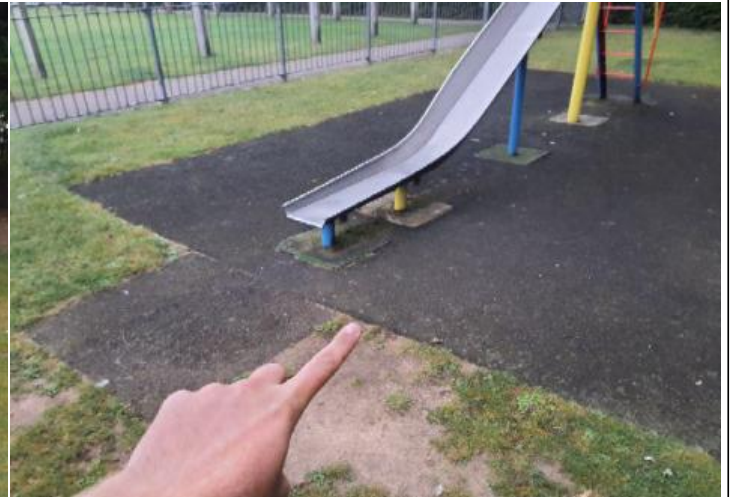
**Item:** Other - Free Standing Slide  
**Manufacturer:** Not Identified

**Finding:** There are trip hazards at the edges of the surface

**Action:** Reinstate surrounding surface levels to remove the trip points

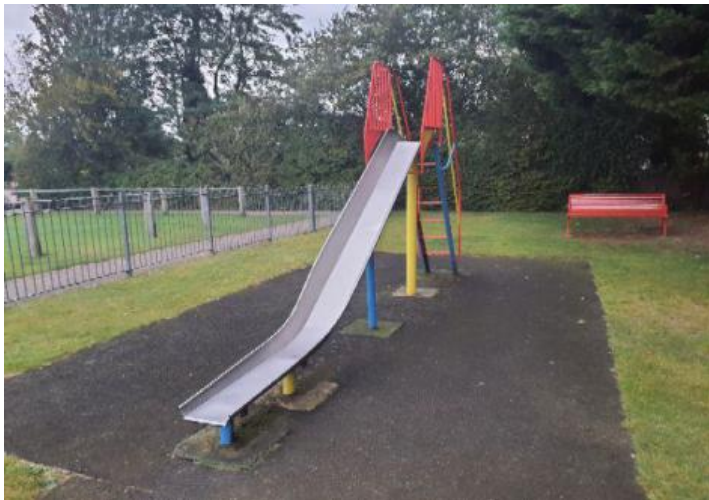
**8 - Low Risk (Finding 2)**

**Item:** Other - Free Standing Slide  
**Manufacturer:** Not Identified  
**Risk Level:** L - Low Risk  
**Surface:** Wet Pour

**Finding:** There is algae, silt or moss growth on the surface resulting in slippery conditions  
**Action:** Clean and treat appropriately

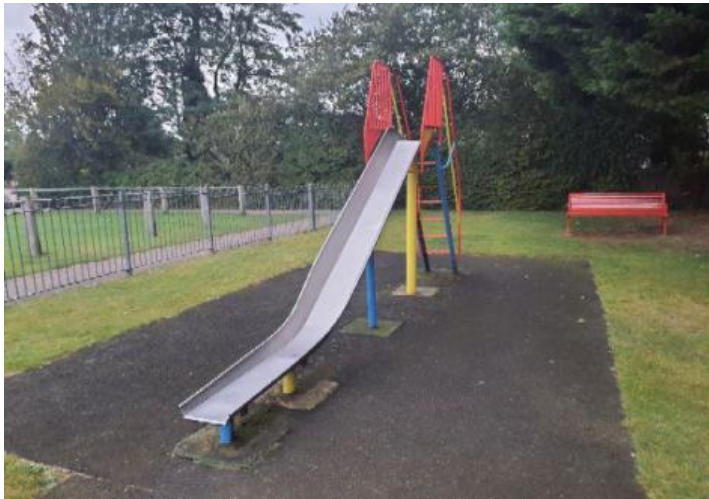
**4 - Very Low Risk (Finding 3)**

**Item:** Other - Free Standing Slide  
**Manufacturer:** Not Identified  
**Risk Level:** V - Very Low Risk  
**Surface:** Wet Pour

**Finding:** There are a number of dents in the slide surface  
**Action:** Monitor for any further deterioration and repair as required

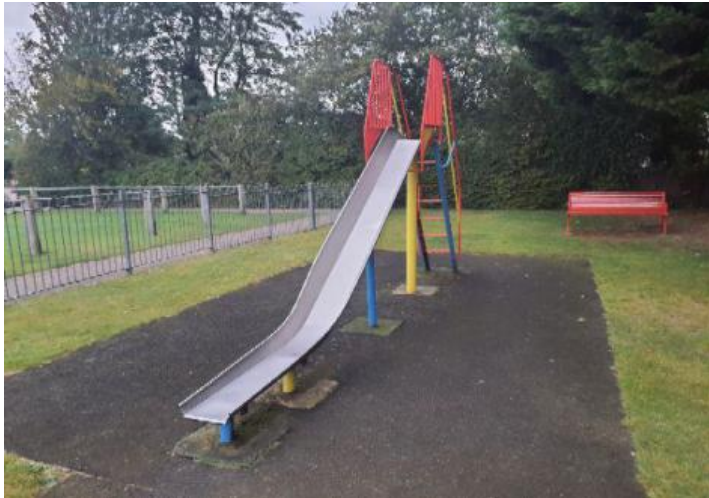
**i** 8 - Low Risk (Finding 4)

**Item:** Other - Free Standing Slide  
**Manufacturer:** Not Identified

**Finding:** The surface is lifting at the edges and creating trip points  
**Action:** Repair perimeter of surfacing to remove trip points

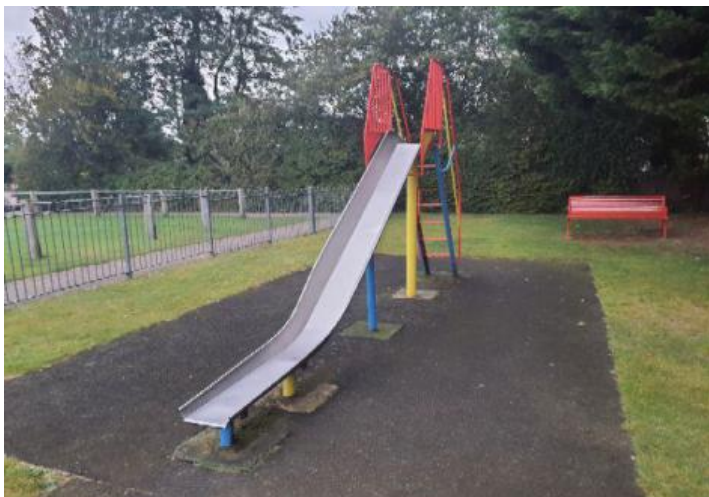
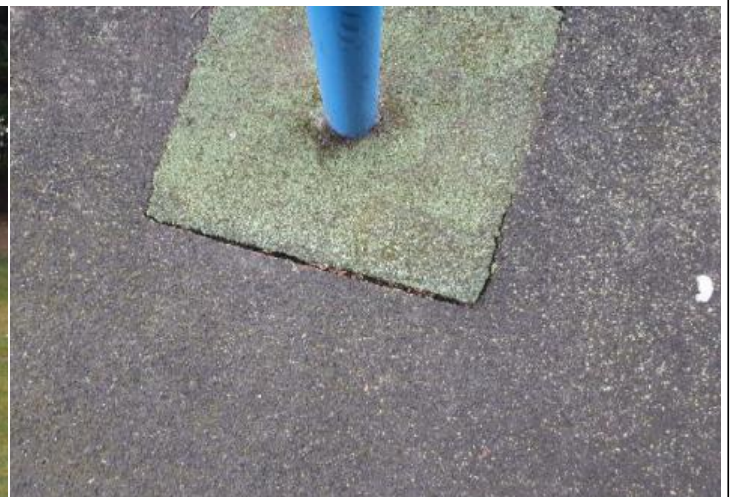
**i** 6 - Low Risk (Finding 5)

**Item:** Other - Free Standing Slide  
**Manufacturer:** Not Identified

**Finding:** There are gaps opening between the surfacing and the edging surround or between the joints in the surfacing  
**Action:** Monitor for any further deterioration and repair as required

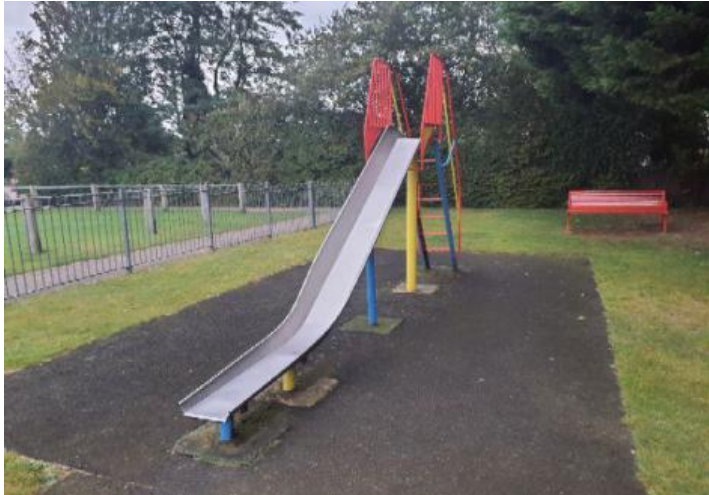
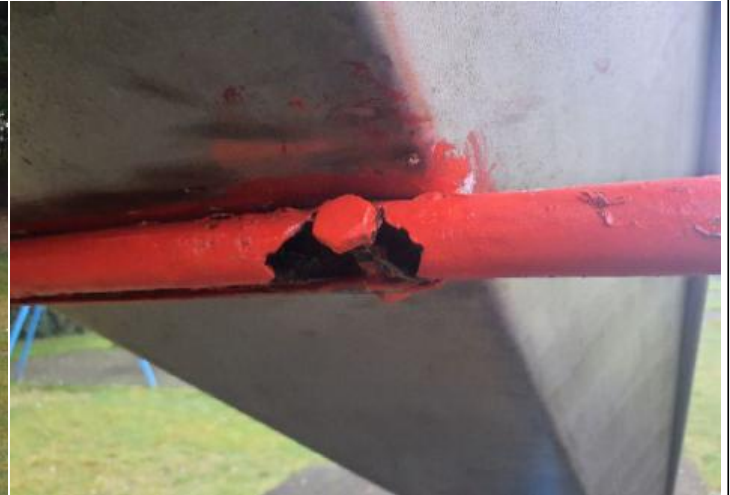
12 - Moderate Risk (Finding 6)

**Item:** Other - Free Standing Slide  
**Manufacturer:** Not Identified

**Finding:** Parts of the steel on this item have corroded excessively and the metal has perforated in places

**Action:** Ensure all affected areas are treated and repaired

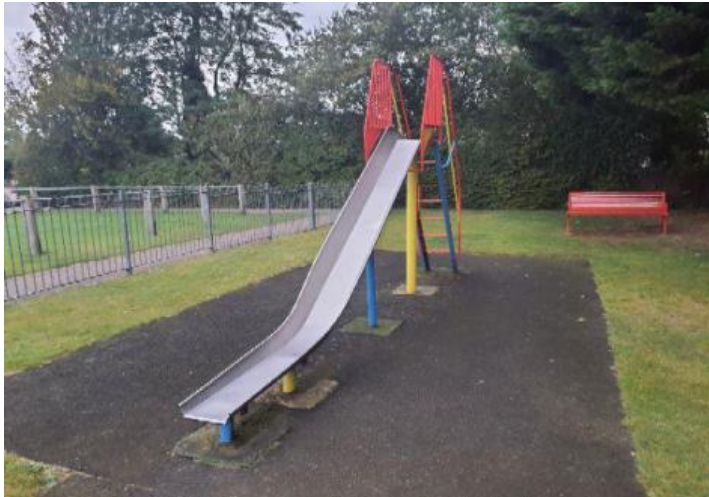
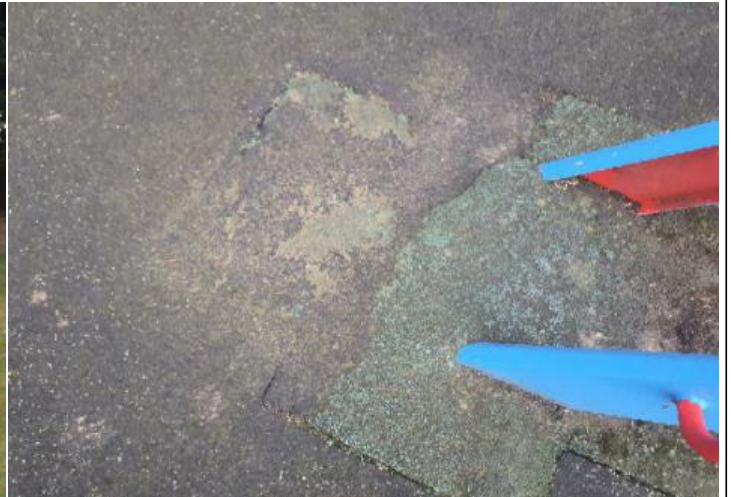
**Item:** Other - Free Standing Slide  
**Manufacturer:** Not Identified

**Finding:** There is some minor damage to the surface

**Action:** Monitor for any further deterioration and repair as required

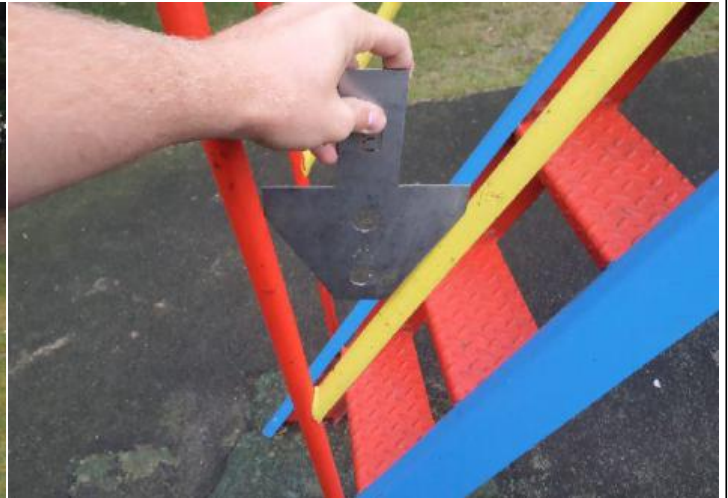
**Item:** Other - Free Standing Slide  
**Manufacturer:** Not Identified

**Finding:** The item fails to meet the requirements of BS EN 1176 Part 1 4.2.7.2 for head and neck entrapment in the frame

**Action:** Monitor - No remedial work recommended

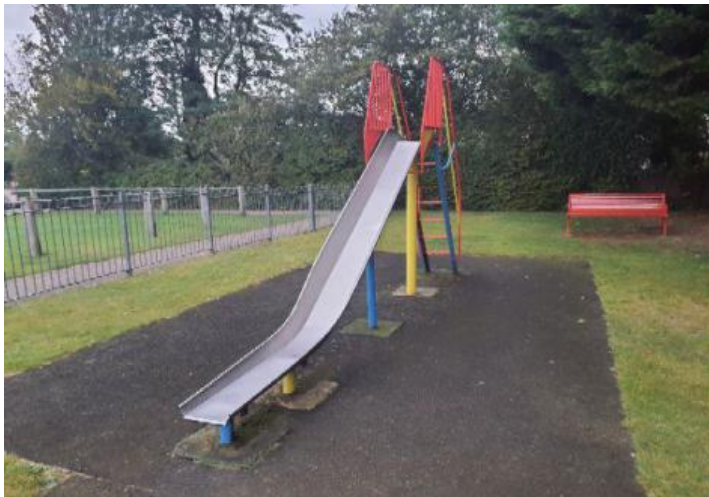
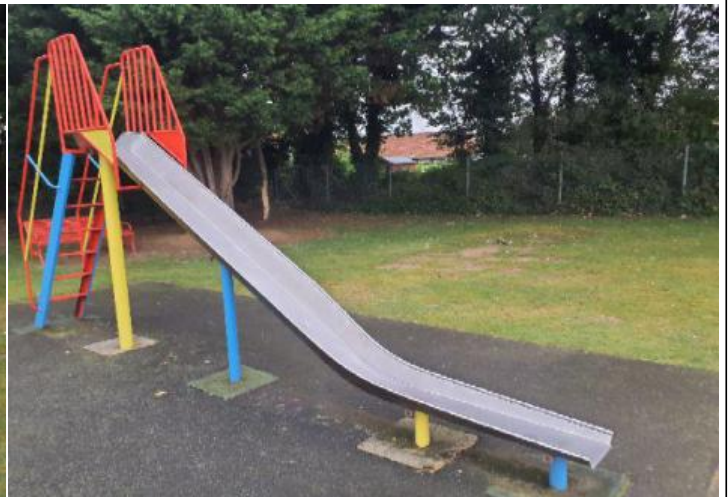
**Item:** Other - Free Standing Slide  
**Manufacturer:** Not Identified

**Finding:** The slide is predominately south facing and will catch the majority of the sun's heat during the day. Slide surfaces can become very warm during periods of sustained sunny weather

**Action:** Monitor - No remedial work recommended

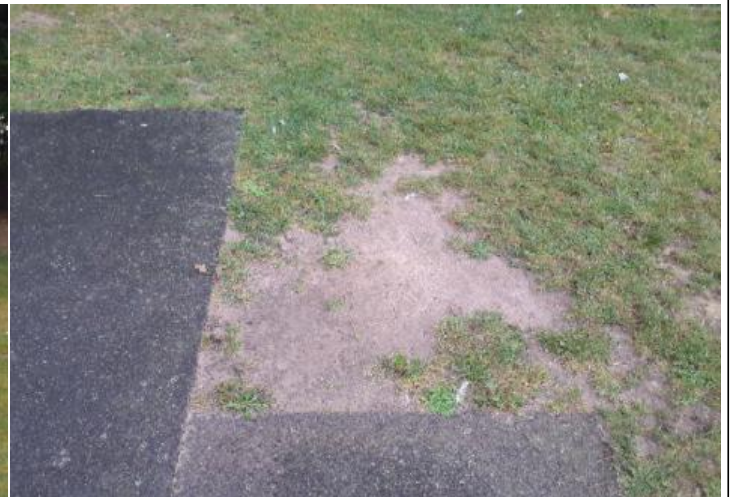
**Item:** Other - Free Standing Slide  
**Manufacturer:** Not Identified

**Finding:** The grass has eroded within the impact area of the equipment and may not provide the necessary impact attenuating properties for the equipment fall height; the surface may also be slippery in wet weather

**Action:** Reinstate the grass or provide an all weather surface

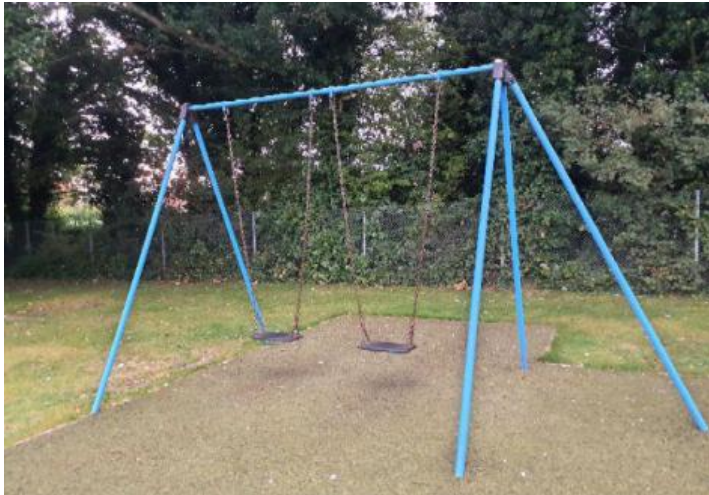
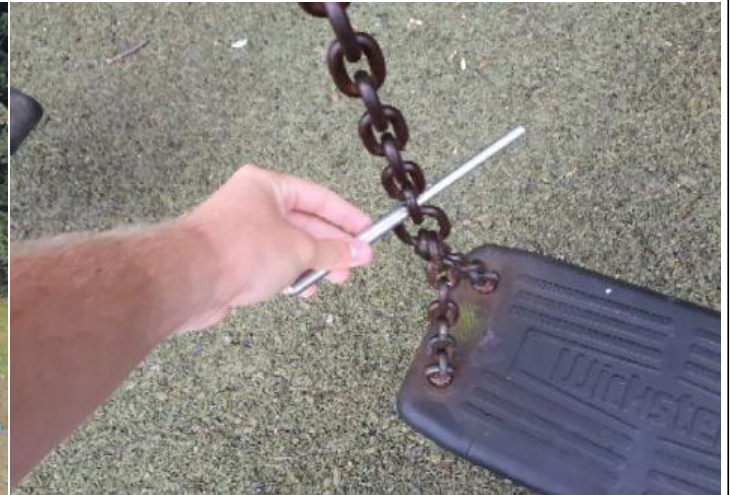
**Item:** Swings - 1 Bay 2 Seat (Flat)  
**Manufacturer:** Wicksteed Playgrounds

**Finding:** The chain openings are in excess of 8.6mm and do not meet the recommendations of BS EN 1176 Part 1

**Action:** Monitor - No remedial work recommended

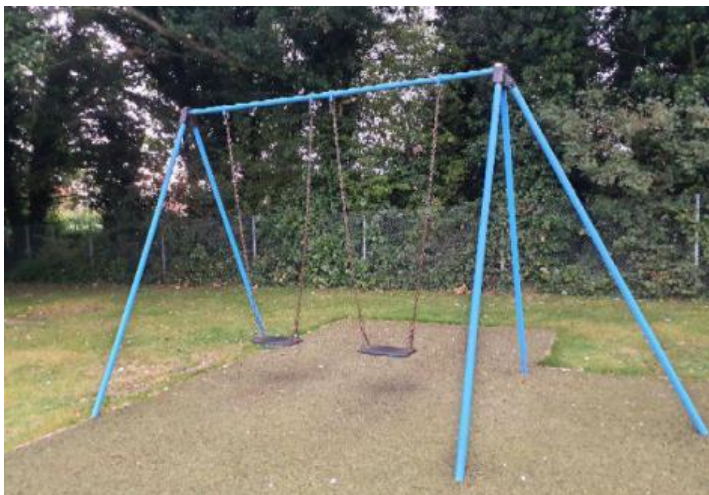
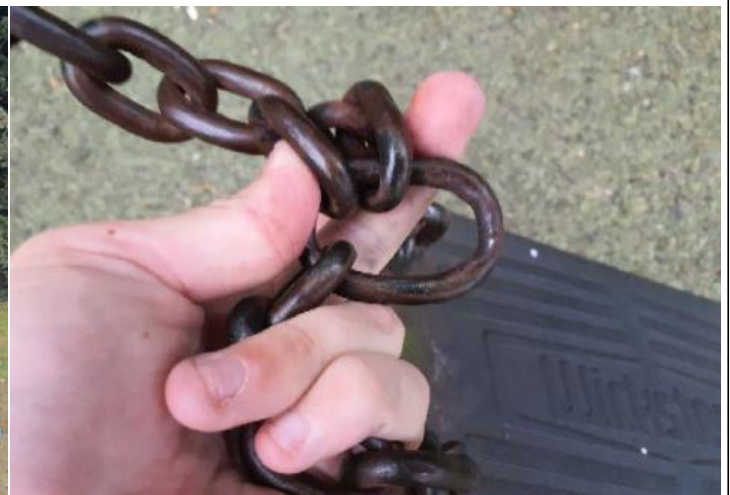
**Item:** Swings - 1 Bay 2 Seat (Flat)  
**Manufacturer:** Wicksteed Playgrounds

**Finding:** There is some notable evidence of chain wear

**Action:** Monitor for any further deterioration and replace when 40% worn

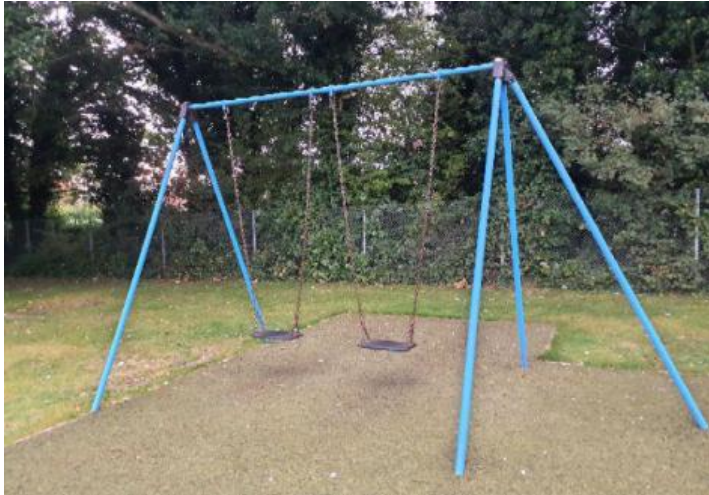
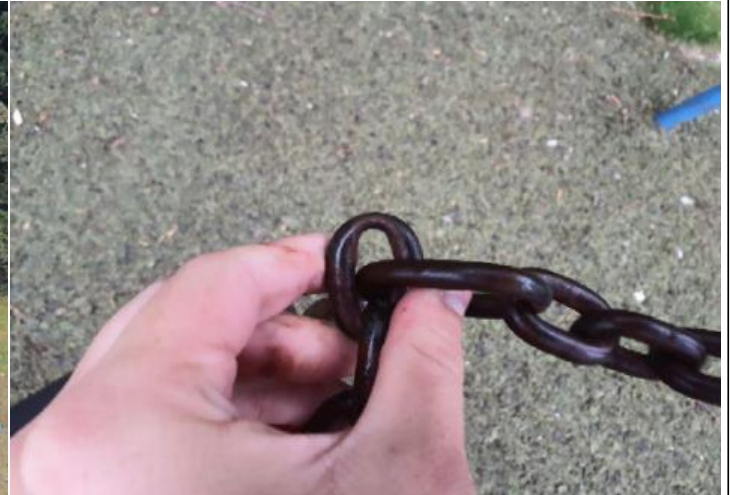
**Item:** Swings - 1 Bay 2 Seat (Flat)  
**Manufacturer:** Wicksteed Playgrounds

**Finding:** The chain links are worn in excess of 40% and require renewing

**Action:** Replace worn chains

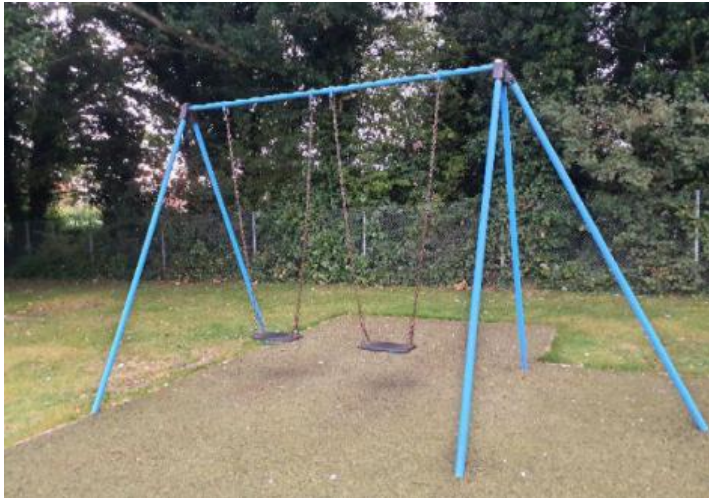
**Item:** Swings - 1 Bay 2 Seat (Flat)  
**Manufacturer:** Wicksteed Playgrounds

**Finding:** The bushes are worn or missing

**Action:** Replace worn or missing bushes

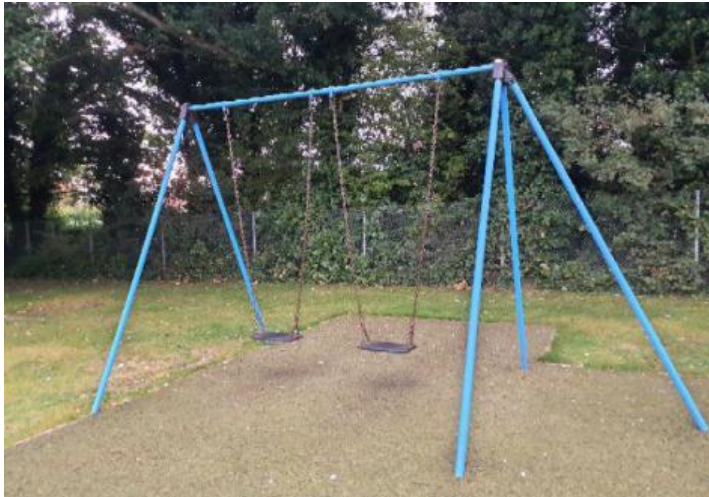
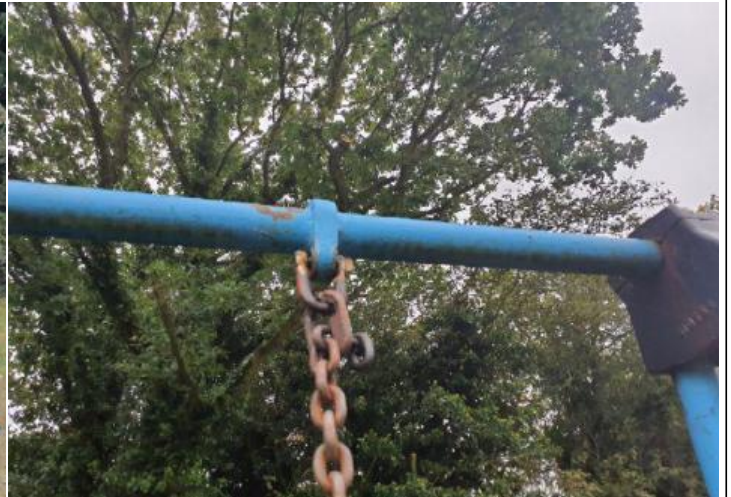
**Item:** Swings - 1 Bay 2 Seat (Flat)  
**Manufacturer:** Wicksteed Playgrounds

**Finding:** There is some wear to the shackles

**Action:** Monitor for any further deterioration and replace when 40% worn

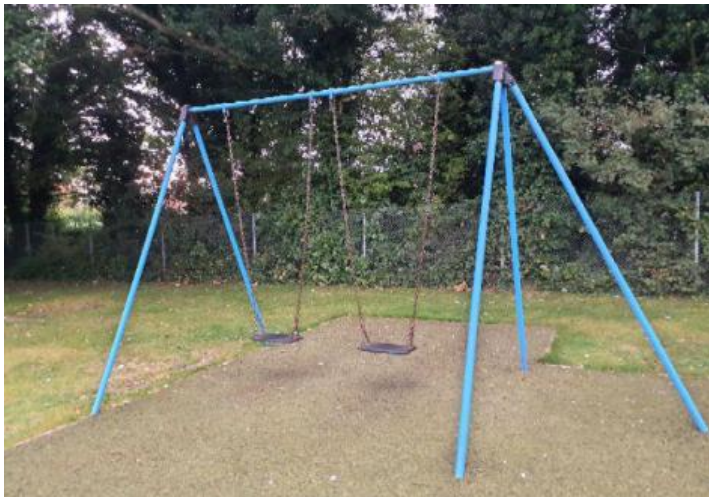
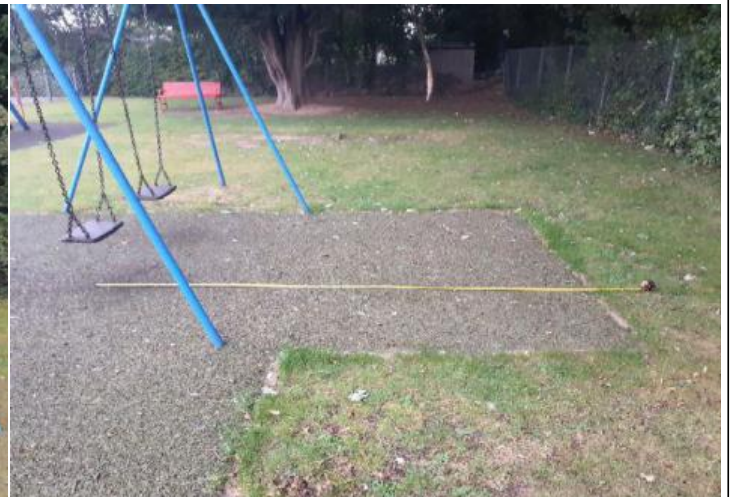
**Item:** Swings - 1 Bay 2 Seat (Flat)  
**Manufacturer:** Wicksteed Playgrounds

**Finding:** The surfacing dimensions are short and do not meet with the requirements of the current applicable standard  
**Action:** Monitor - no remedial action recommended

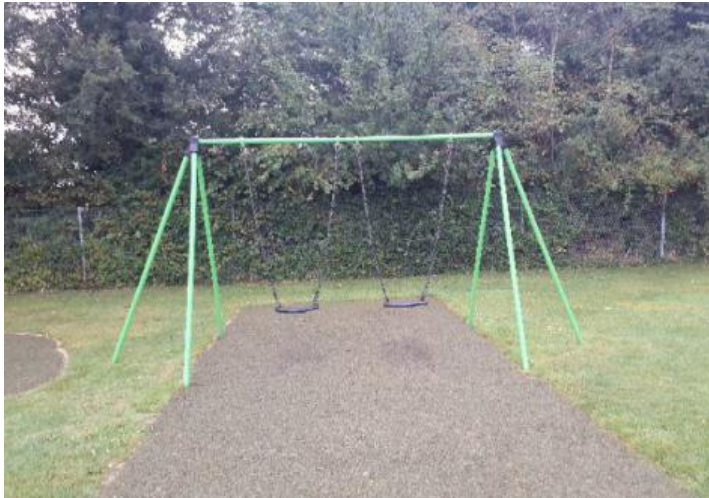
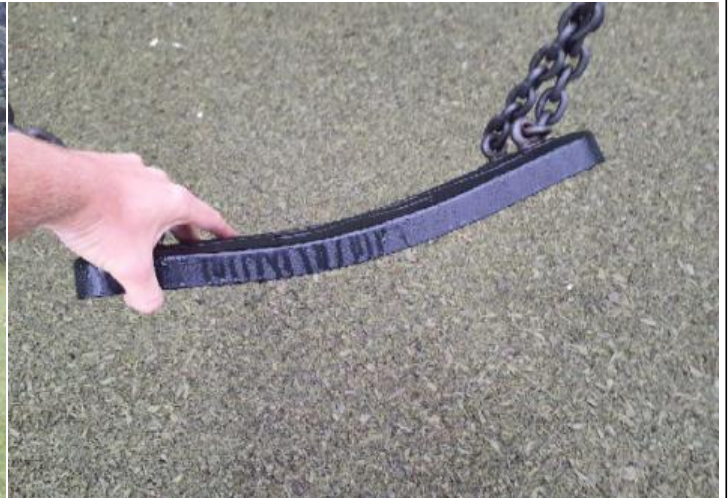
**i** 6 - Low Risk (Finding 1)

**Item:** Swings - 1 Bay 2 Seat (Flat)  
**Manufacturer:** Wicksteed Playgrounds

**Finding:** The seat has minor damage or wear

**Action:** Monitor for any further deterioration and replace as required

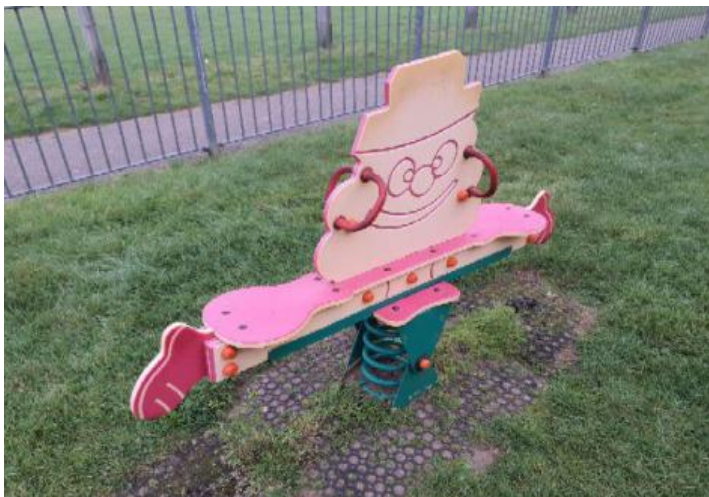
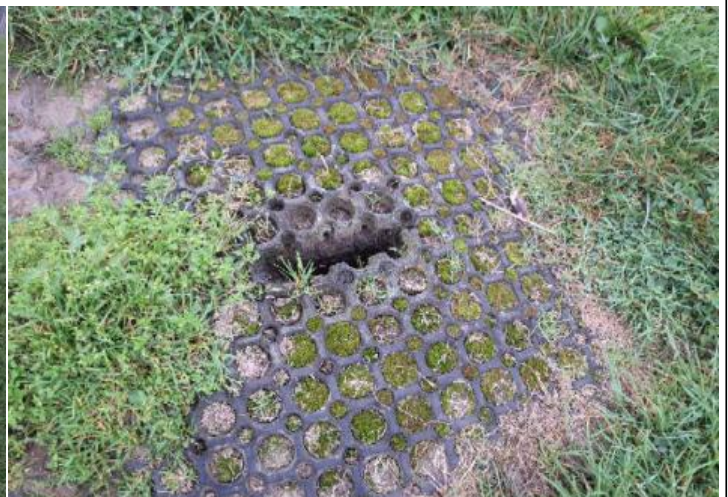
**Item:** Rocking Equipment - Spring See-Saw  
**Manufacturer:** Not Identified

**Finding:** There is moderate damage to the surface

**Action:** Repair the damaged areas of surfacing

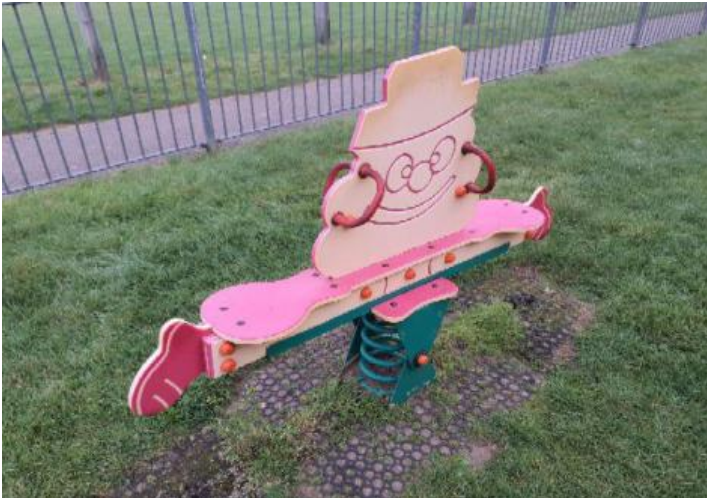
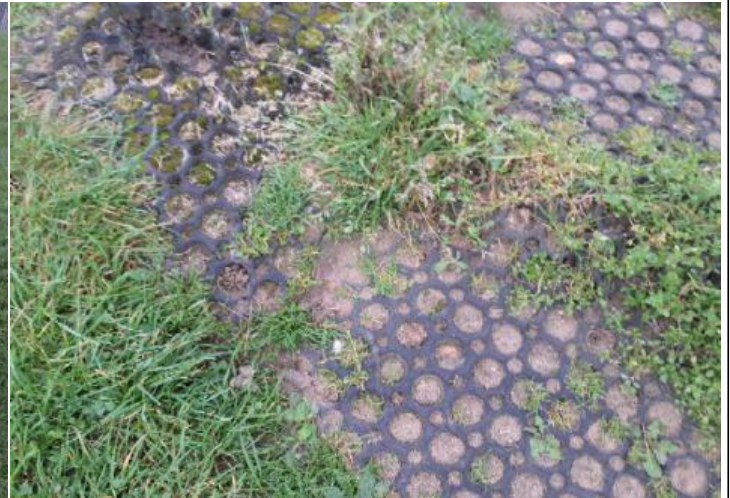
**Item:** Rocking Equipment - Spring See-Saw  
**Manufacturer:** Not Identified

**Finding:** There are gaps opening between the grass mat tiles

**Action:** Provide additional ties or secure / reinstate surface tiles

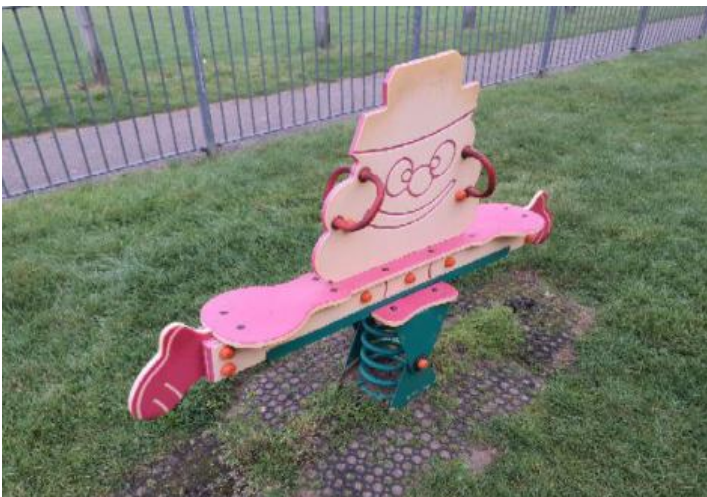
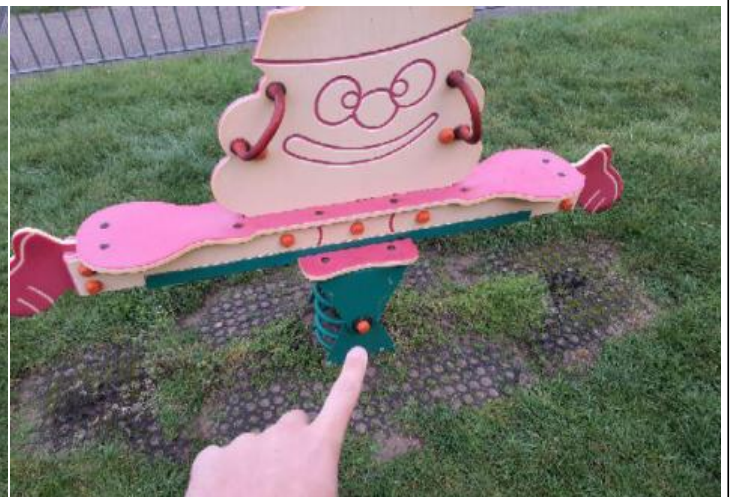
**Item:** Rocking Equipment - Spring See-Saw  
**Manufacturer:** Not Identified

**Finding:** There is movement within the pivot point

**Action:** Monitor for any further deterioration and repair as required

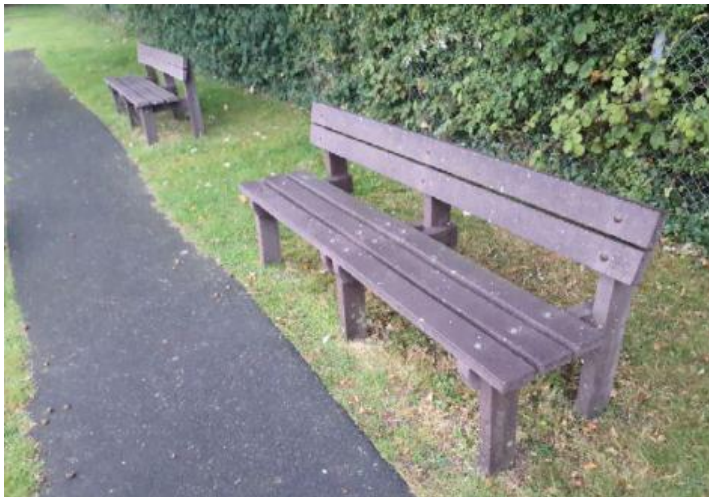
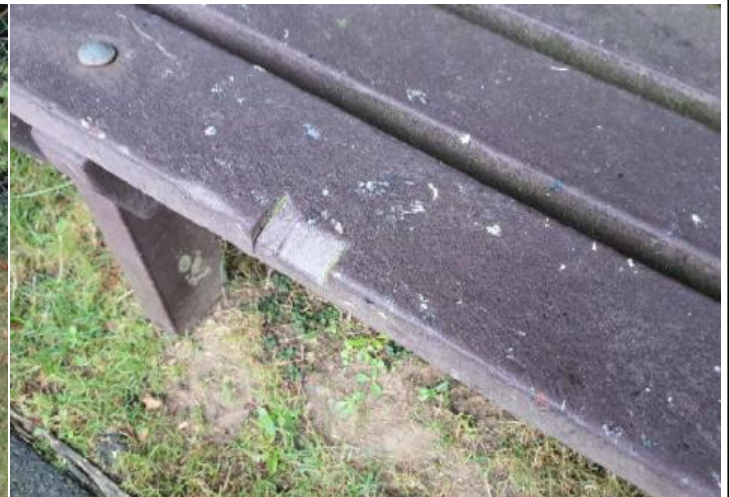
**i** 6 - Low Risk (Finding 1)

<b>Item:</b>	Ancillary Items - Bench	<b>Risk Level:</b>	L - Low Risk
<b>Manufacturer:</b>	Not Identified	<b>Surface:</b>	Grass

**Finding:** There is some damage to the item  
**Action:** Monitor for any further deterioration and repair as required

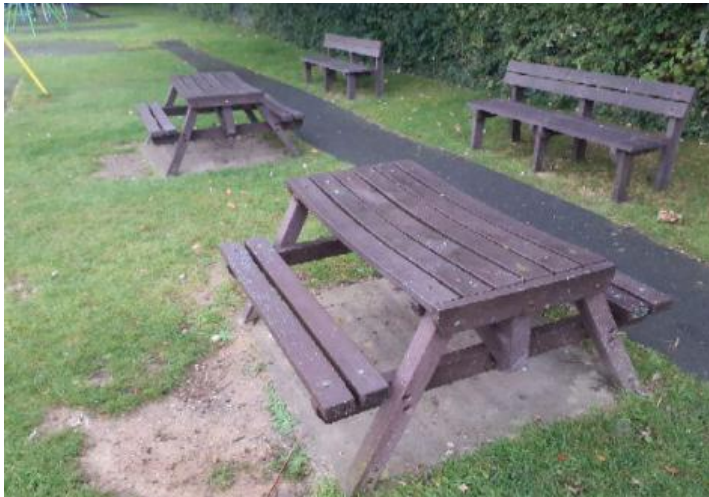
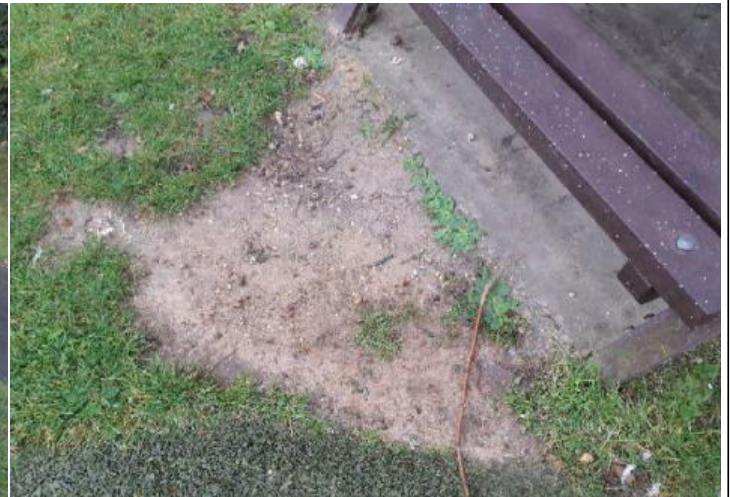
**i** 6 - Low Risk (Finding 1)

<b>Item:</b>	Ancillary Items - Picnic Table	<b>Risk Level:</b>	L - Low Risk
<b>Manufacturer:</b>	Not Identified	<b>Surface:</b>	Grass

**Finding:** The surface has eroded in some areas and may be slippery in wet conditions  
**Action:** Reinstate the surface

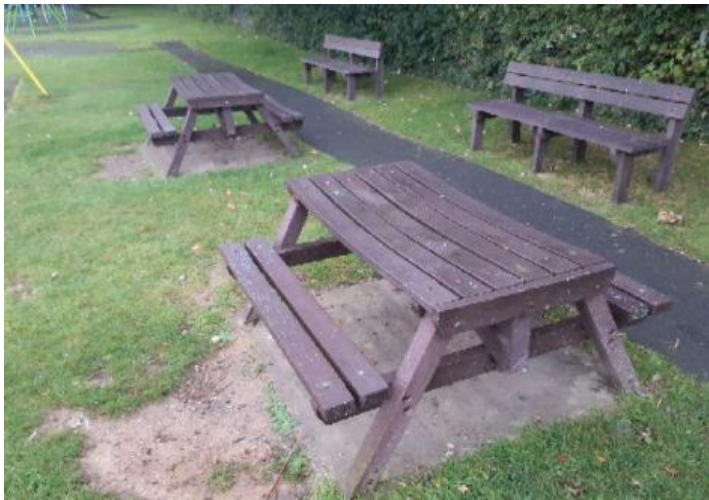
**i** 4 - Very Low Risk (Finding 2)

**Item:** Ancillary Items - Picnic Table  
**Manufacturer:** Not Identified  
**Risk Level:** V - Very Low Risk  
**Surface:** Grass

**Finding:** The slats are distorted  
**Action:** Monitor for any further deterioration and replace as required

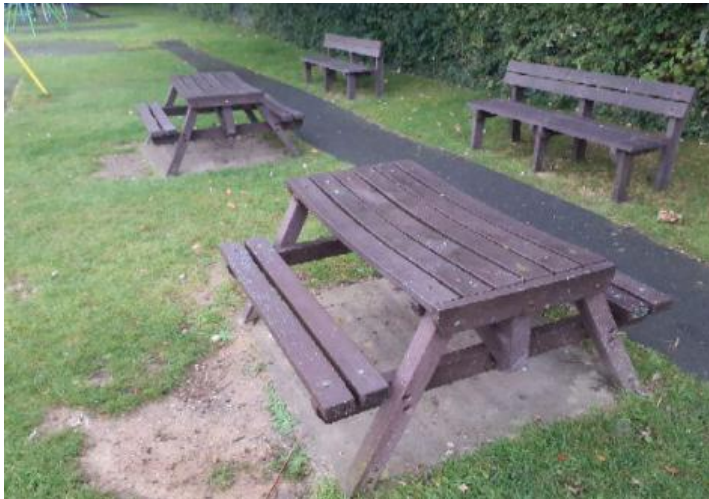
**i** 6 - Low Risk (Finding 3)

**Item:** Ancillary Items - Picnic Table  
**Manufacturer:** Not Identified  
**Risk Level:** L - Low Risk  
**Surface:** Grass

**Finding:** There is some damage to the item  
**Action:** Monitor for any further deterioration and repair as required

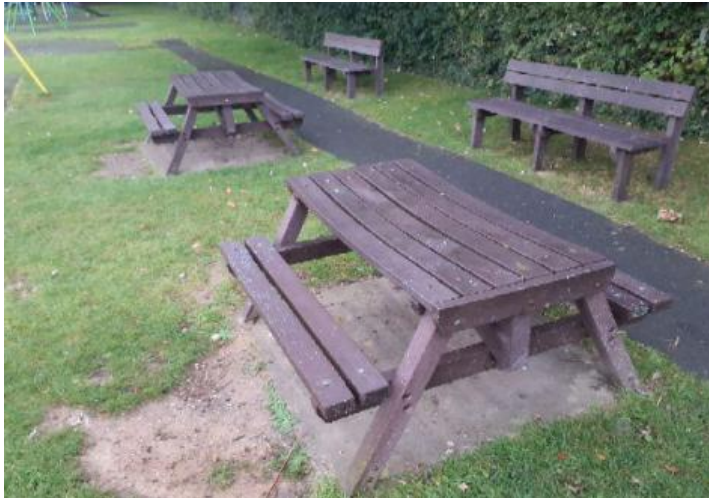
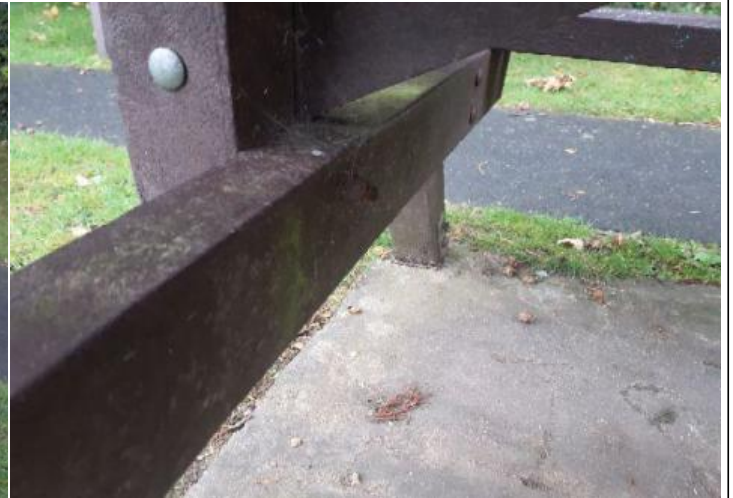
**i** 8 - Low Risk (Finding 4)

**Item:** Ancillary Items - Picnic Table  
**Manufacturer:** Not Identified

**Finding:** There are projecting bolt thread(s) present

**Action:** Remove excess thread length and deburr or provide cap

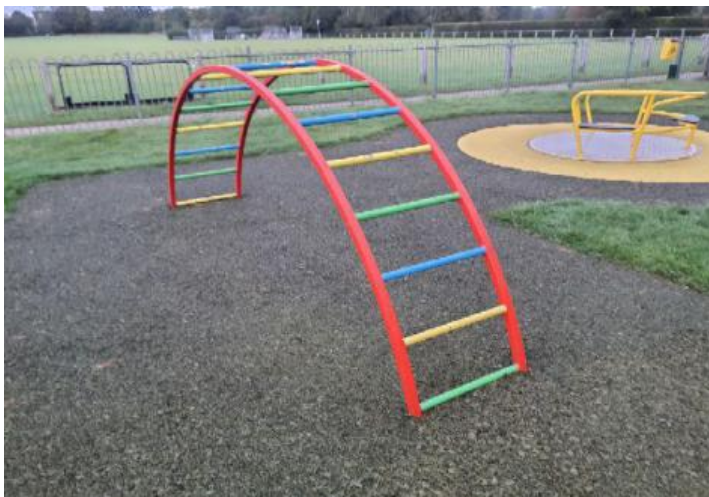
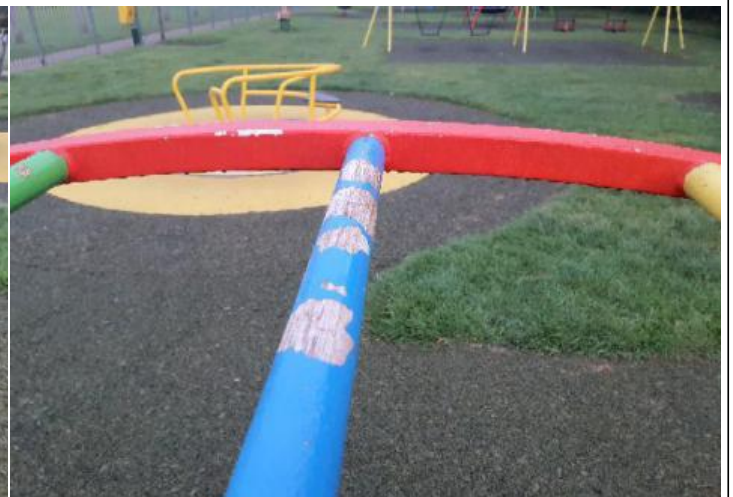
**Item:** Activity Equipment - Climbing Frame  
**Manufacturer:** Wicksteed Playgrounds

**Finding:** The paint is flaking off the metalwork

**Action:** Rub down and re-paint

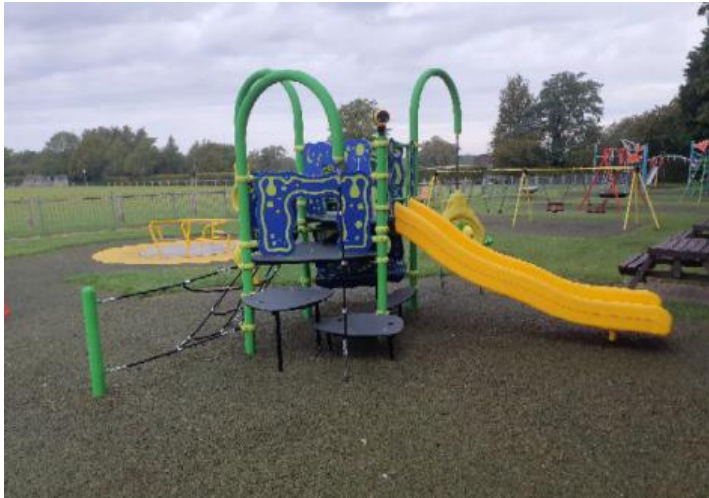
**Item:** Activity Equipment - Multi Play (Junior)  
**Manufacturer:** Hags

**Finding:** The item has been installed marginally too high which has resulted in the platform height being in excess of 600mm (610 mm) and technically, the height of the barriers are now insufficient to meet the requirements of BS EN 1176 Part 1. This is however a very low risk technicality and no remedial action is recommended as it has not affected the risk assessment of the item

**Action:** No action given the risk assessment

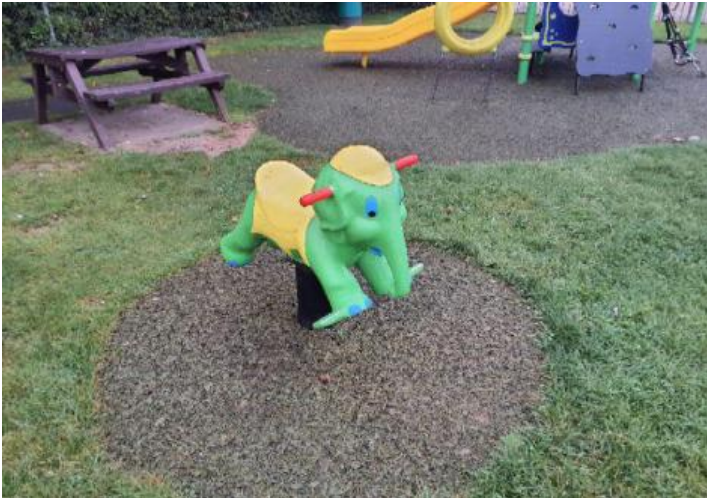
**Item:** Rocking Equipment - Spring Elephant  
**Manufacturer:** Wicksteed Playgrounds

**Finding:** The end of handgrips and/or footrests have a cross section of less than 15cm<sup>2</sup> and fail to meet the requirements of BS EN 1176 Part 6  
**Action:** Monitor - No remedial work recommended

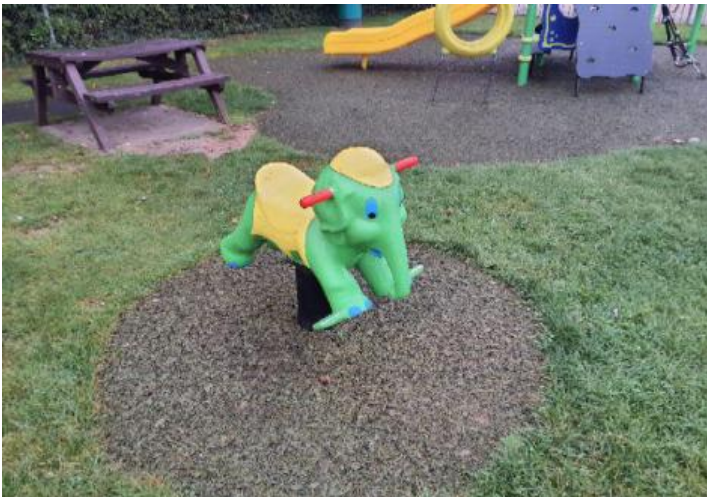
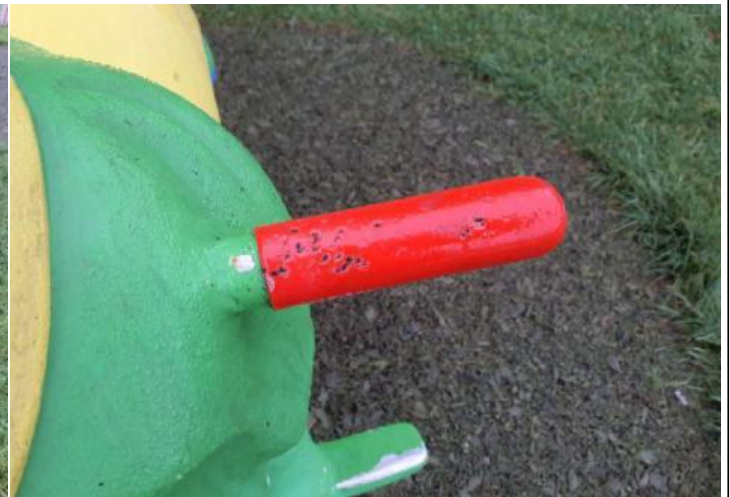
**i** 6 - Low Risk (Finding 2)

**Item:** Rocking Equipment - Spring Elephant  
**Manufacturer:** Wicksteed Playgrounds

**Finding:** There is some damage to the item

**Action:** Monitor for any further deterioration and repair as required

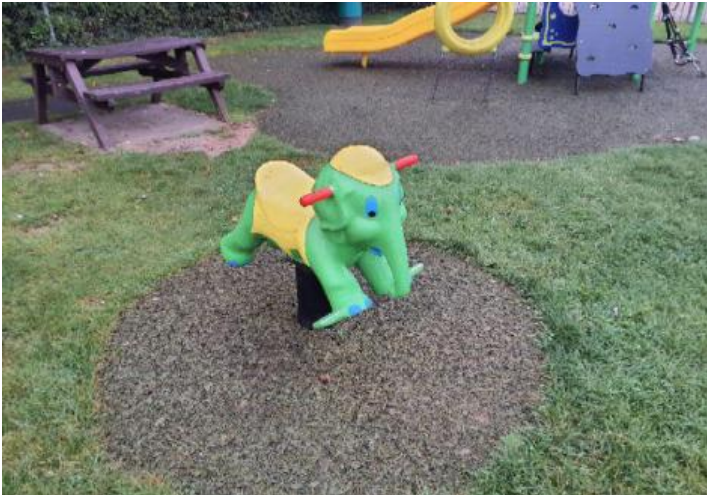
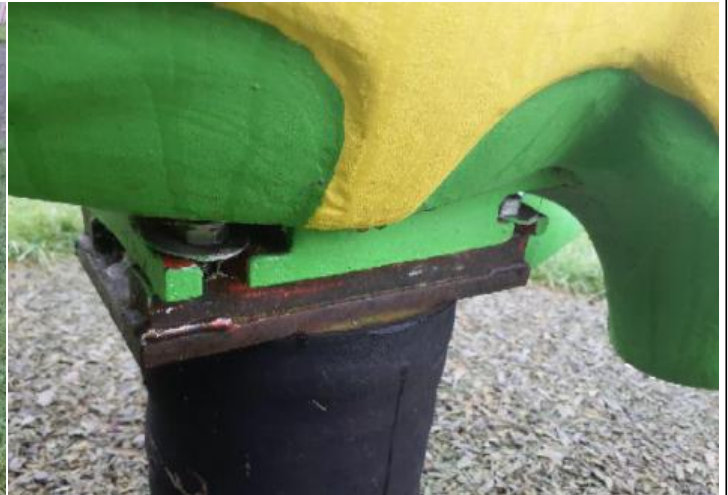
**Item:** Rocking Equipment - Spring Elephant  
**Manufacturer:** Wicksteed Playgrounds

**Finding:** The paintwork on this item has been damaged or worn exposing the metal underneath which is rusting / corroding

**Action:** Treat affected areas and repaint

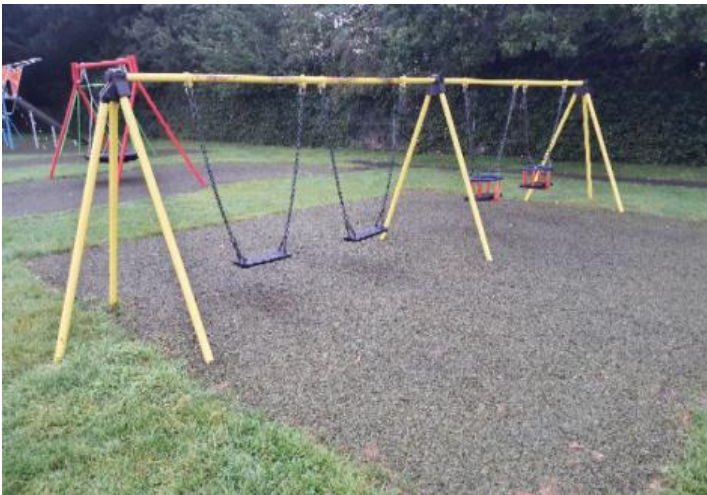
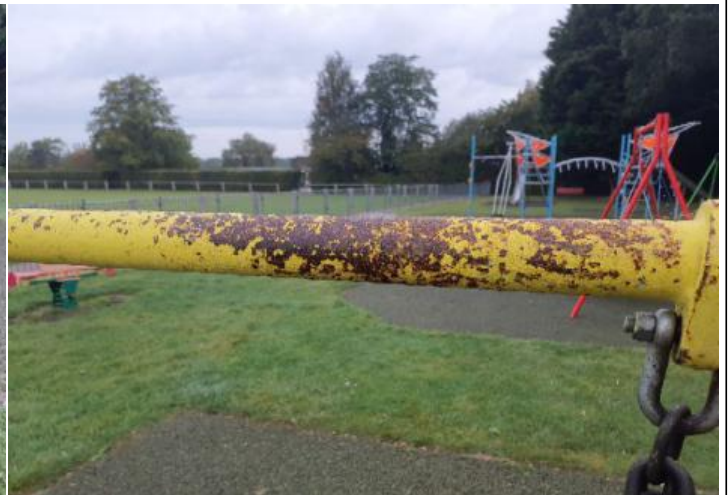
**Item:** Swings - 2 Bay (2 Flat, 2 Cradle)  
**Manufacturer:** Wicksteed Playgrounds

**Finding:** The paintwork on this item has been damaged or worn exposing the metal underneath which is rusting / corroding

**Action:** Treat affected areas and repaint

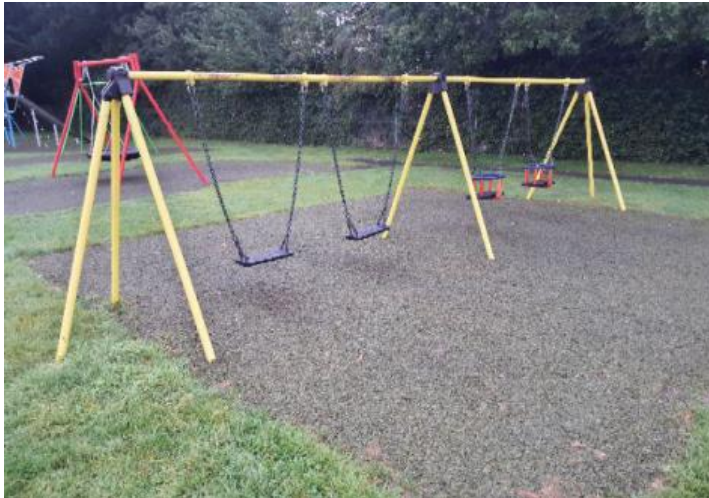
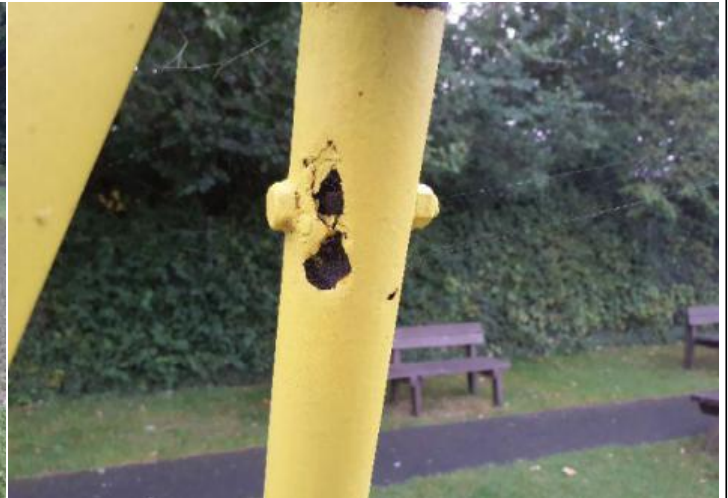
**Item:** Swings - 2 Bay (2 Flat, 2 Cradle)  
**Manufacturer:** Wicksteed Playgrounds

**Finding:** Parts of the steel on this item have corroded excessively and the metal has perforated in places

**Action:** Ensure all affected areas are treated and repaired

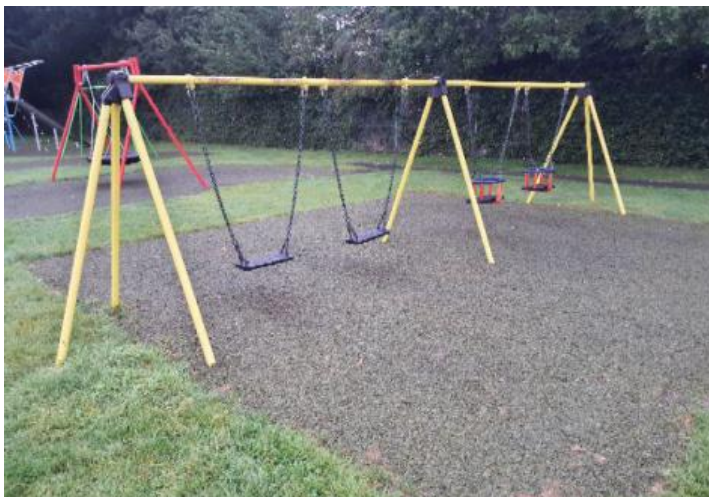
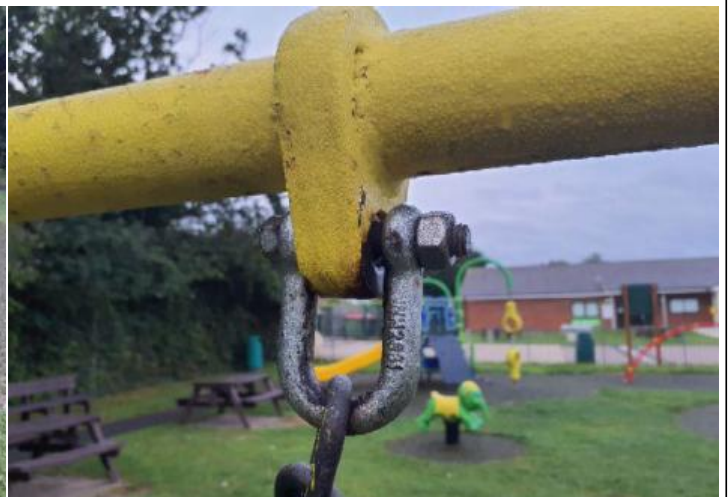
**Item:** Swings - 2 Bay (2 Flat, 2 Cradle)  
**Manufacturer:** Wicksteed Playgrounds

**Finding:** The bushes are showing signs of wear

**Action:** Monitor for any further deterioration and replace as required
