# the **play inspection** company

## Annual Inspection

Long Stratton Town Council

Manor Road Playing Fields

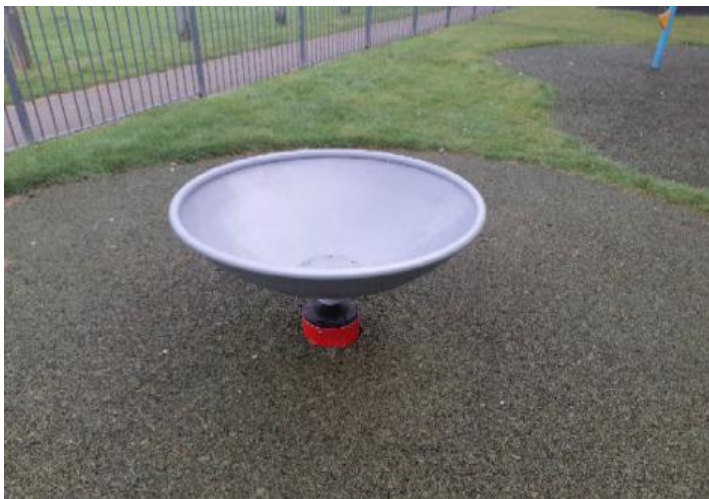
**Item:** Rotor Play - Dish Roundabout  
**Manufacturer:** Hags

**Finding:** A number of fixing(s) have worked loose

**Action:** Secure all loose fixings

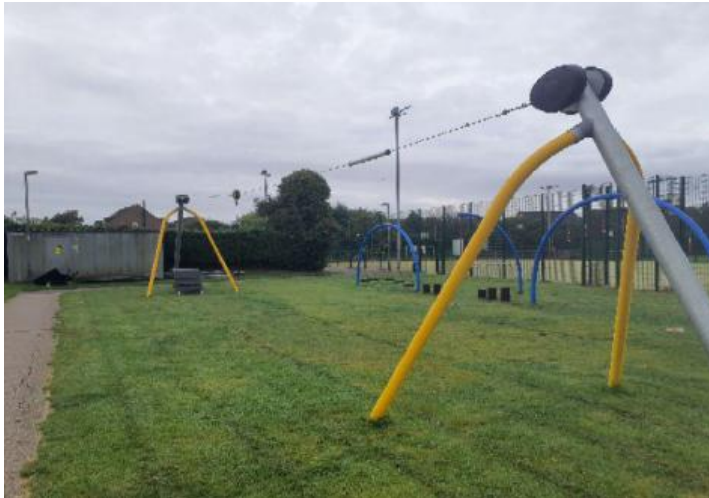
**Item:** Other - Cable Runway  
**Manufacturer:** Hags

**Finding:** The installation of the cable end does not appear to have been installed in accordance with the manufacturers recommendations

**Action:** Refer to manufacturer

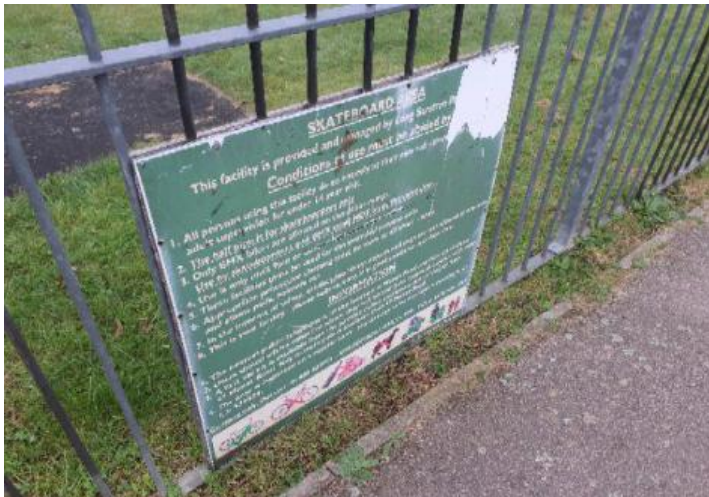
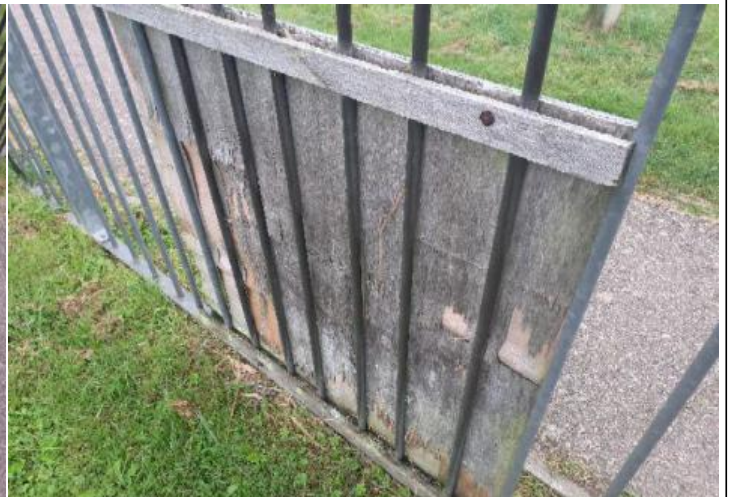
**Item:** Ancillary Items - Sign  
**Manufacturer:** Owner/Operator

**Finding:** The plywood has delaminated in some places

**Action:** Remove all rough or splintered edges.

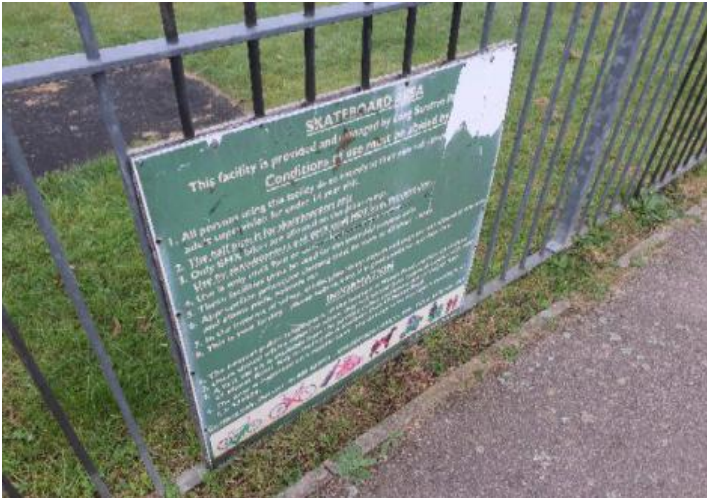
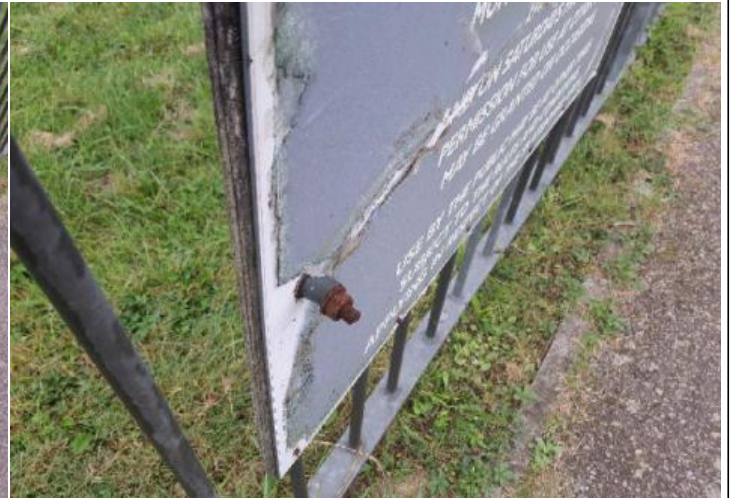
**Item:** Ancillary Items - Sign  
**Manufacturer:** Owner/Operator

**Finding:** There are projecting bolt thread(s) present

**Action:** Remove excess thread length and deburr or provide cap

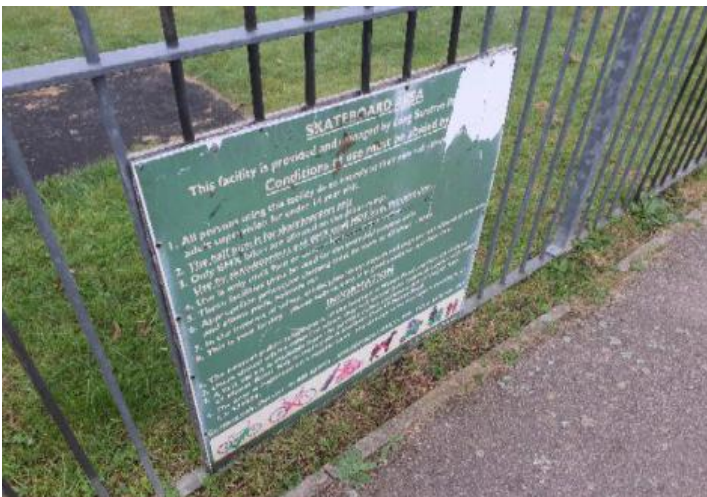
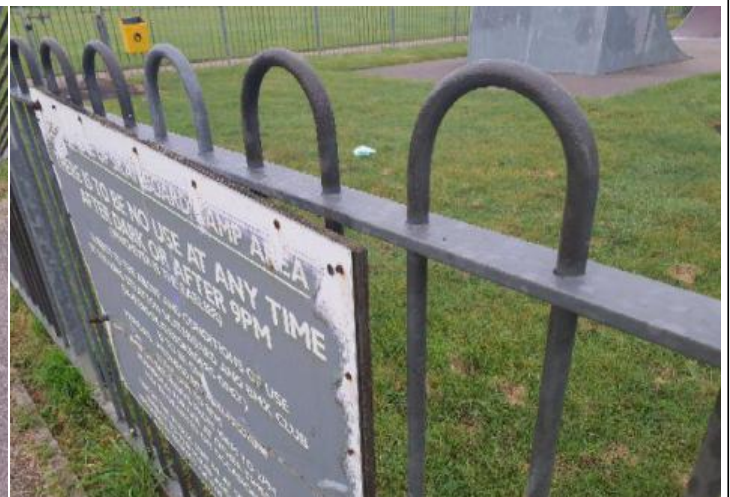
**Item:** Ancillary Items - Sign  
**Manufacturer:** Owner/Operator

**Finding:** There is or are fixings missing on the item

**Action:** Replace all missing fixings

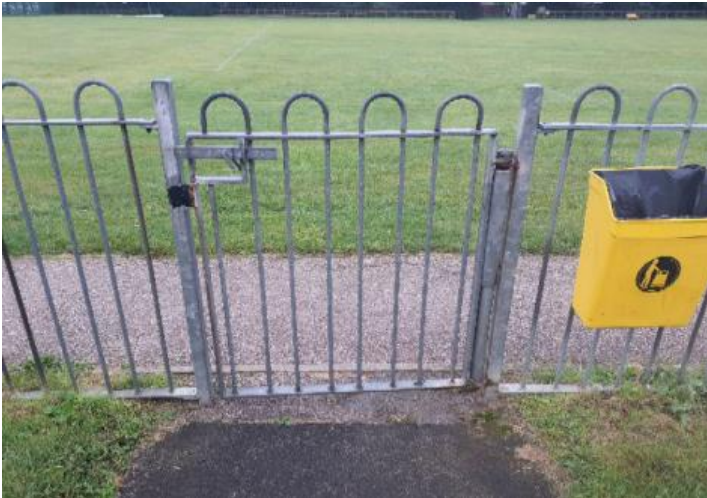
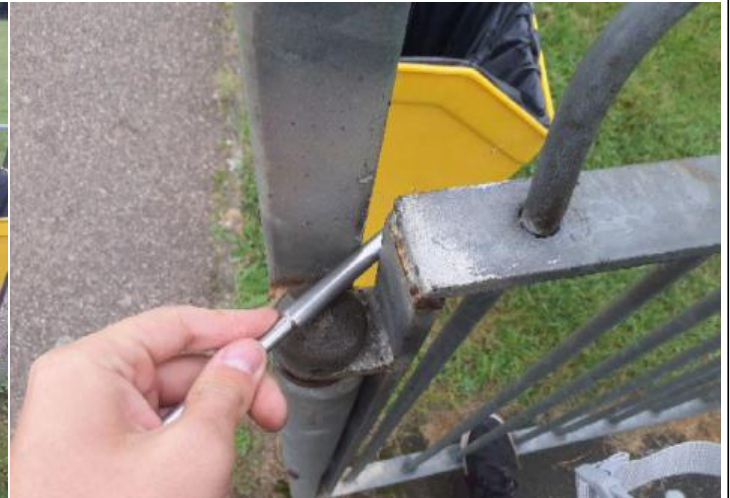
**Item:** Gates - Gate - Self Closing  
**Manufacturer:** Not Identified

**Finding:** There are openings that are less than 12mm that could trap or crush fingers

**Action:** Provide a 12mm gap throughout full range of motion at both sides of gate

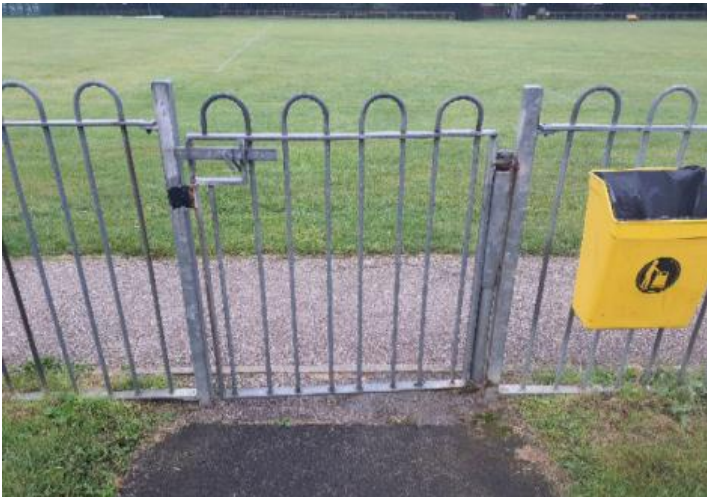
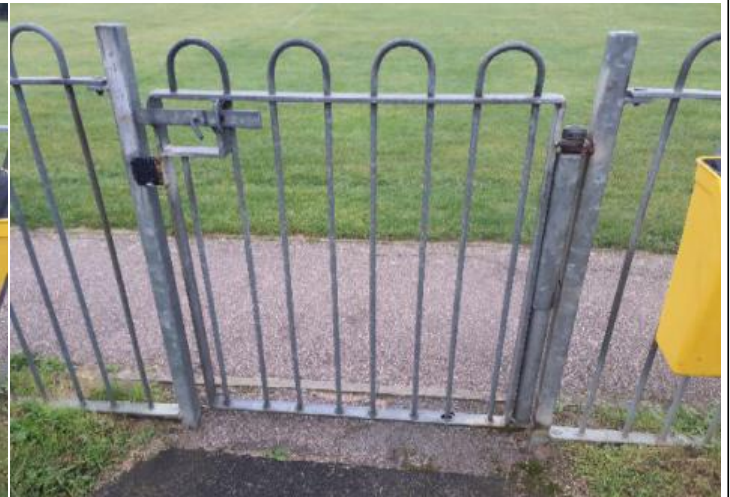
**Item:** Gates - Gate - Self Closing  
**Manufacturer:** Not Identified

**Finding:** The gate is closing too quickly (less than 4 seconds)

**Action:** Take corrective action to ensure that the gate closes in 4-8 seconds

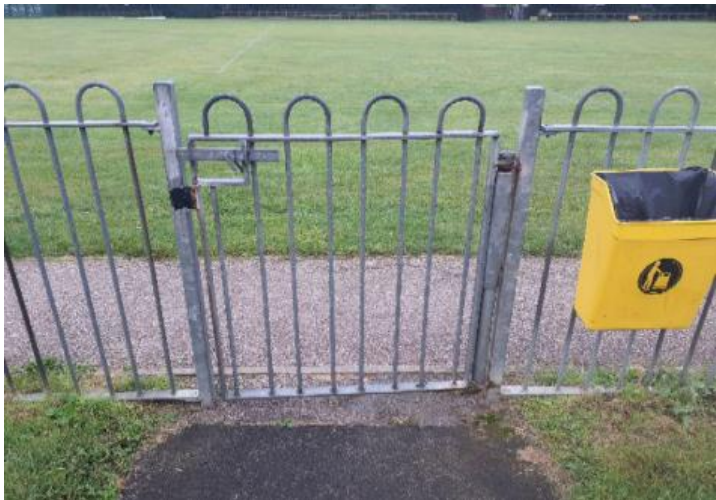
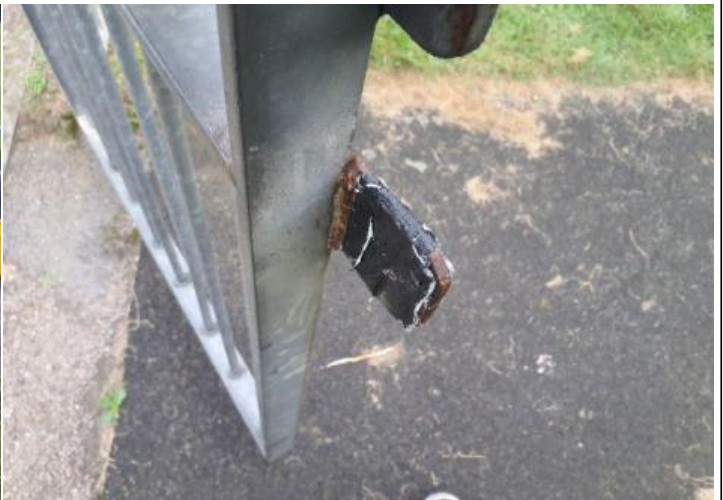
**6 - Low Risk (Finding 3)**

**Item:** Gates - Gate - Self Closing  
**Manufacturer:** Not Identified  
**Risk Level:** L - Low Risk  
**Surface:** Bitmac

**Finding:** The rubber buffer is missing from the latch plate  
**Action:** Replace rubber buffer

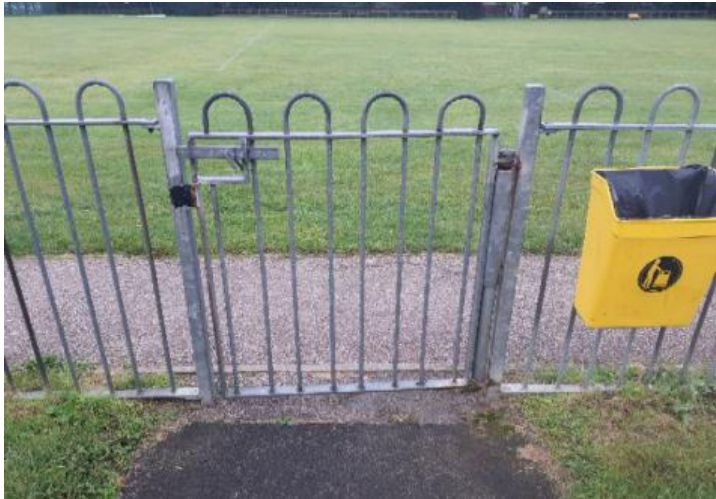
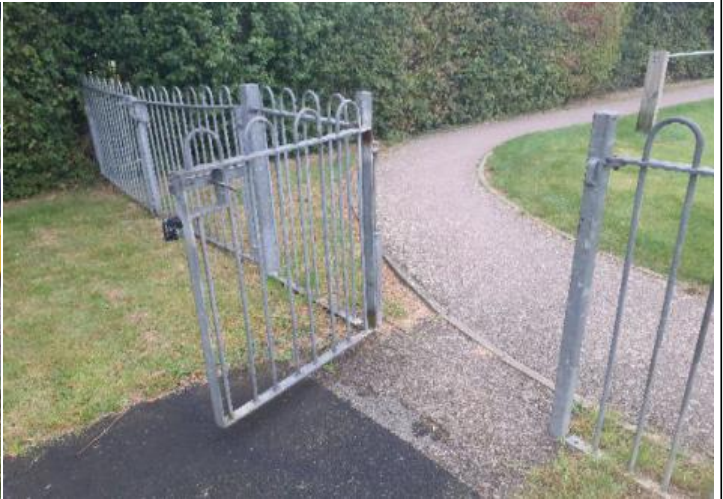
**5 - Very Low Risk (Finding 4)**

**Item:** Gates - Gate - Self Closing  
**Manufacturer:** Not Identified  
**Risk Level:** V - Very Low Risk  
**Surface:** Bitmac

**Finding:** The gate is not operating correctly  
**Action:** Take effective action to ensure the gate closes between 4 and 8 seconds

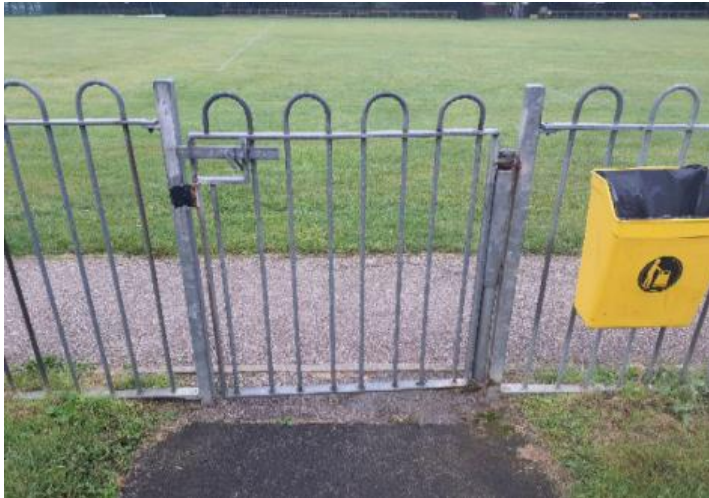
**i** 6 - Low Risk (Finding 5)

**Item:** Gates - Gate - Self Closing  
**Manufacturer:** Not Identified  
**Risk Level:** L - Low Risk  
**Surface:** Bitmac

**Finding:** There is surface corrosion / rust present on the item

**Action:** Consider treating the item

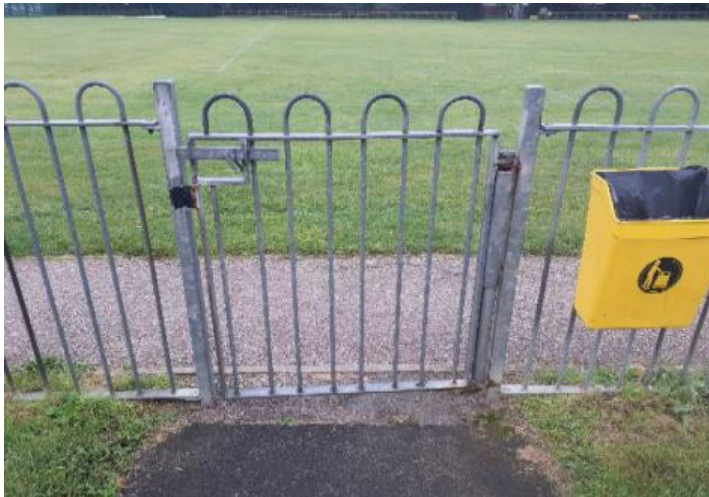
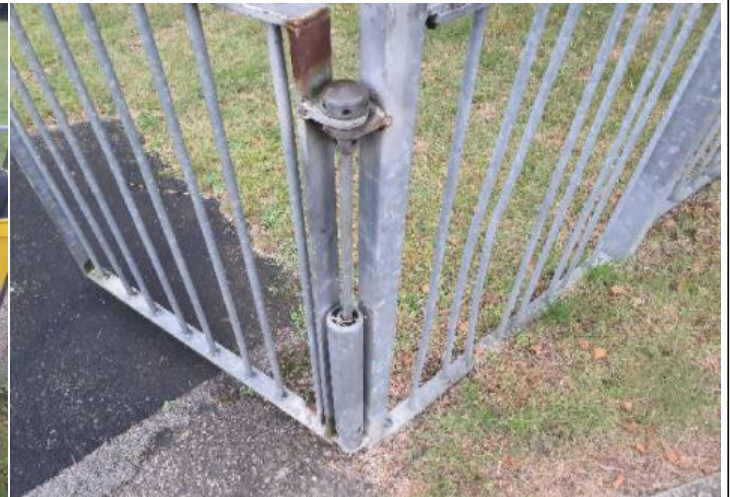
**i** 6 - Low Risk (Finding 6)

**Item:** Gates - Gate - Self Closing  
**Manufacturer:** Not Identified  
**Risk Level:** L - Low Risk  
**Surface:** Bitmac

**Finding:** The gate spring cover has slipped out of position

**Action:** Replace the spring cover in the correct position

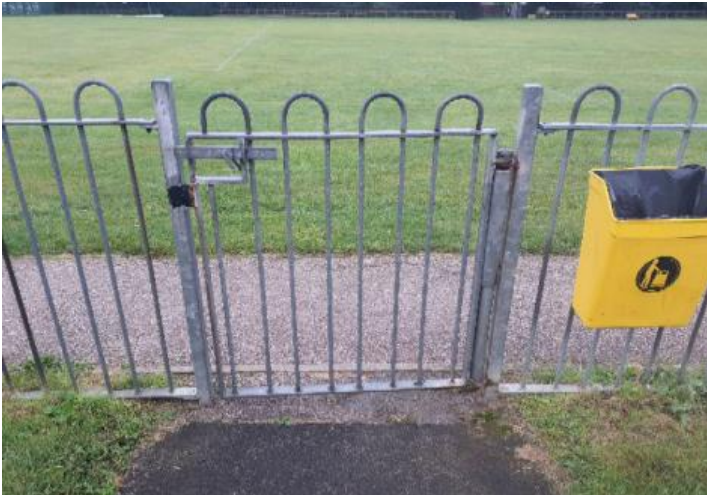
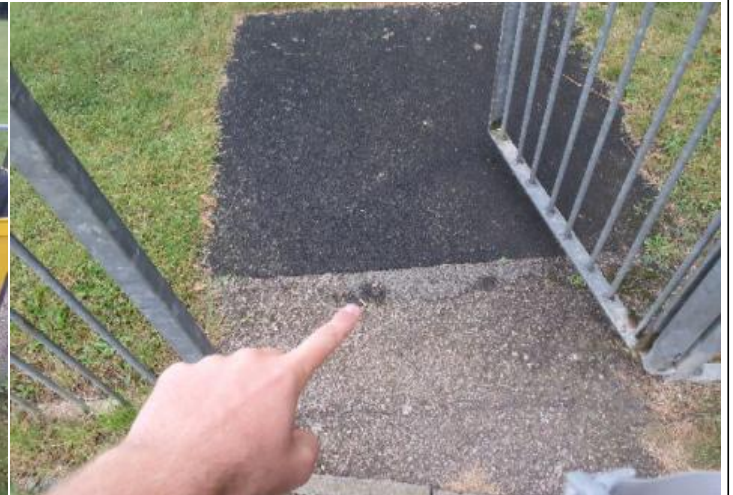
**i** 4 - Very Low Risk (Finding 7)

**Item:** Gates - Gate - Self Closing  
**Manufacturer:** Not Identified  
**Risk Level:** V - Very Low Risk  
**Surface:** Bitmac

**Finding:** There is some minor damage to the surface  
**Action:** Monitor for any further deterioration and repair as required

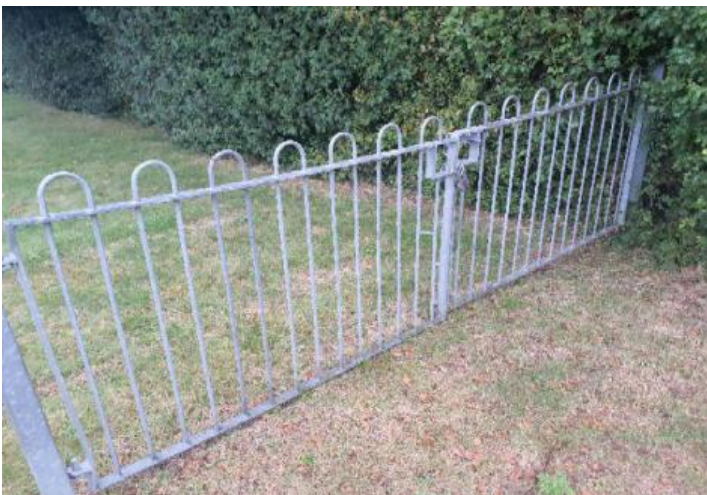
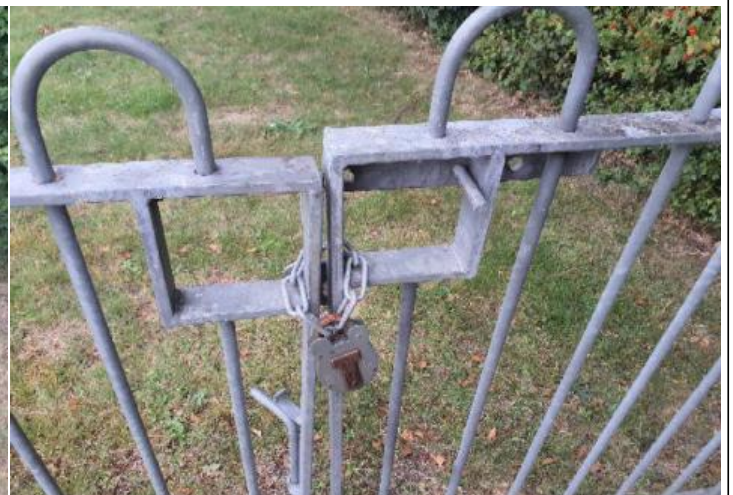
**i** 0 - Risk Assessment not Undertaken (Finding 1)

**Item:** Gates - Gate - Maintenance  
**Manufacturer:** Not Identified  
**Risk Level:** N - Risk Assessment not Undertaken  
**Surface:** Grass

**Finding:** The maintenance gate was correctly padlocked at the time of inspection, however this means that the inspector was unable to fully assess the gate  
**Action:** Ensure that there are 12mm gaps throughout the full range of motion on gate/s and between leaves where relevant

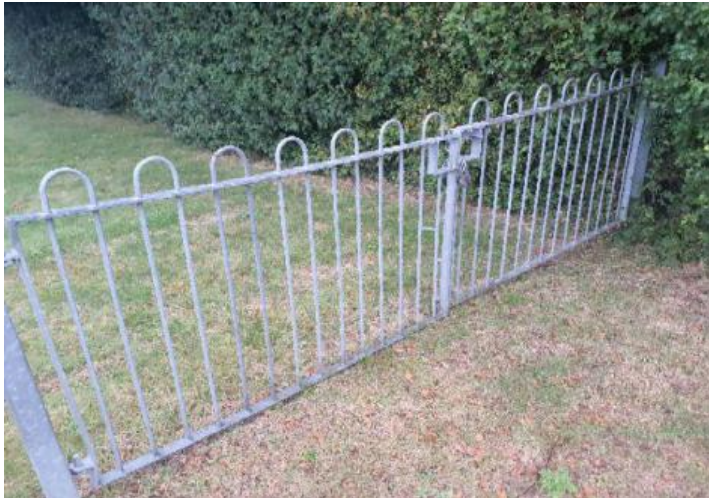
**i** 6 - Low Risk (Finding 2)

**Item:** Gates - Gate - Maintenance  
**Manufacturer:** Not Identified

**Finding:** There is some damage to the item

**Action:** Monitor for any further deterioration and repair as required

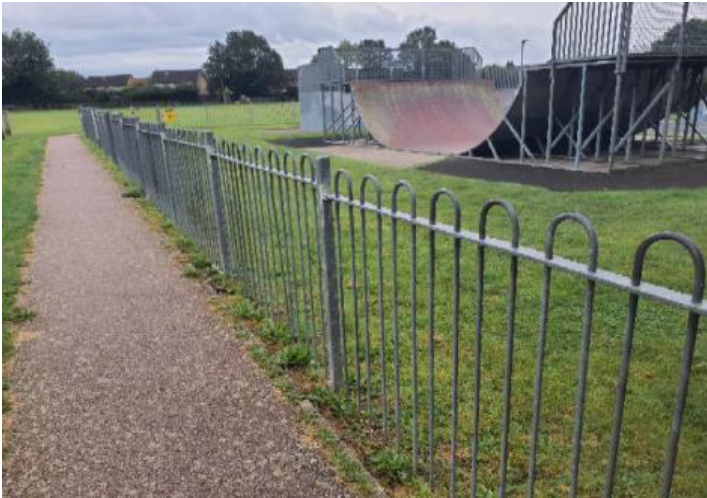
**Item:** Fences - Fence - Bow Top  
**Manufacturer:** Not Identified

**Finding:** There is or are fixings missing on the item

**Action:** Replace all missing fixings

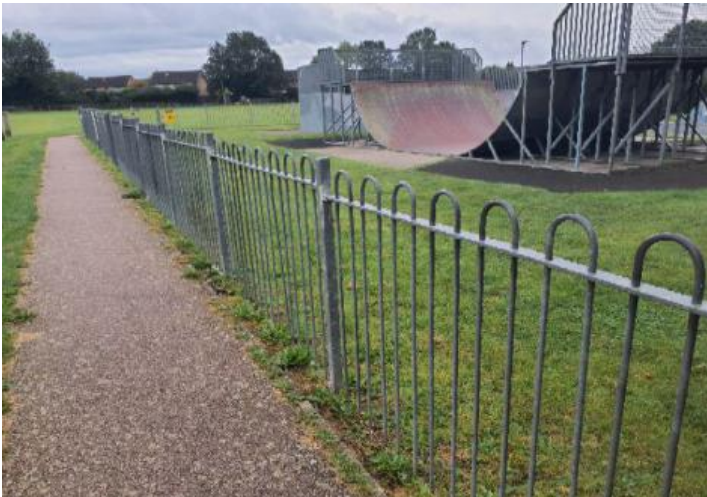
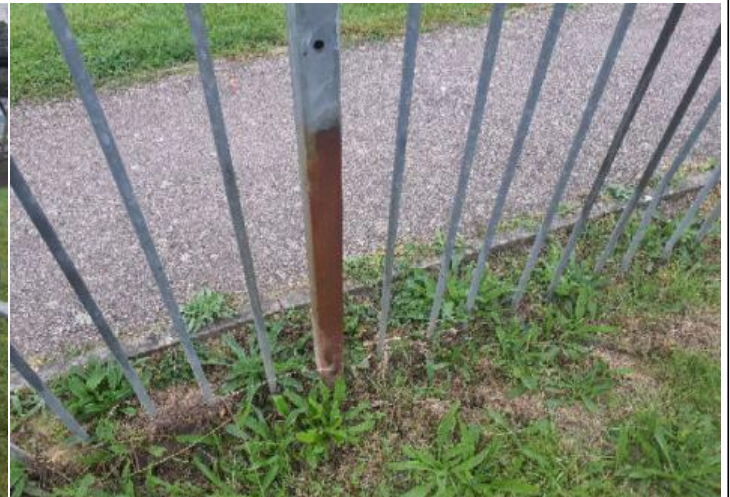
**i** 6 - Low Risk (Finding 3)

**Item:** Fences - Fence - Bow Top  
**Manufacturer:** Not Identified  
**Risk Level:** L - Low Risk  
**Surface:** Grass

**Finding:** There is surface corrosion / rust present on the item  
**Action:** Consider treating the item

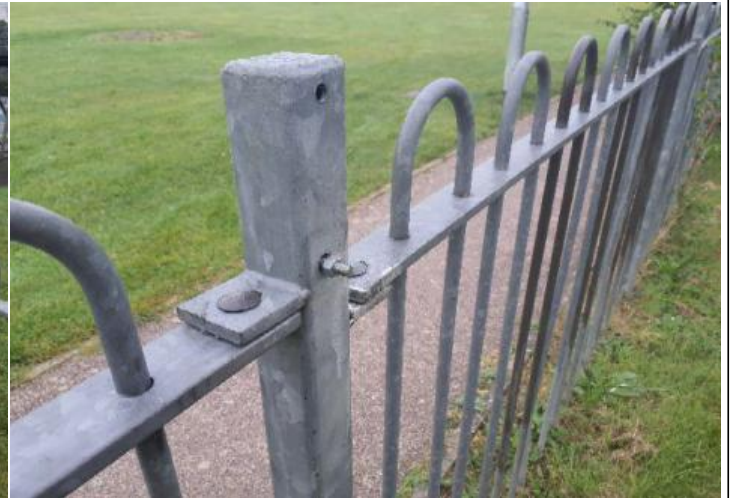
**i** 8 - Low Risk (Finding 4)

**Item:** Fences - Fence - Bow Top  
**Manufacturer:** Not Identified

**Finding:** There are projecting bolt thread(s) present

**Action:** Remove excess thread length and deburr or provide cap

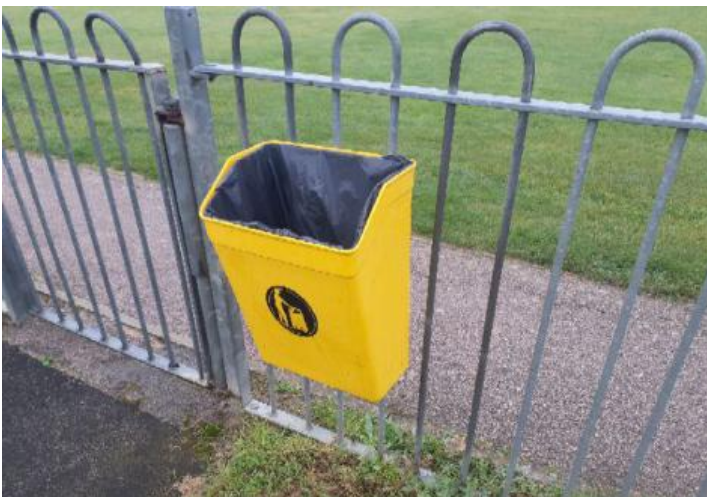
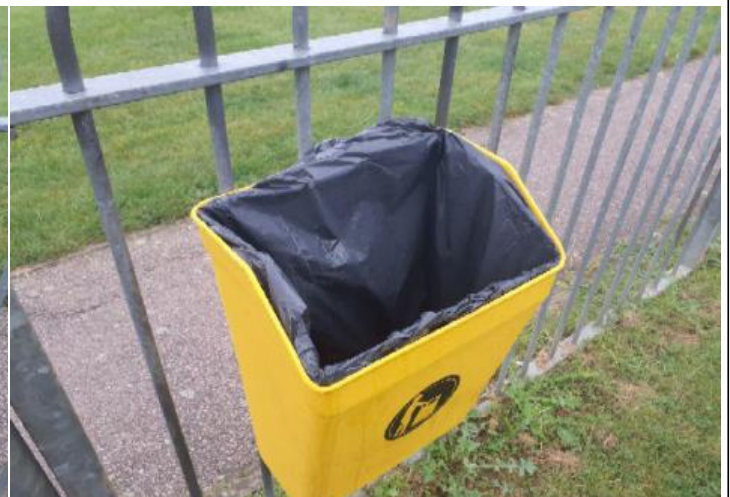
**Item:** Ancillary Items - Litter Bin  
**Manufacturer:** Not Identified

**Finding:** The liner of the litter bin is not secured

**Action:** Ensure the lid/door is kept locked and the liner secured

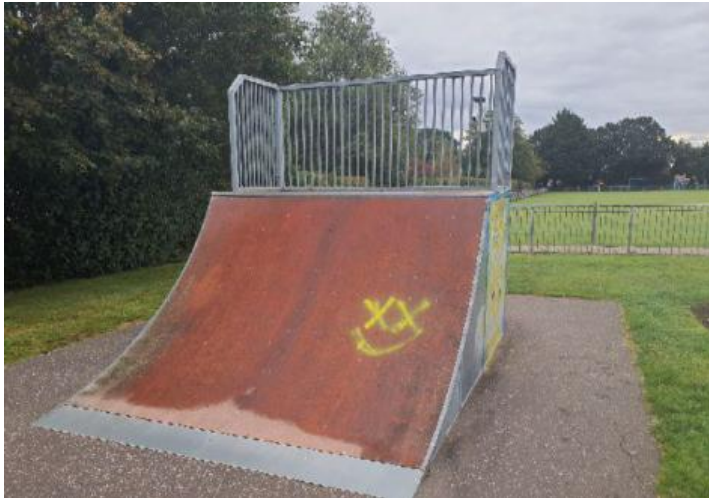
**Item:** Wheeled Sports - Quarter Pipe  
**Manufacturer:** Not Identified

**Finding:** The height of the barrier is less than 1200mm at a distance exceeding 300mm from the front of the barrier and fails the requirements of BS EN 14974

**Action:** Monitor - No remedial work recommended

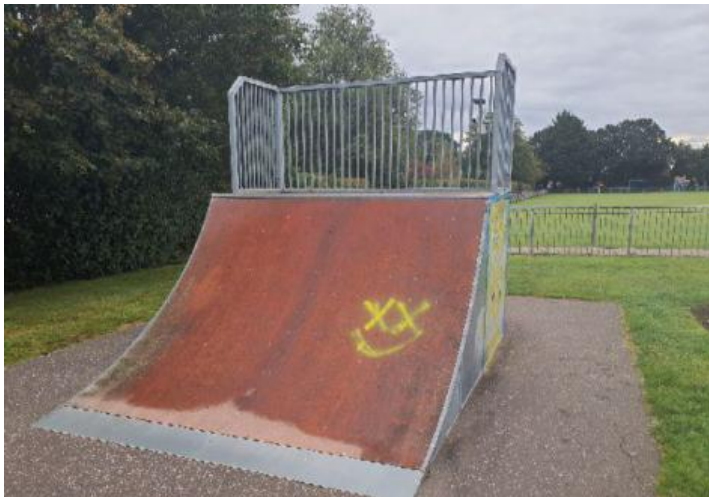
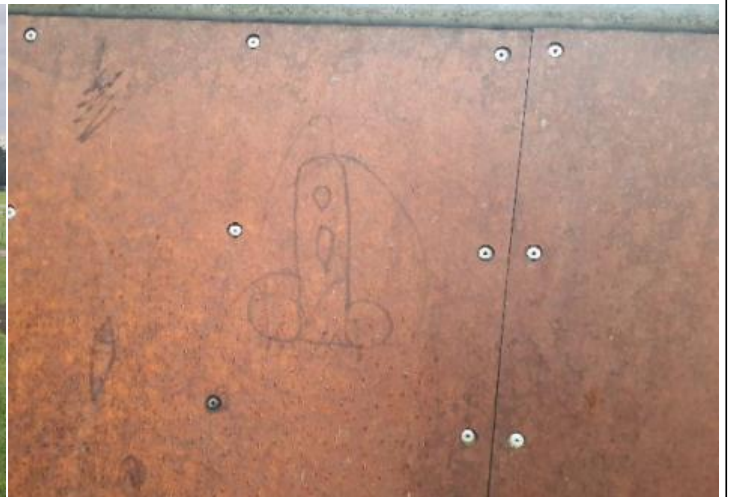
**Item:** Wheeled Sports - Quarter Pipe  
**Manufacturer:** Not Identified

**Finding:** There is offensive graffiti present

**Action:** Remove as soon as practicable

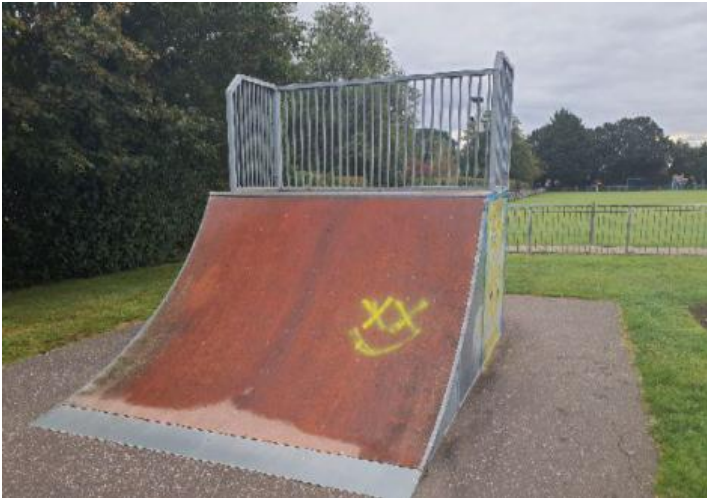
**Item:** Wheeled Sports - Quarter Pipe  
**Manufacturer:** Not Identified

**Finding:** The riding surface of the ramp has some damage apparent

**Action:** Monitor for any further deterioration and repair as required

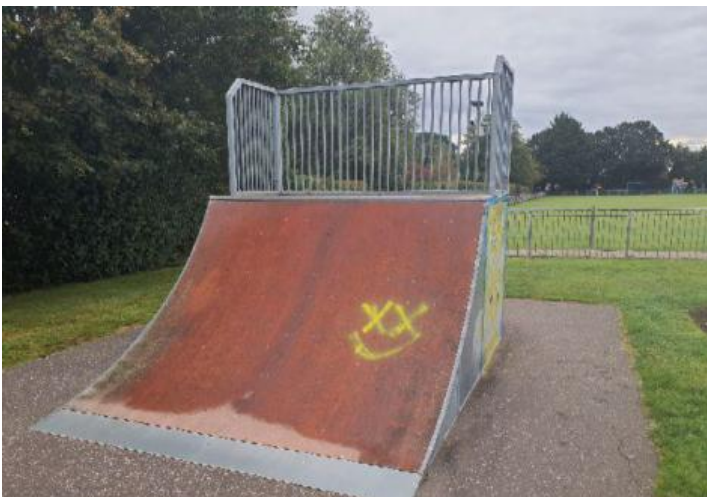
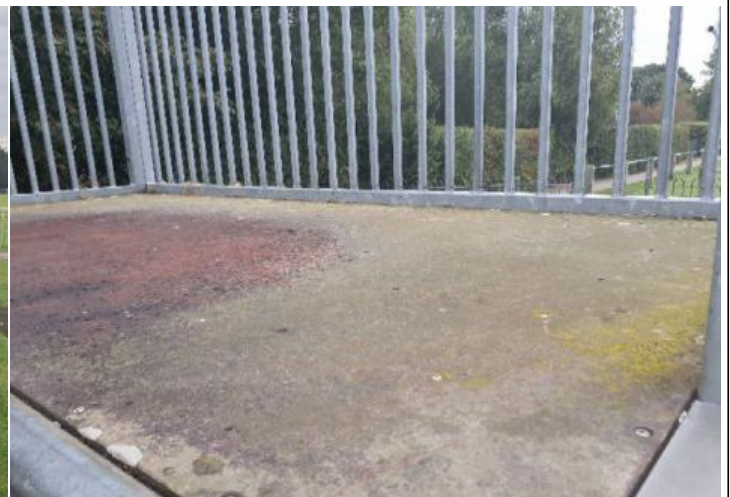
**Item:** Wheeled Sports - Quarter Pipe  
**Manufacturer:** Not Identified

**Finding:** There is algae or moss on the surface of the equipment

**Action:** Clean and treat appropriately

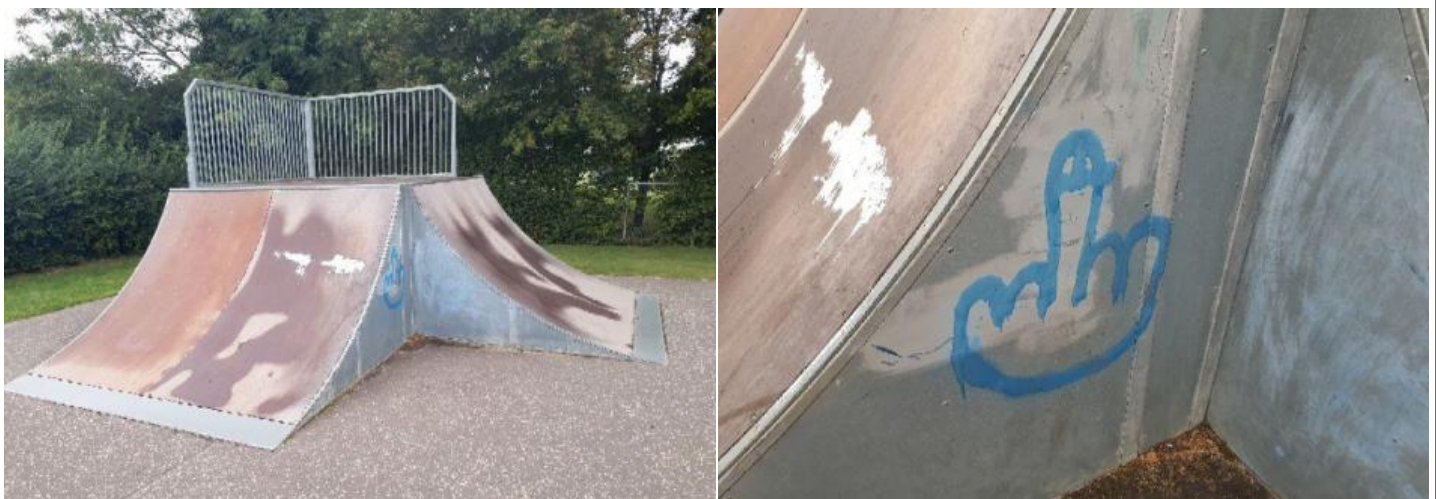
**i 0 - Risk Assessment not Undertaken (Finding 1)**

**Item:** Wheeled Sports - Start Ramp  
**Manufacturer:** StreetSkapes  
**Risk Level:** N - Risk Assessment not Undertaken  
**Surface:** Bitmac

**Finding:** There is offensive graffiti present  
**Action:** Remove as soon as practicable

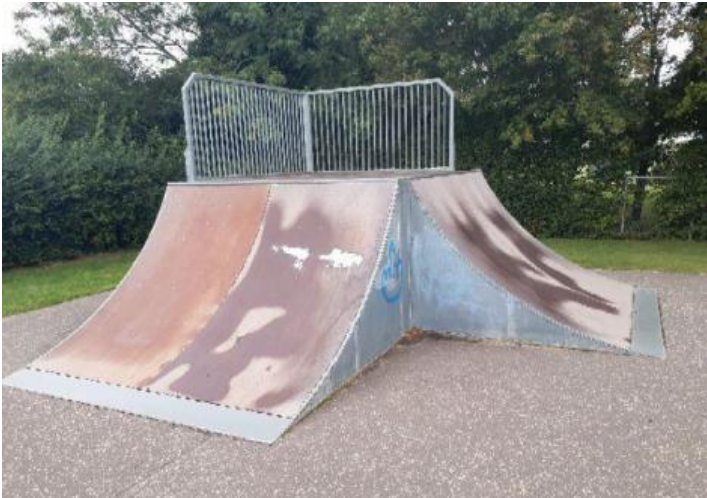
**i** 6 - Low Risk (Finding 2)

**Item:** Wheeled Sports - Start Ramp  
**Manufacturer:** StreetSkapes

**Finding:** The riding surface of the ramp has some damage apparent

**Action:** Monitor for any further deterioration and repair as required

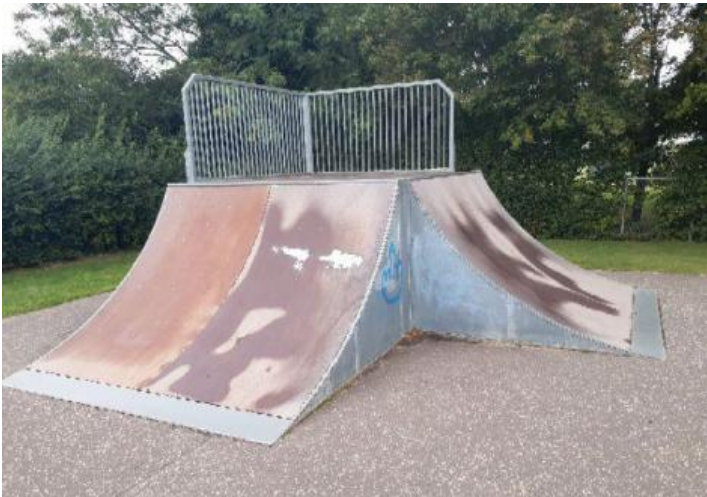
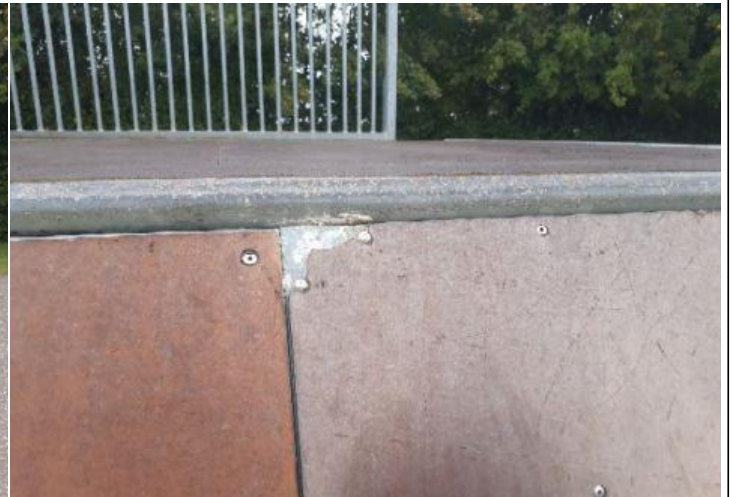
**Item:** Wheeled Sports - Start Ramp  
**Manufacturer:** StreetSkapes

**Finding:** The riding surface of the ramp is damaged

**Action:** Repair all damaged surfaces

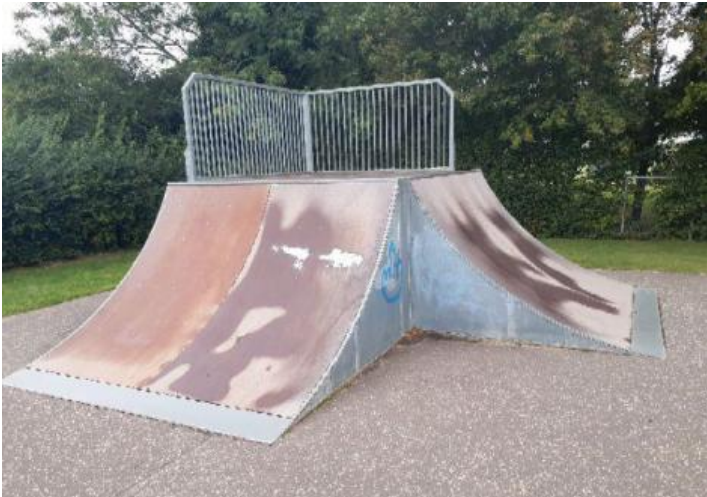
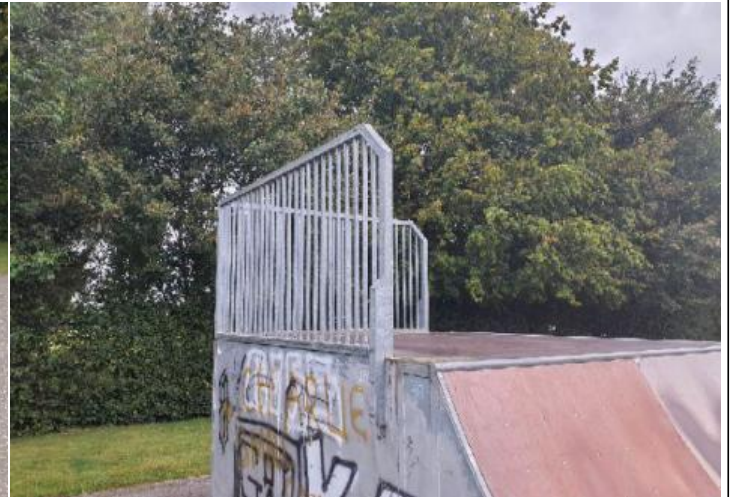
**Item:** Wheeled Sports - Start Ramp  
**Manufacturer:** StreetSkapes

**Finding:** The height of the barrier is less than 1200mm at a distance exceeding 300mm from the front of a barrier and fails the requirements of BS EN 14974

**Action:** Monitor - No remedial work recommended

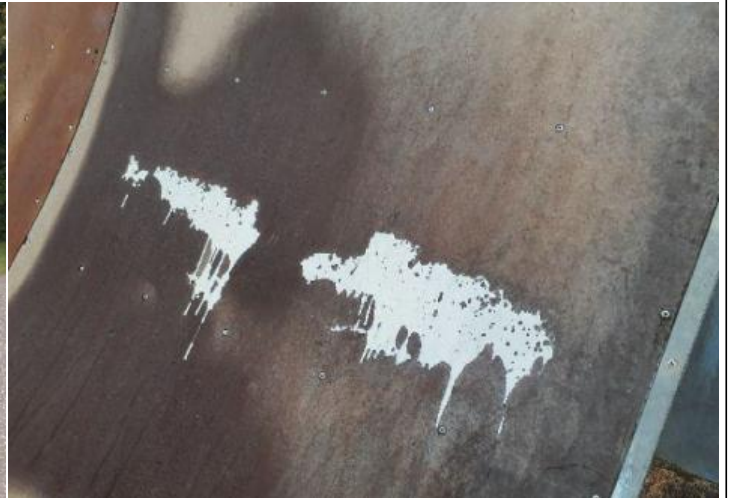
**Item:** Wheeled Sports - Start Ramp  
**Manufacturer:** StreetSkapes

**Finding:** There is paint on the ramp

**Action:** Remove

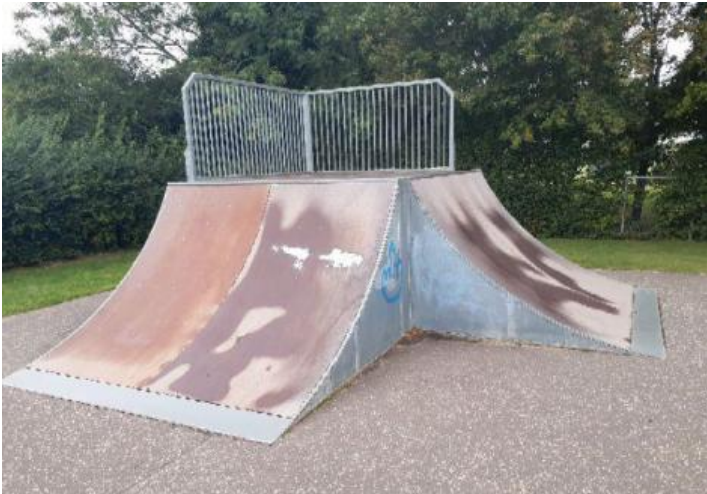
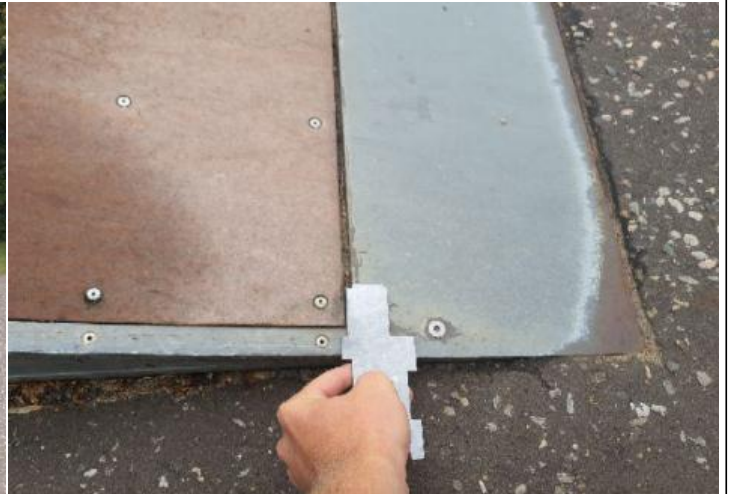
**Item:** Wheeled Sports - Start Ramp  
**Manufacturer:** StreetSkapes

**Finding:** Joints between the riding surfaces should not be greater than 5mm to meet the requirements of BS EN 14974

**Action:** Take corrective action to ensure that the gaps between the joints do not exceed 5mm

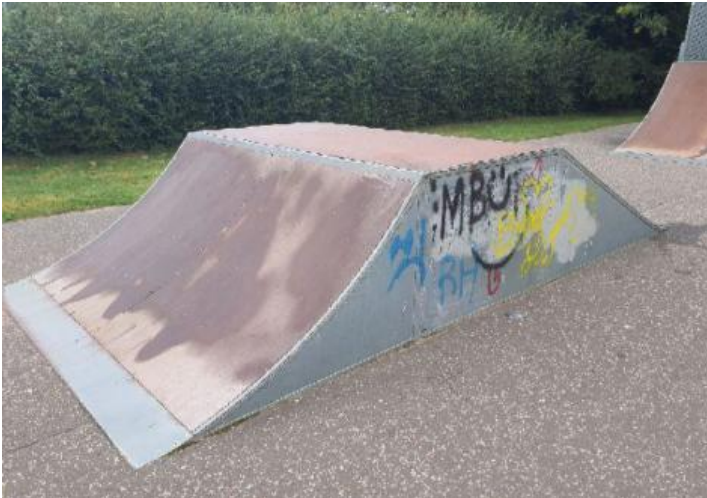
**Item:** Wheeled Sports - Fun Box  
**Manufacturer:** Streetscape Products

**Finding:** The riding surface of the ramp is damaged

**Action:** Repair all damaged surfaces

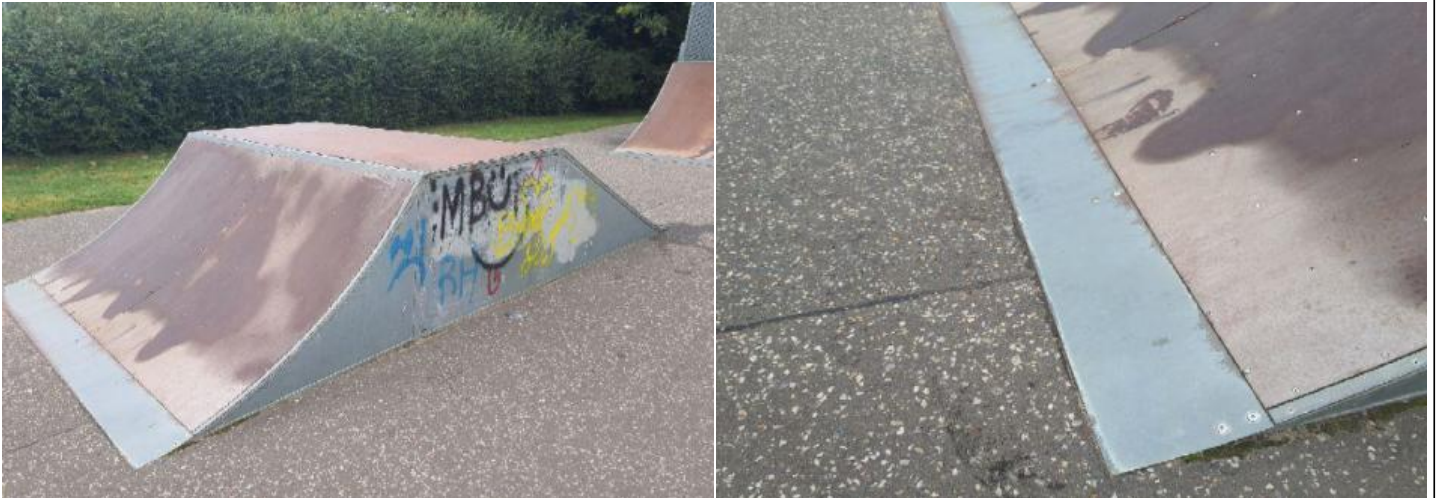
**Item:** Wheeled Sports - Fun Box  
**Manufacturer:** Streetscape Products

**Finding:** The kicker plate has sunk into the surface leaving a vertical height differences in excess of 3mm in contravention of BS EN 14974  
**Action:** Reinstate the surface to level

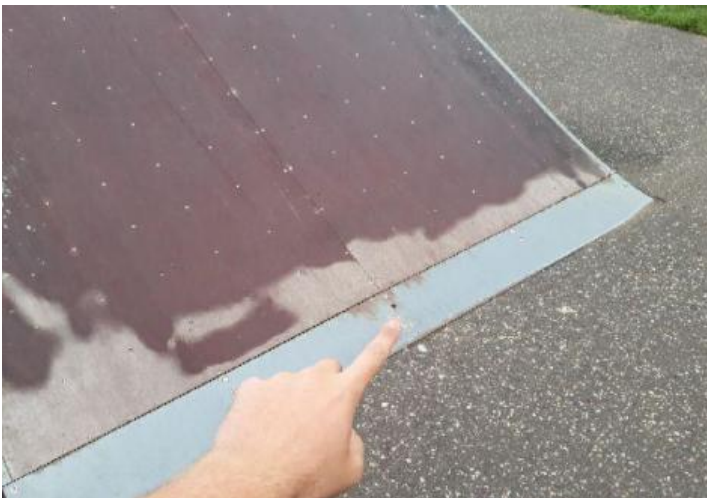
**i** 8 - Low Risk (Finding 3)

**Item:** Wheeled Sports - Fun Box  
**Manufacturer:** Streetscape Products

**Finding:** There is or are fixings missing on the item

**Action:** Replace all missing fixings

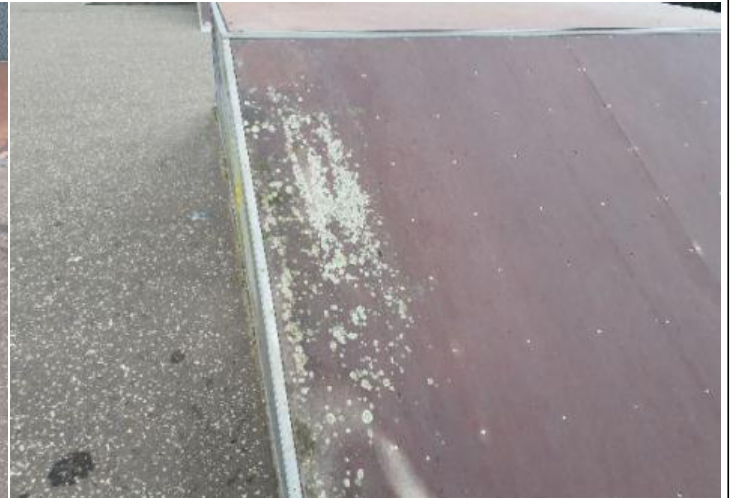
**Item:** Wheeled Sports - Fun Box  
**Manufacturer:** Streetscape Products

**Finding:** There is algae or moss on the surface of the equipment

**Action:** Clean and treat appropriately

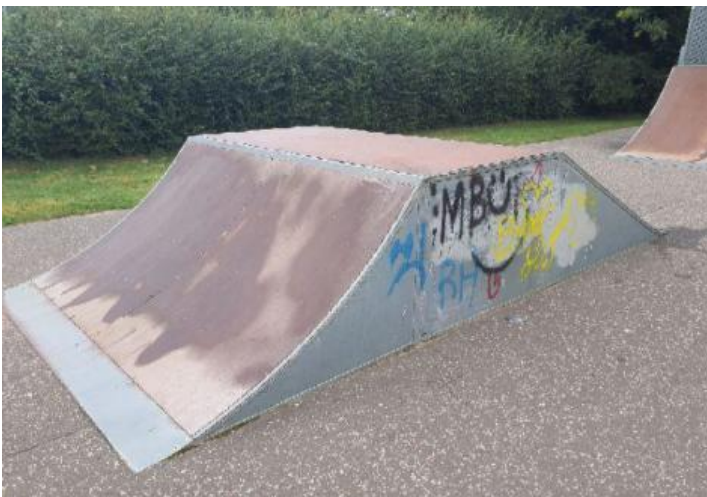
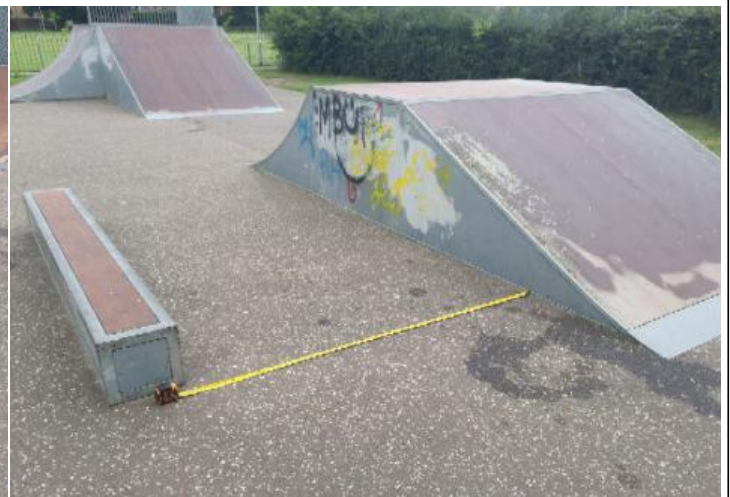
**Item:** Wheeled Sports - Fun Box  
**Manufacturer:** Streetscape Products

**Finding:** The item has insufficient safety zone allowed as required by BS EN 14974. This should consist of a bound uniform material and extend at least 2.0 metres on most items (1.50m for ledges, curbs and rails installed adjacent to each other)

**Action:** Monitor - No remedial work recommended

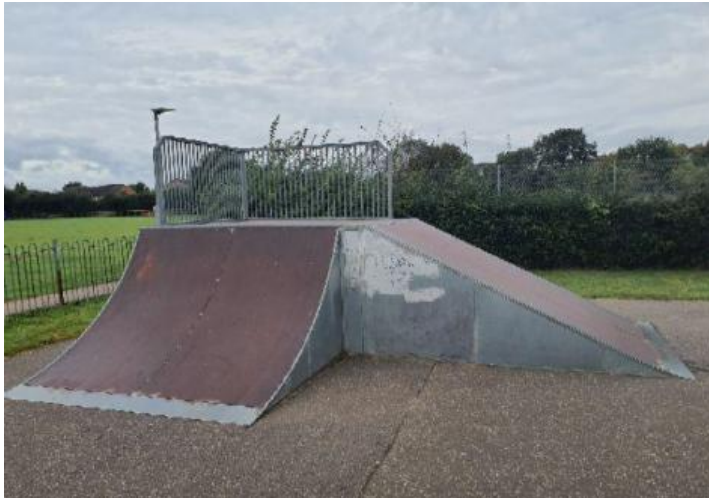
**Item:** Wheeled Sports - Start Ramp  
**Manufacturer:** StreetSkapes

**Finding:** There is or are fixings missing on the item

**Action:** Replace all missing fixings

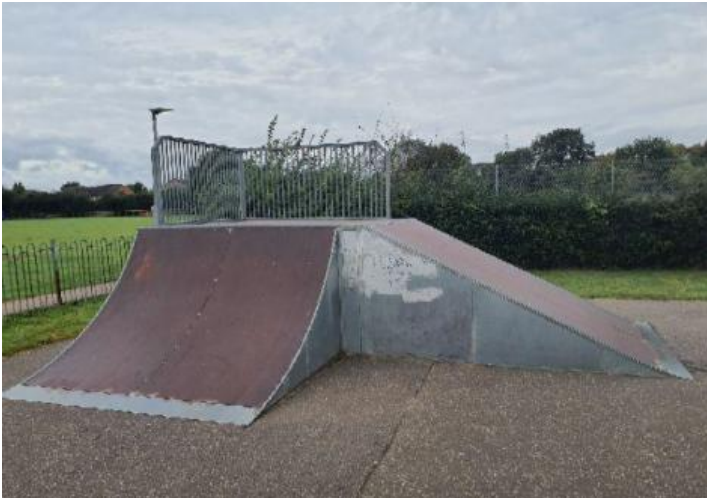
**Item:** Wheeled Sports - Start Ramp  
**Manufacturer:** StreetSkapes

**Finding:** The riding surface of the ramp is damaged

**Action:** Repair all damaged surfaces

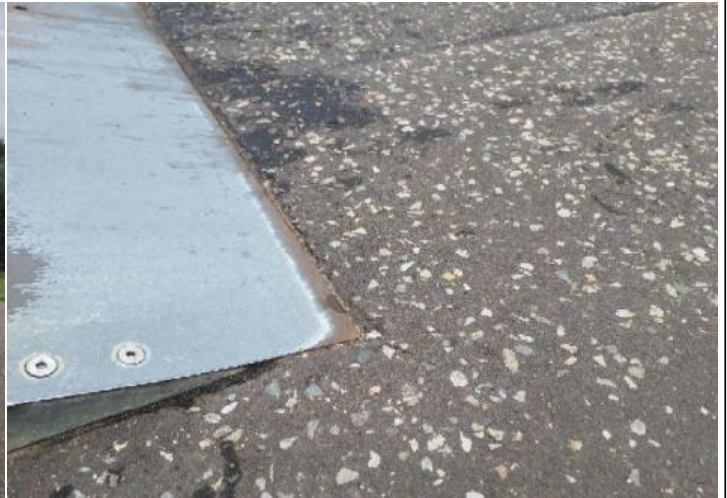
**Item:** Wheeled Sports - Start Ramp  
**Manufacturer:** StreetSkapes

**Finding:** The kicker plate has sunk into the surface creating a height differences exceeding 3mm in contravention of BS EN 14974

**Action:** Reinstate the surface to level

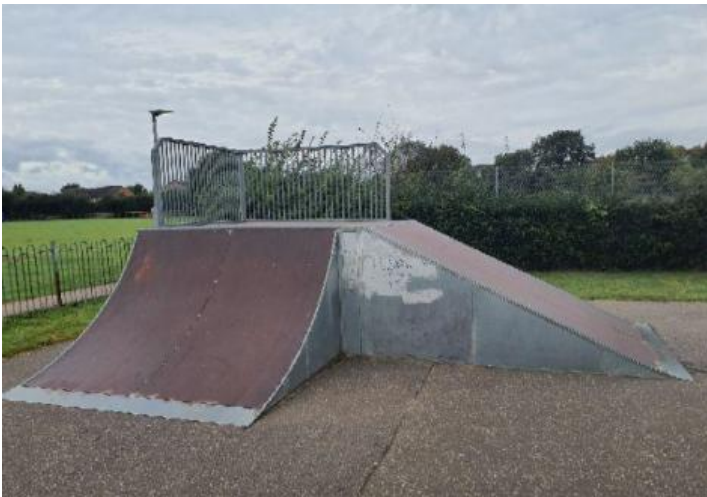
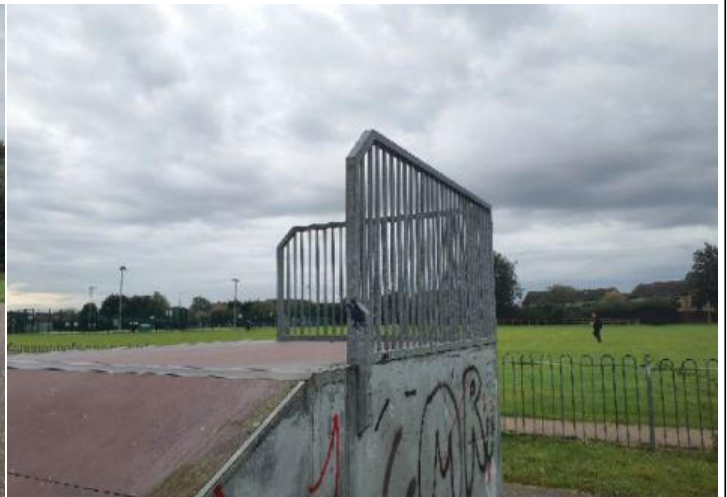
**Item:** Wheeled Sports - Start Ramp  
**Manufacturer:** StreetSkapes

**Finding:** The height of the barrier is less than 1200mm at a distance exceeding 300mm from the front of the barrier and fails the requirements of BS EN 14974

**Action:** Monitor - No remedial work recommended
