# the **play inspection** company

## Annual Inspection

Long Stratton Town Council

Manor Road Playing Fields

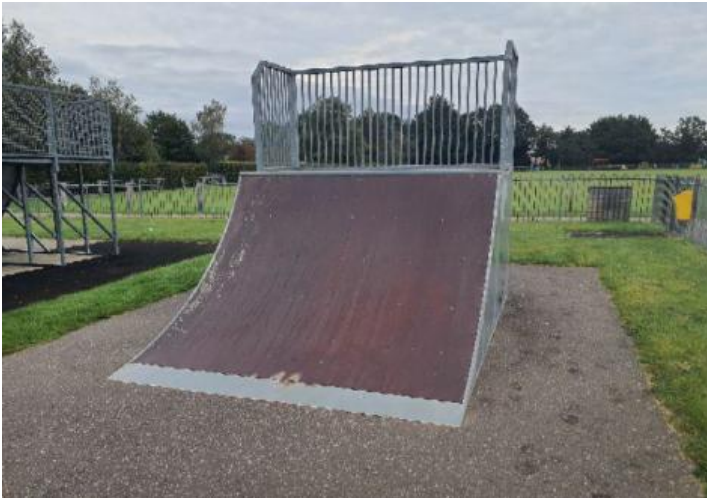
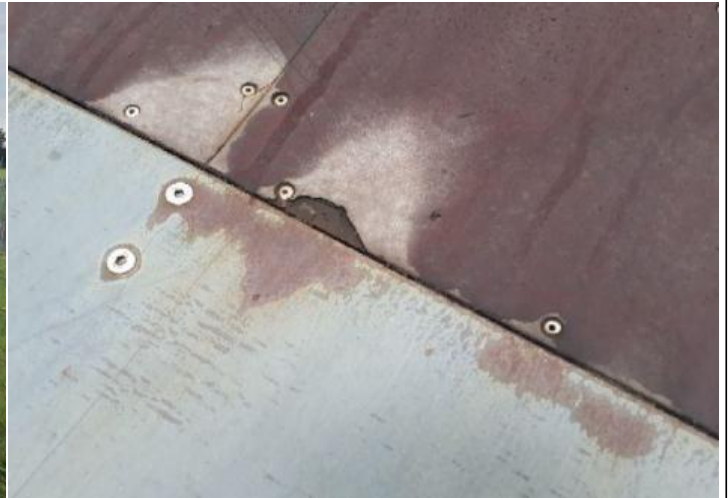
**Item:** Wheeled Sports - Quarter Pipe  
**Manufacturer:** StreetSkapes

**Finding:** The riding surface of the ramp has some damage apparent

**Action:** Monitor for any further deterioration and repair as required

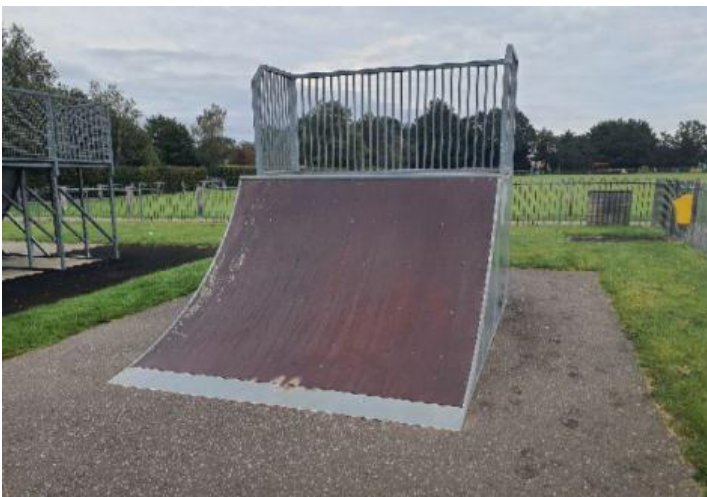
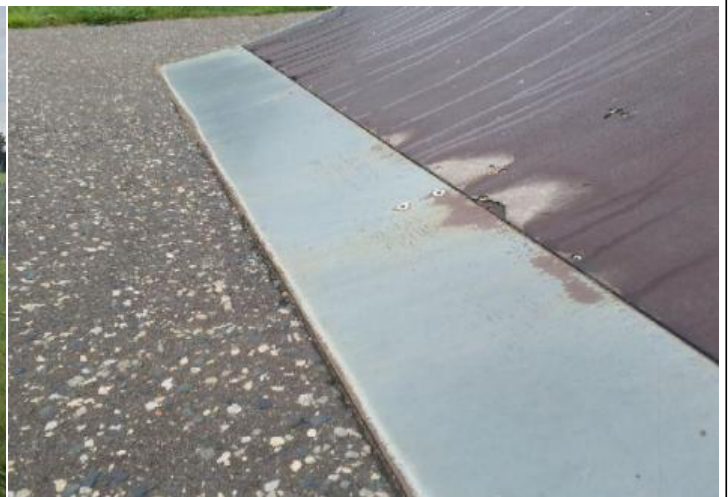
**Item:** Wheeled Sports - Quarter Pipe  
**Manufacturer:** StreetSkapes

**Finding:** The kicker plate has sunk into the surface creating a height difference exceeding 3mm in contravention of the requirements of BS EN 14974

**Action:** Reinstate the surface to level

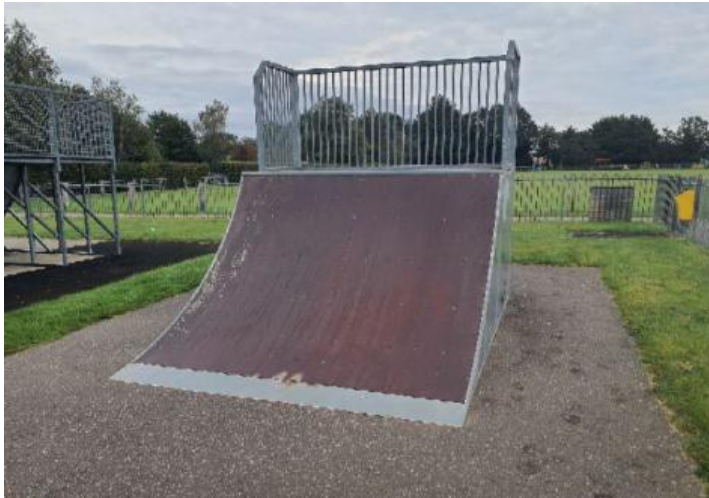
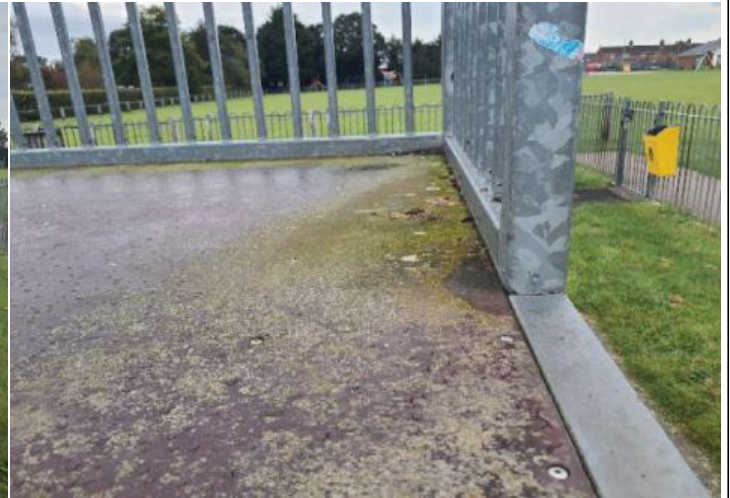
**Item:** Wheeled Sports - Quarter Pipe  
**Manufacturer:** StreetSkapes

**Finding:** There is algae or moss on the surface of the equipment

**Action:** Clean and treat appropriately

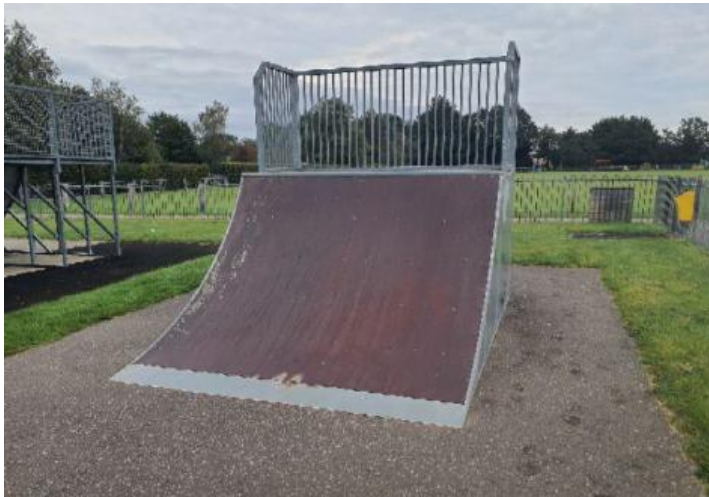
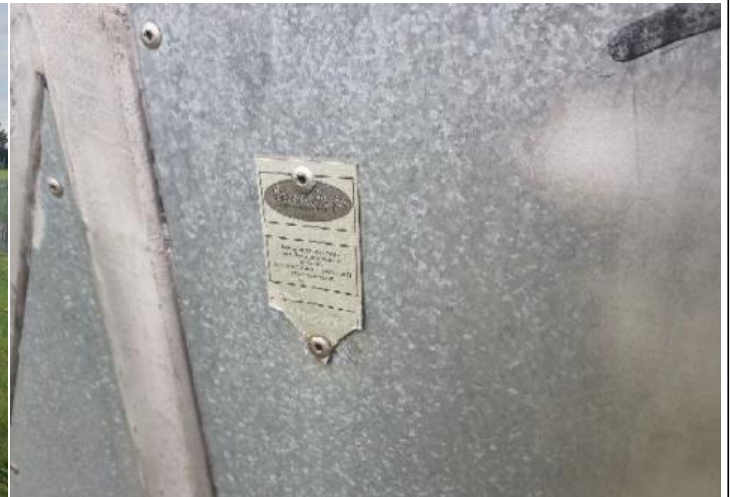
**Item:** Wheeled Sports - Quarter Pipe  
**Manufacturer:** StreetSkapes

**Finding:** The identification label is damaged

**Action:** Remove the label

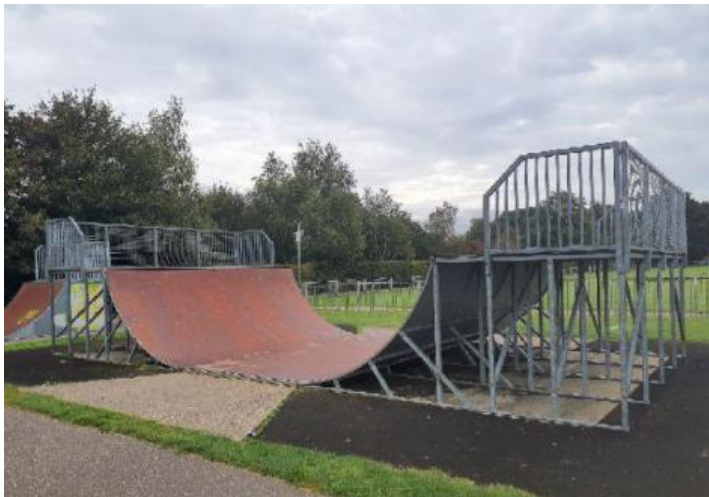
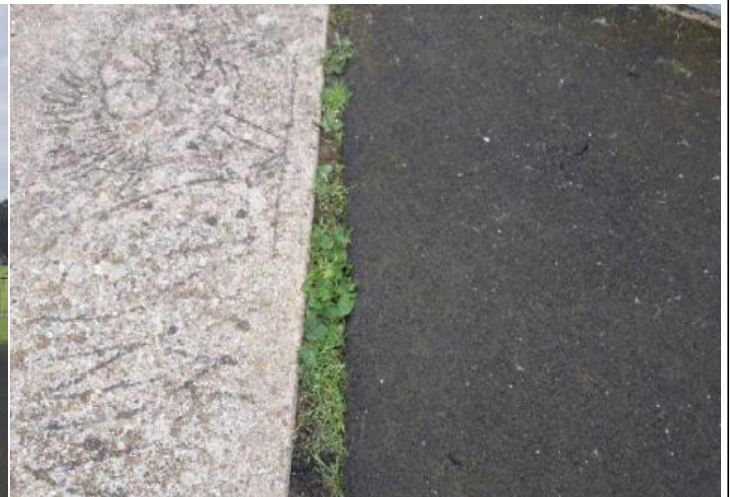
**Item:** Wheeled Sports - Half Pipe  
**Manufacturer:** StreetSkapes

**Finding:** There are significant gaps (over 30mm) between the surface and the edging or between the joints in the surface; these are large enough for a small foot to enter

**Action:** Repair surfacing

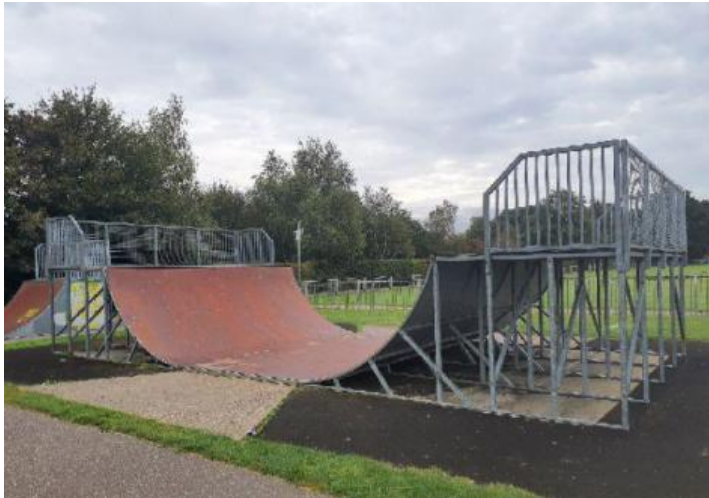
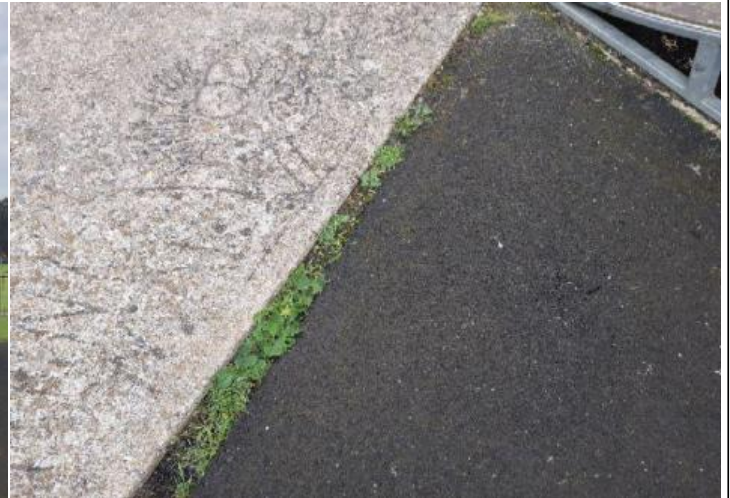
**Item:** Wheeled Sports - Half Pipe  
**Manufacturer:** StreetSkapes

**Finding:** There is weed / vegetation growth on, between, or around the edges of the surfacing  
**Action:** Remove weed / vegetation growth

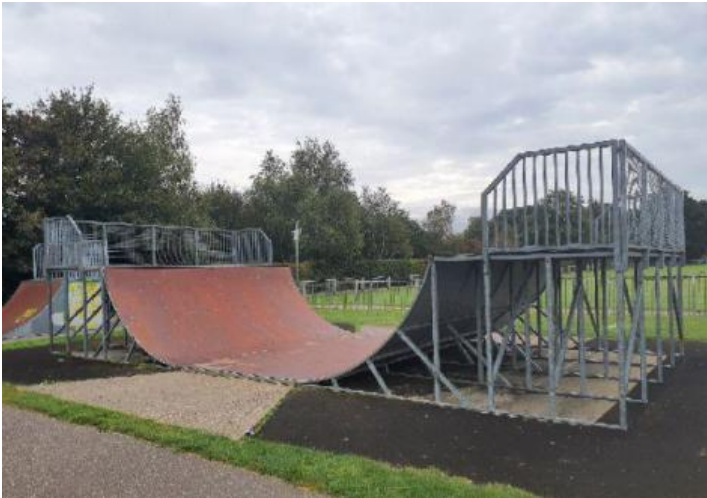
**Item:** Wheeled Sports - Half Pipe  
**Manufacturer:** StreetSkapes

**Finding:** There is moderate damage to the surface

**Action:** Repair the damaged areas of surfacing

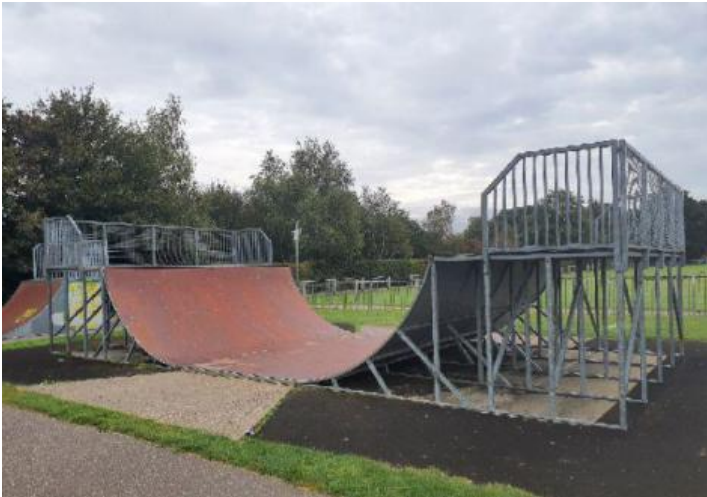
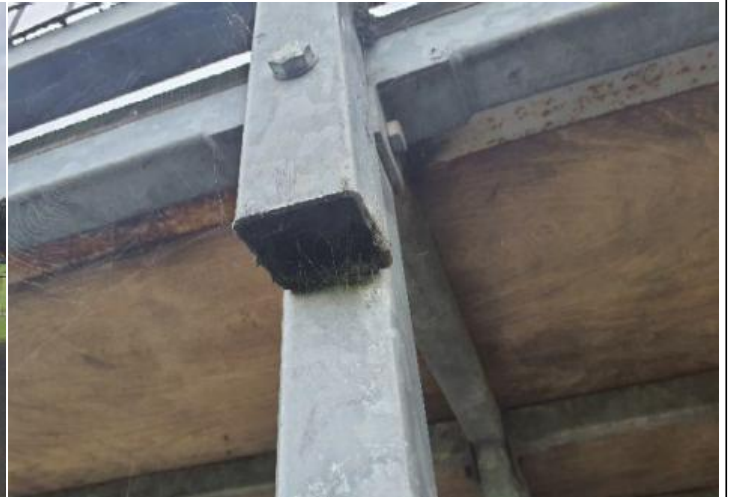
**Item:** Wheeled Sports - Half Pipe  
**Manufacturer:** StreetSkapes

**Finding:** There are post / end caps missing from the item

**Action:** Replace missing post caps

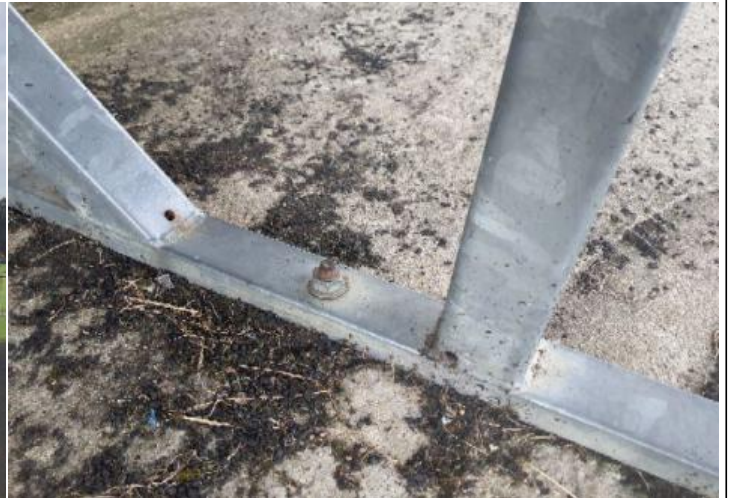
**Item:** Wheeled Sports - Half Pipe  
**Manufacturer:** StreetSkapes

**Finding:** There are projecting bolt thread(s) present

**Action:** Remove excess thread length and deburr or provide cap

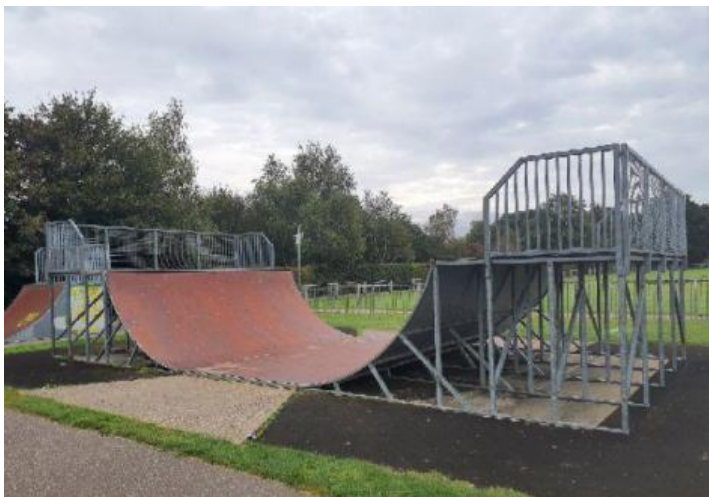
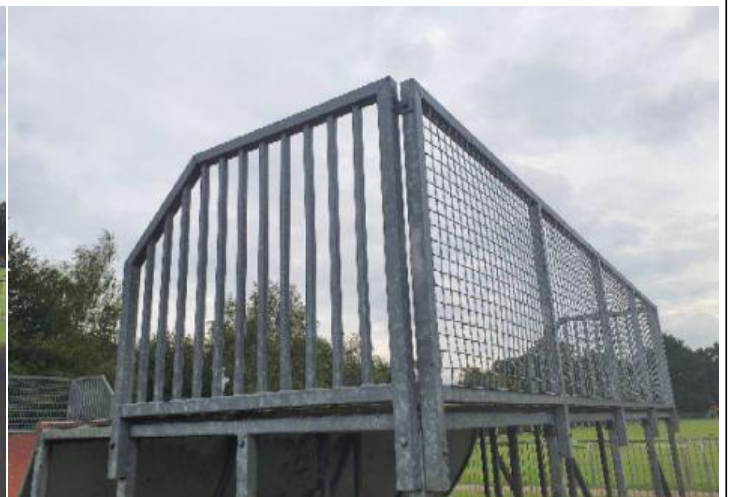
**Item:** Wheeled Sports - Half Pipe  
**Manufacturer:** StreetSkapes

**Finding:** The height of the barrier is less than 1200mm and fails the requirements of BS EN 14974

**Action:** Monitor - No remedial work recommended

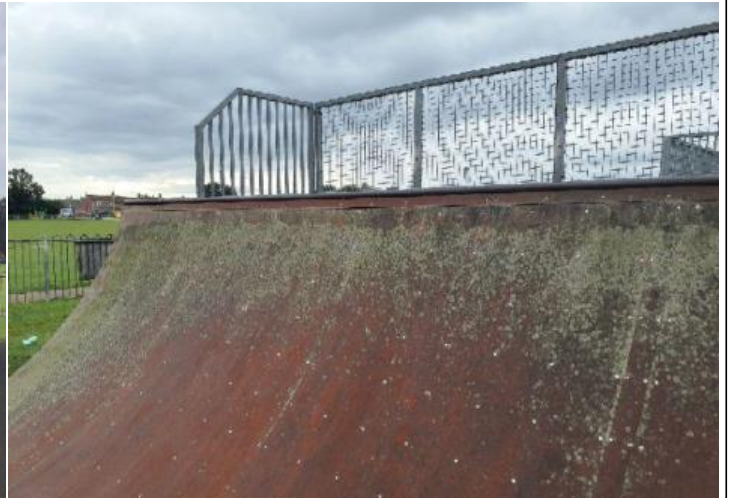
**Item:** Wheeled Sports - Half Pipe  
**Manufacturer:** StreetSkapes

**Finding:** There is algae or moss on the surface of the equipment

**Action:** Clean and treat appropriately

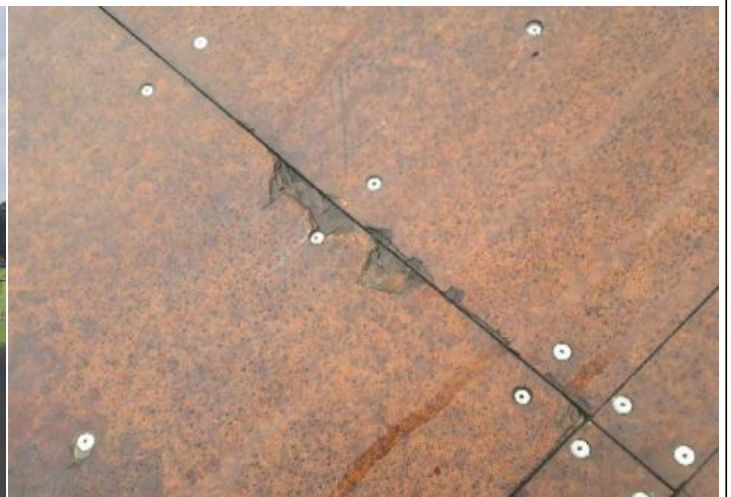
**Item:** Wheeled Sports - Half Pipe  
**Manufacturer:** StreetSkapes

**Finding:** The riding surface of the ramp has some damage apparent

**Action:** Monitor for any further deterioration and repair as required

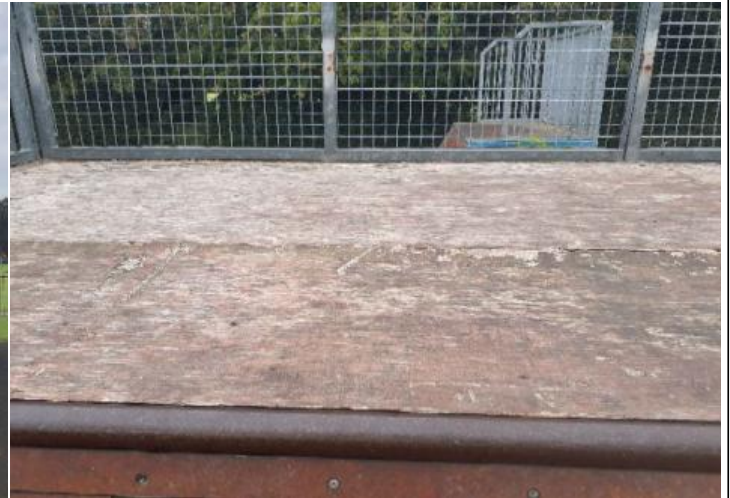
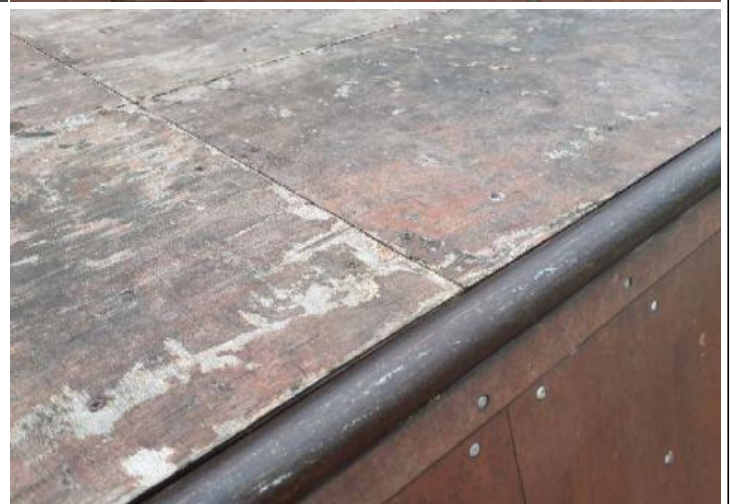
**Item:** Wheeled Sports - Half Pipe  
**Manufacturer:** StreetSkapes

**Finding:** The plywood has delaminated in some places

**Action:** Remove all rough or splintered edges.

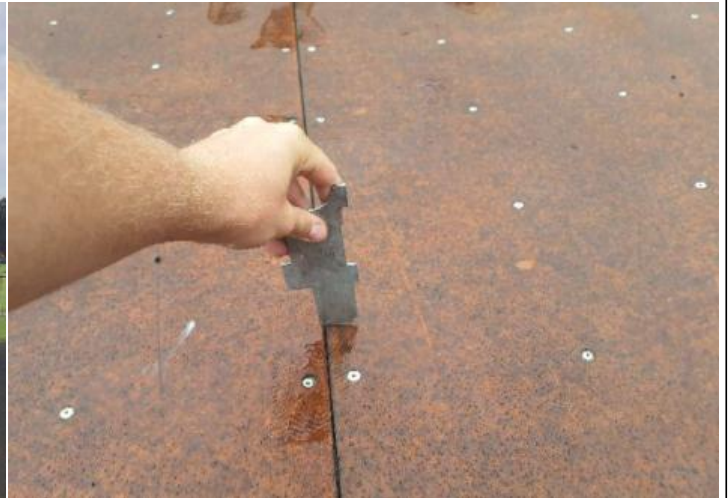
**Item:** Wheeled Sports - Half Pipe  
**Manufacturer:** StreetSkapes

**Finding:** There is a change in the level of the rolling surface in excess of 3mm and the item fails the requirements of BS EN 14974 Clause 5.1.2.3  
**Action:** Monitor - No remedial work recommended

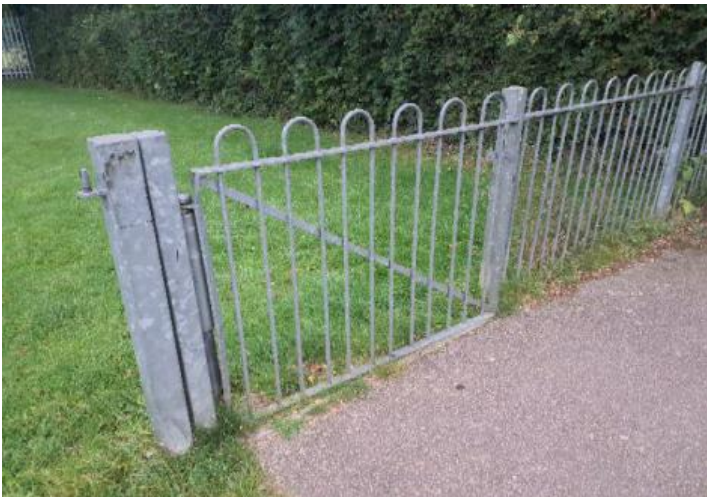
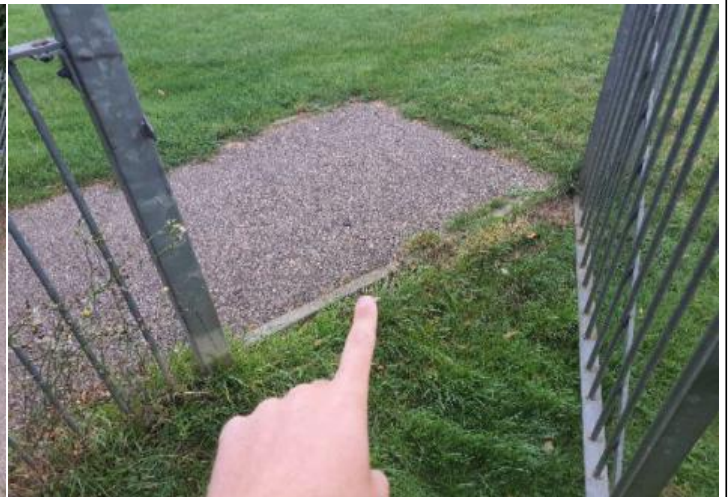
**Item:** Gates - Gate - Self Closing  
**Manufacturer:** Not Identified

**Finding:** There are trip hazards at the edges of the surface  
**Action:** Reinstate surrounding surface levels to remove the trip points

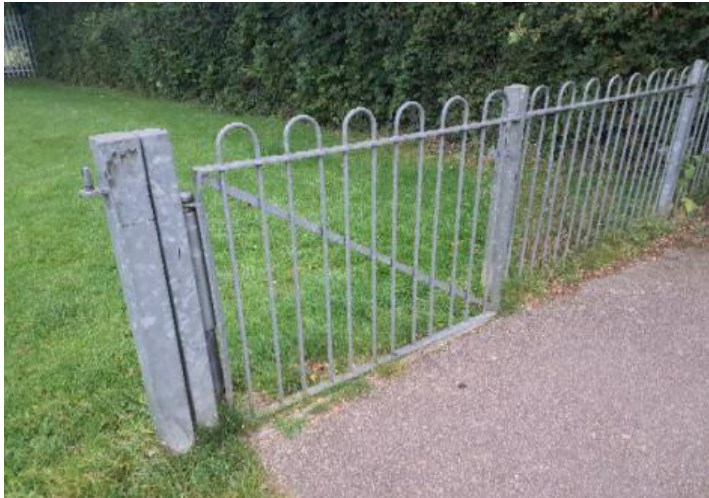
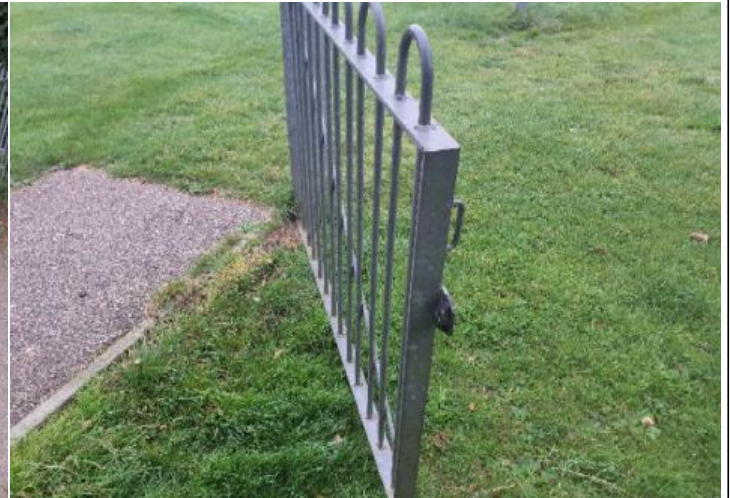
**Item:** Gates - Gate - Self Closing  
**Manufacturer:** Not Identified

**Finding:** The gate is not operating correctly

**Action:** Take effective action to ensure the gate closes between 4 and 8 seconds

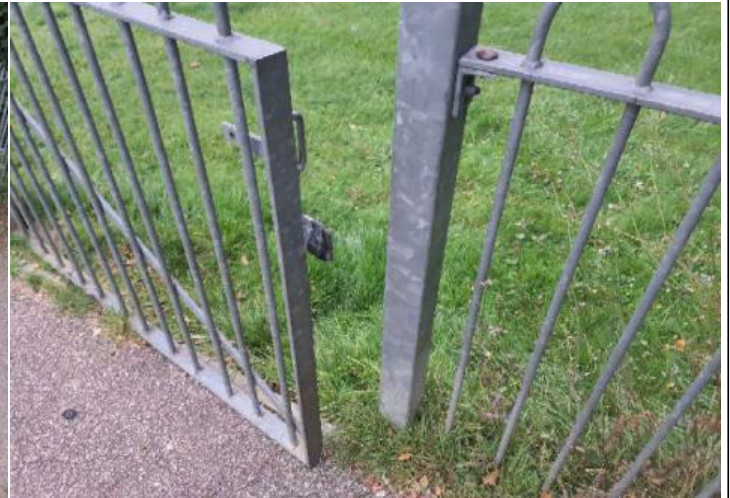
**Item:** Gates - Gate - Self Closing  
**Manufacturer:** Not Identified

**Finding:** The gate passes the slamming post

**Action:** Adjust gate

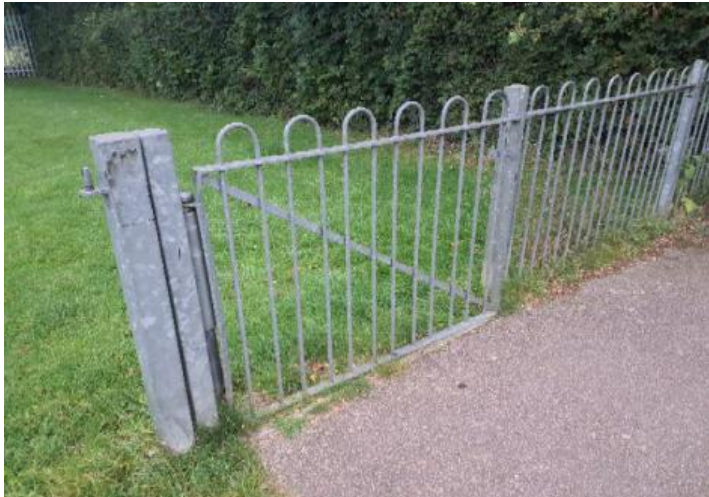
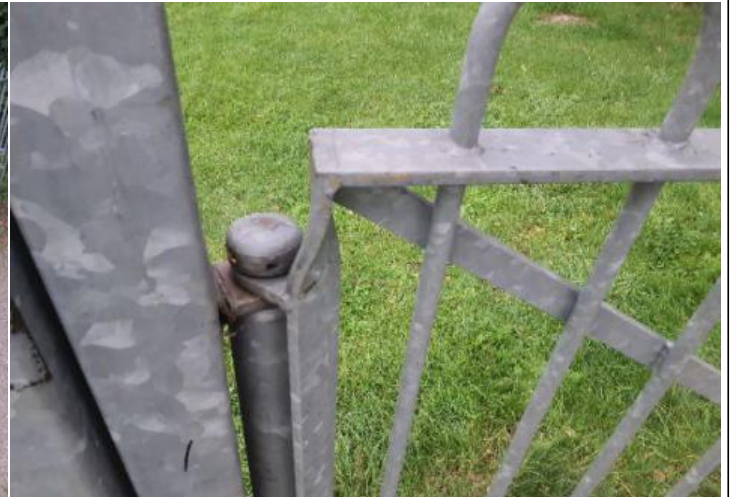
**Item:** Gates - Gate - Self Closing  
**Manufacturer:** Not Identified

**Finding:** There is some damage to the item

**Action:** Monitor for any further deterioration and repair as required

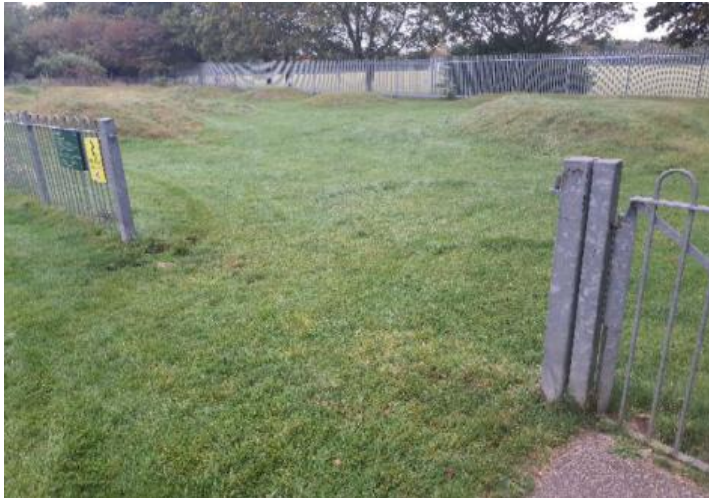
**Item:** Gates - Maintenance Gate  
**Manufacturer:** Not Identified

**Finding:** The gate is missing

**Action:** Replace the gate

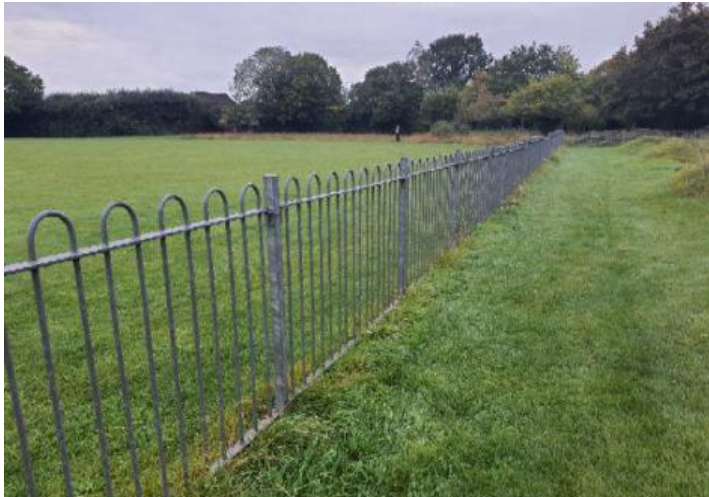
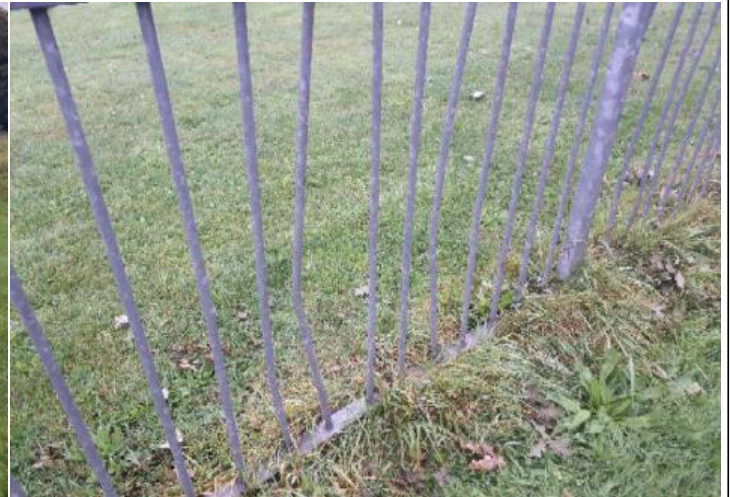
**Item:** Fences - Fence - Bow Top  
**Manufacturer:** Not Identified

**Finding:** There is some damage to the fence sections

**Action:** Monitor for any further deterioration and repair as required

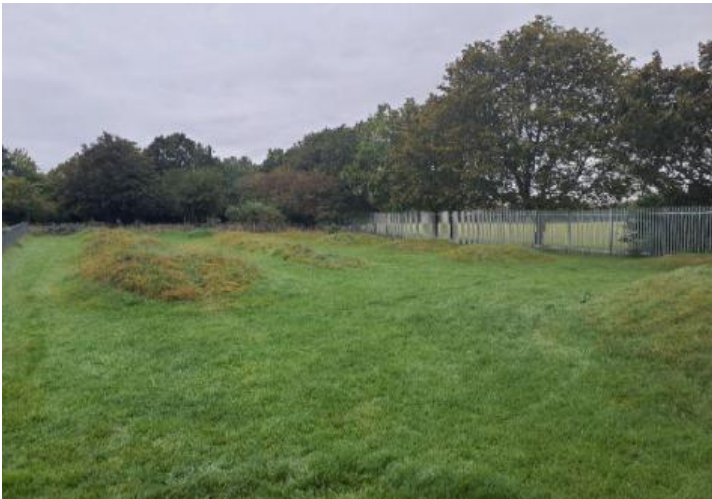
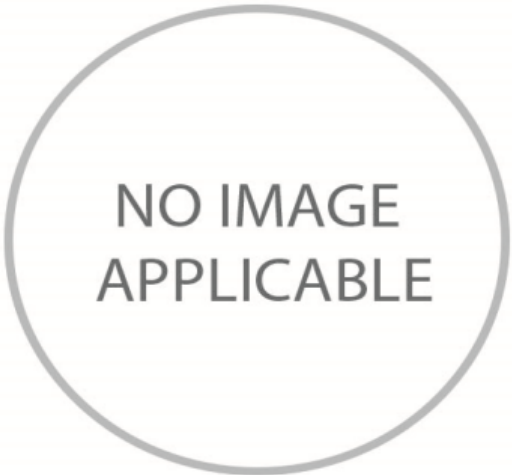
<b>Item:</b>	Wheeled Sports - BMX Track	<b>Risk Level:</b>	L - Low Risk
<b>Manufacturer:</b>	Not Identified	<b>Surface:</b>	Grass

**Finding:** BMX tracks are not currently covered by any British or European Standard; comments made in the report are based on the application of our knowledge and understanding of the Wheeled Sports Standard (BS EN 14974) and their maintenance and the area has been risk assessed accordingly

**Action:** Monitor use and review risk assessment regularly

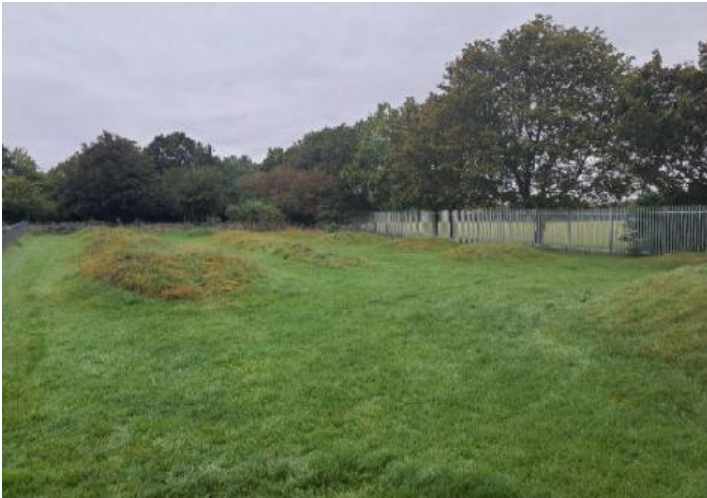
**Item:** Wheeled Sports - BMX Track  
**Manufacturer:** Not Identified

**Finding:** The grass is overgrown within the play area and may hide hazards

**Action:** Reduce the length of grass to an acceptable height and maintain

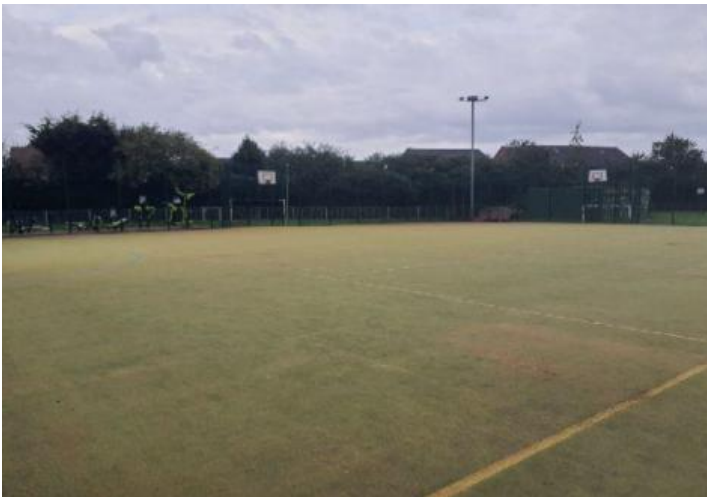
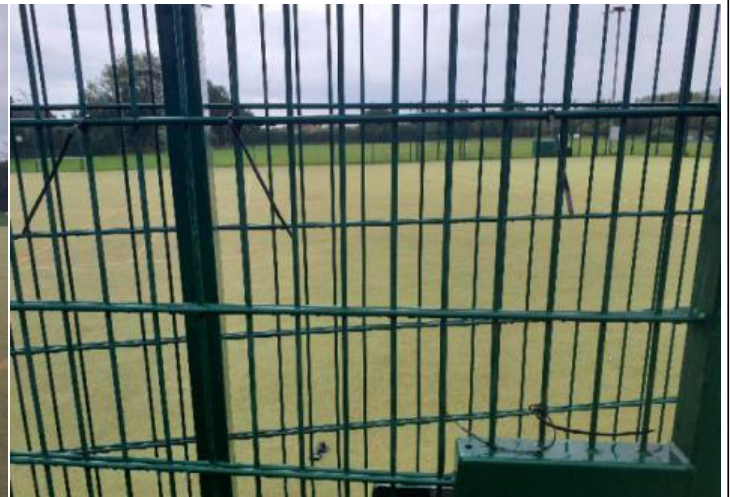
**Finding:** There are a number of redundant cable ties attached to the gate

**Action:** Remove redundant cable ties

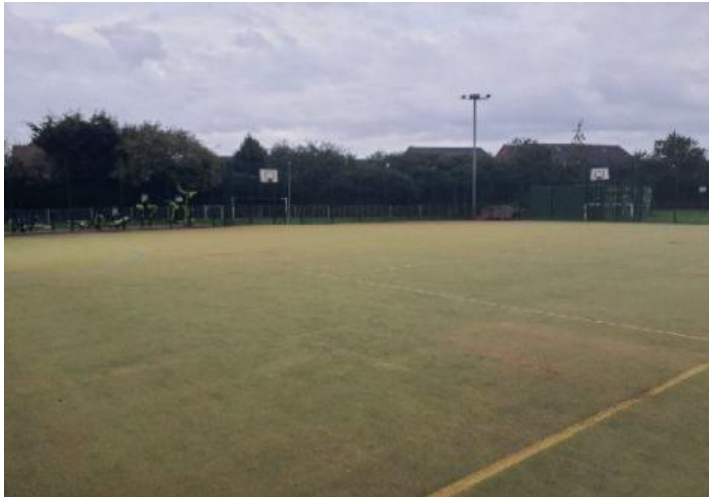
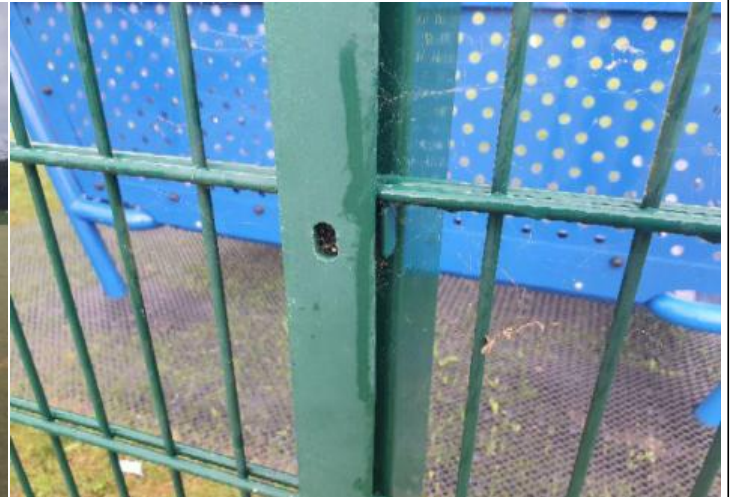
**Finding:** There is or are numerous fixings missing on the clamping rails

**Action:** Replace all missing fixings

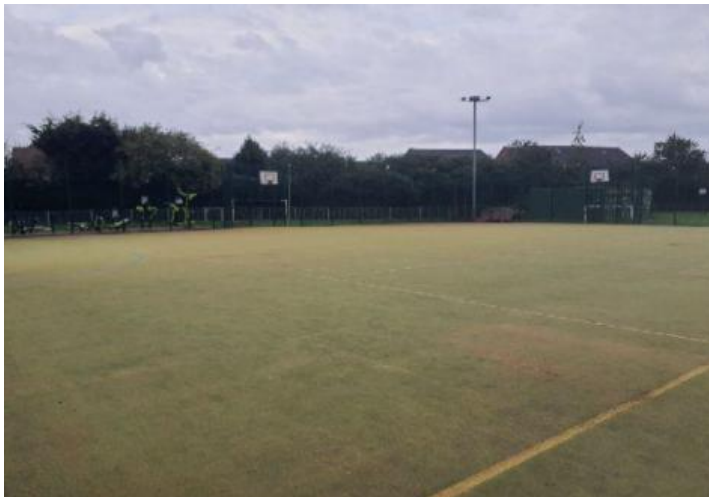
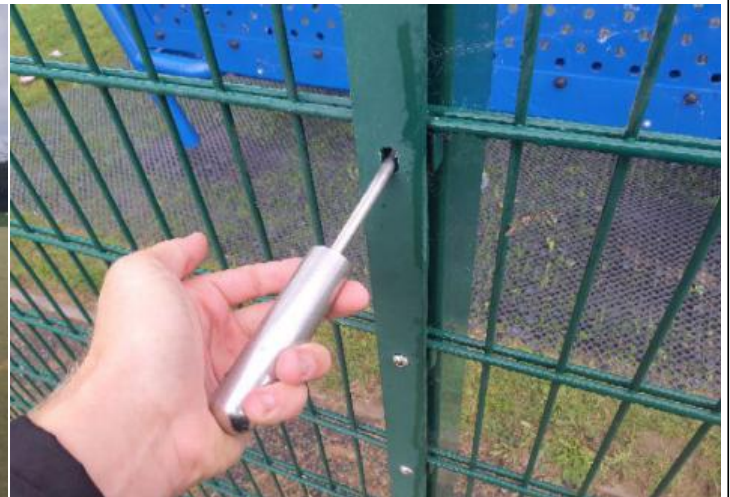
**Finding:** There is/are finger entrapments in the frame due to missing fixings and the item fails to meet the requirements of BS EN 15312 Clause 4.4.2.2 Entrapment of fingers

**Action:** Provide missing fixings to remove entrapment

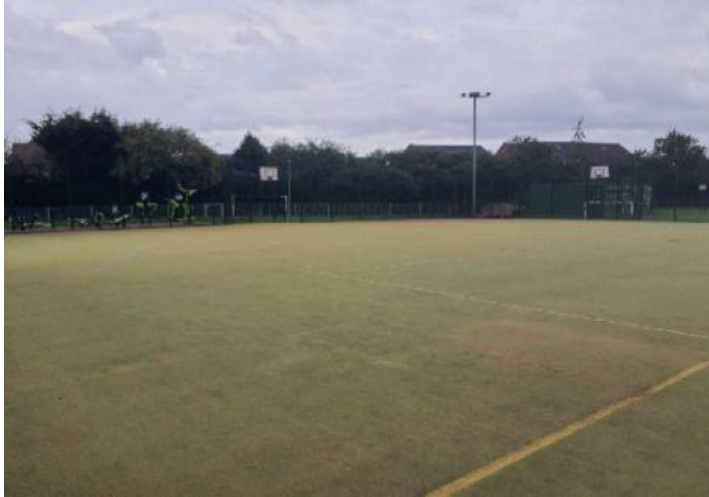
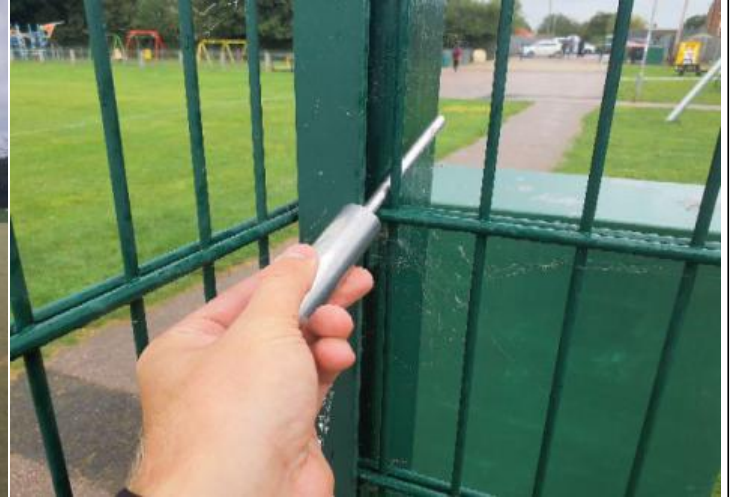
**Finding:** There is/are finger entrapments in the frame and the item fails to meet the requirements of BS EN 15312 Clause 4.4.2.2 Entrapment of fingers

**Action:** Monitor - No remedial work recommended

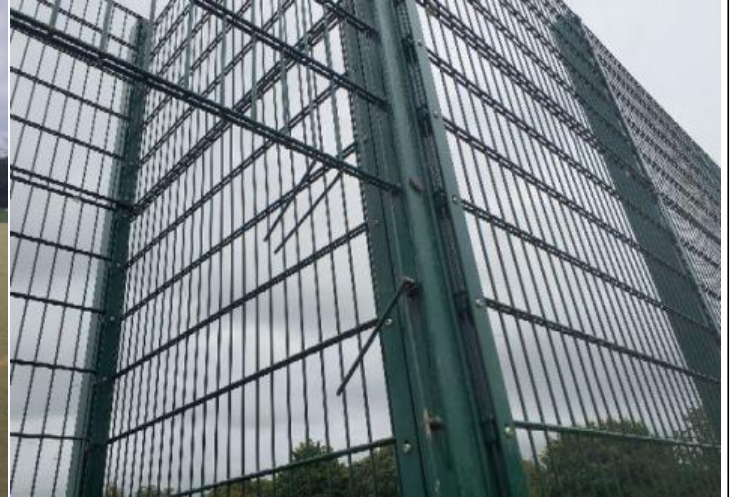
**Finding:** A panel is damaged

**Action:** Repair or replace as required

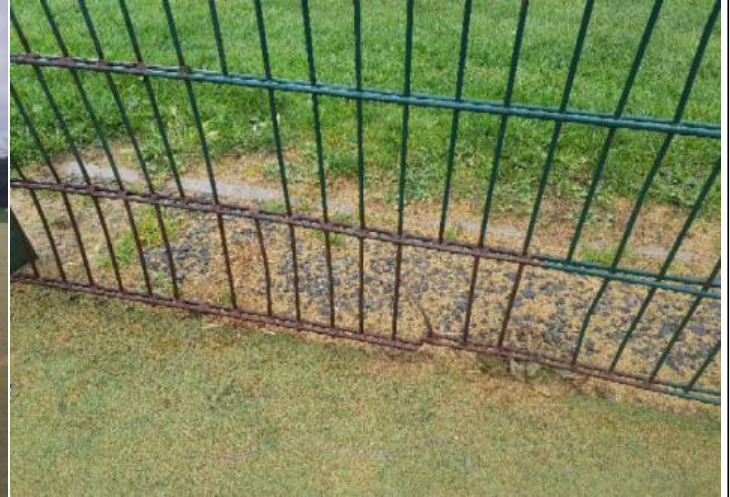
**Finding:** There is some damage to the goal panel

**Action:** Repair or replace as required

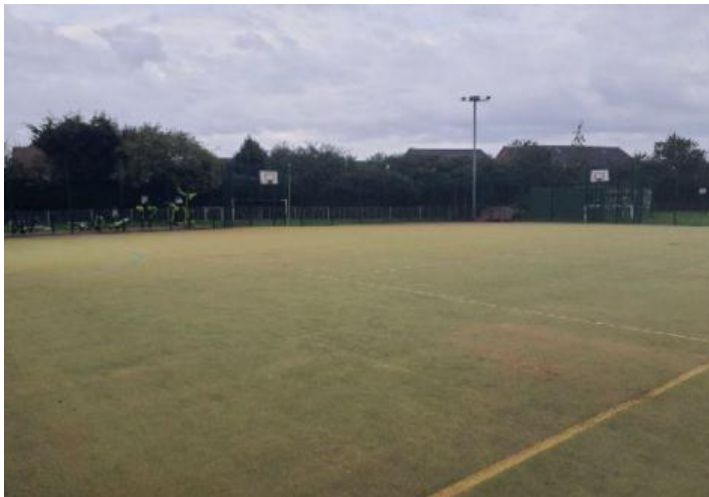
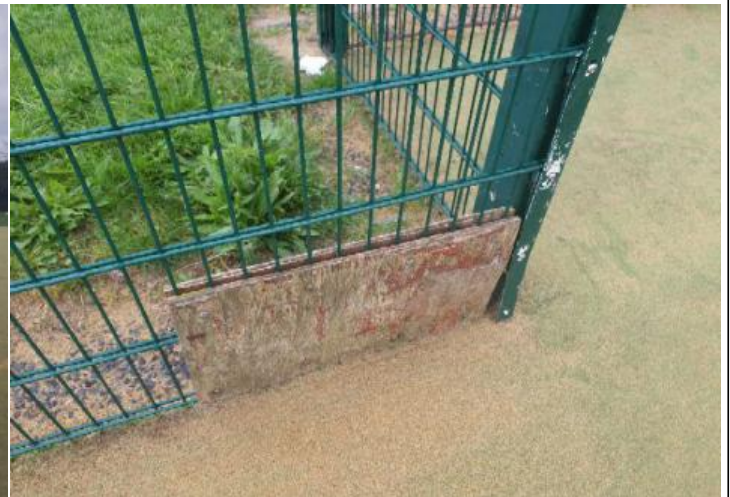
**Finding:** There is a redundant sign on the muga

**Action:** Remove if no longer required

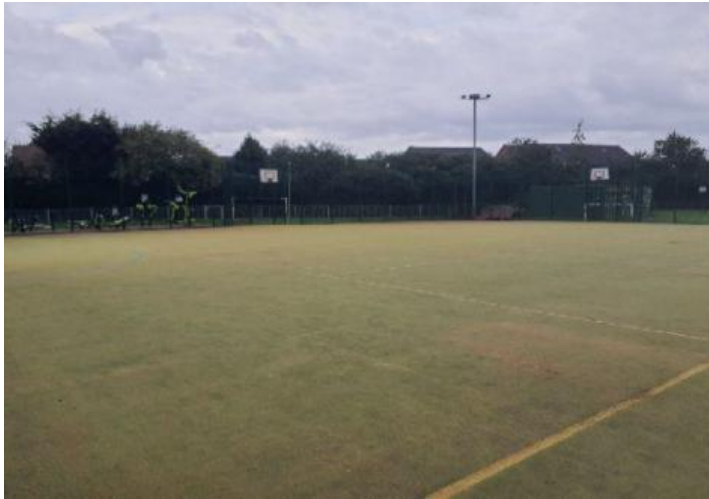
**Finding:** There is or are fixings missing on the item

**Action:** Replace all missing fixings

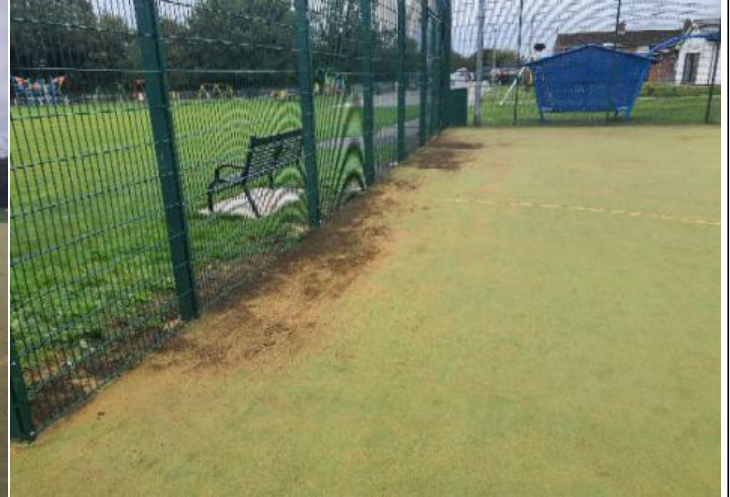
**Finding:** There is algae or moss growth on the surface resulting in slippery conditions

**Action:** Clean and treat appropriately

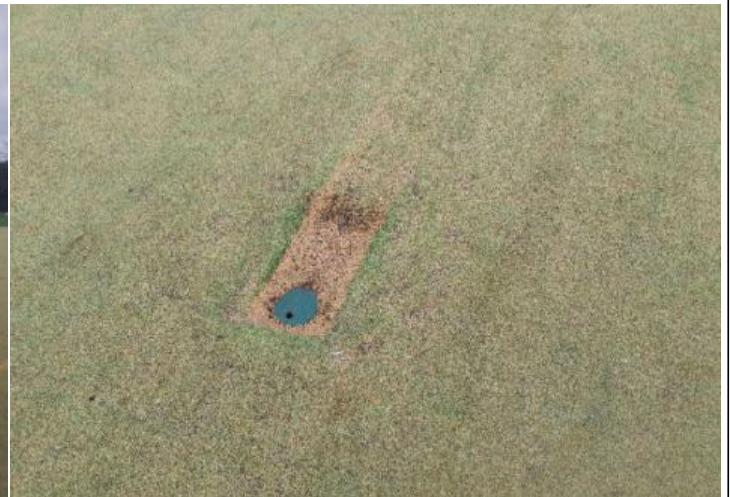
**Finding:** There is moderate damage to the surface

**Action:** Repair the damaged areas of surfacing

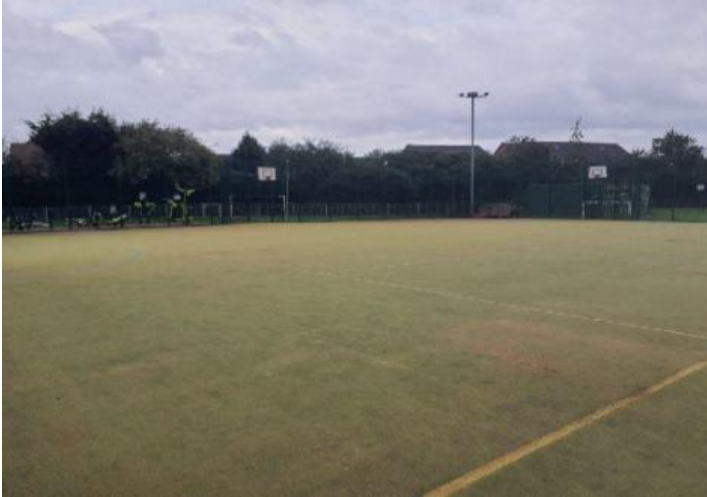
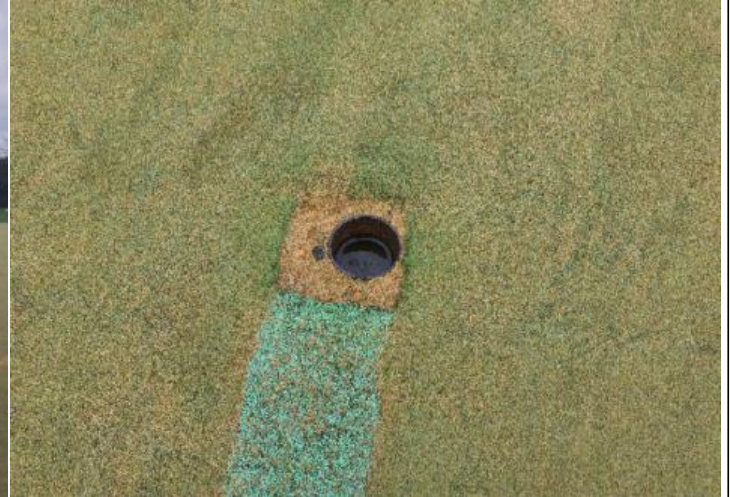
**Finding:** Socket covers are missing creating a foot entrapment

**Action:** Replace the cover

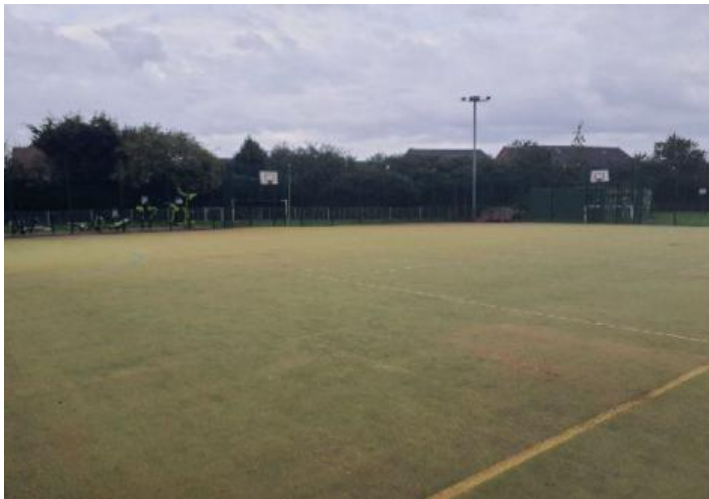
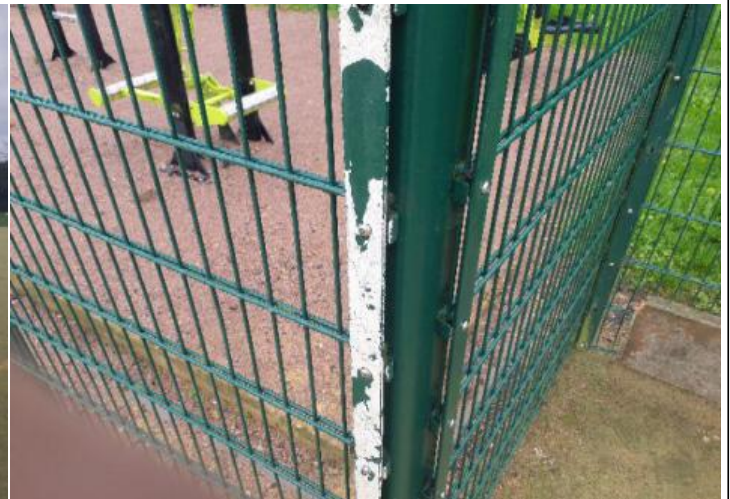
**Finding:** The paint is flaking off the metalwork  
**Action:** Rub down and re-paint

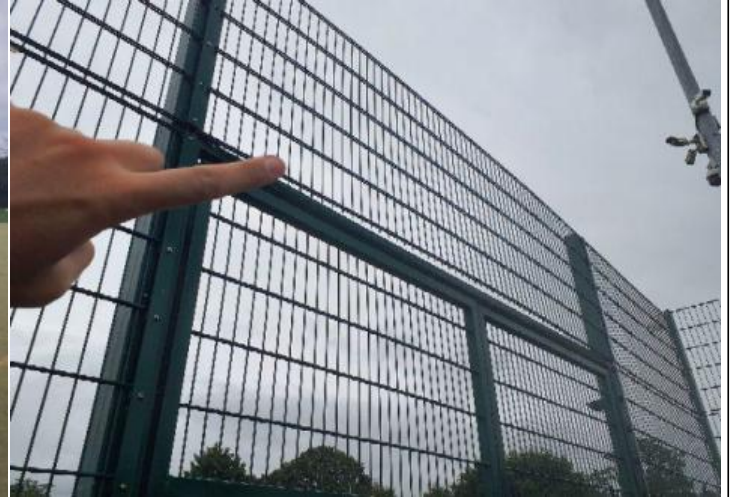
**Finding:** A panel is loose

**Action:** Secure

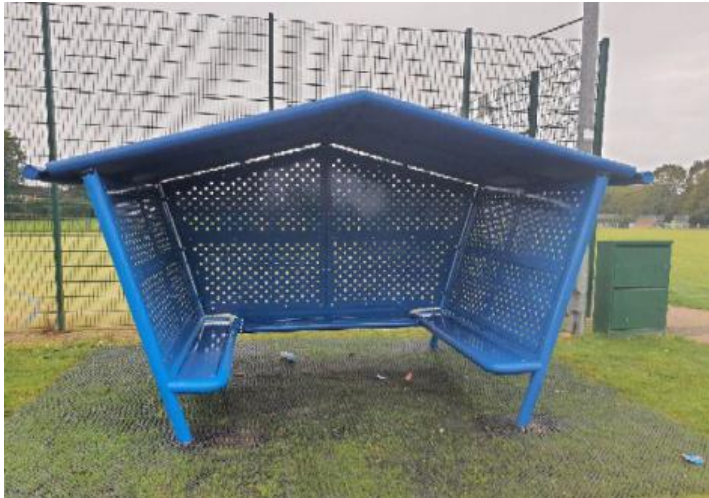
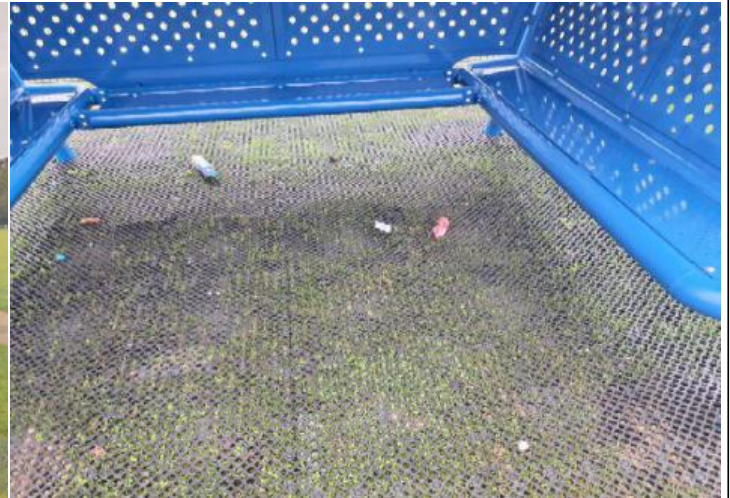
**Finding:** There is litter/debris in the area

**Action:** Remove litter/debris from the area and maintain
