# the **play inspection** company

## Annual Inspection

Long Stratton Town Council

Manor Road Playing Fields

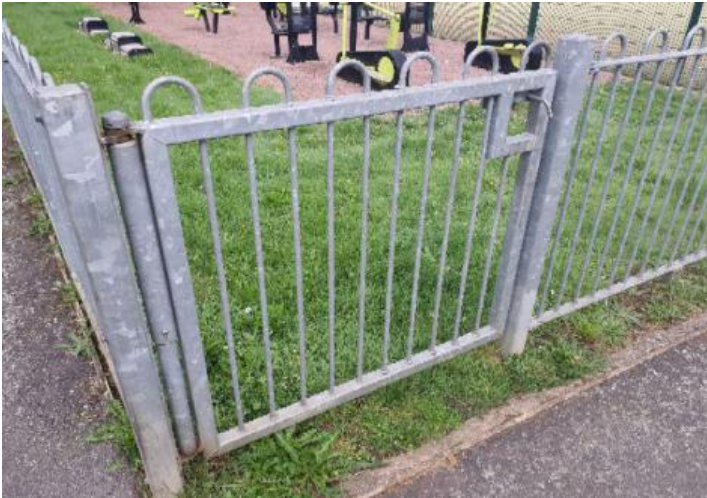
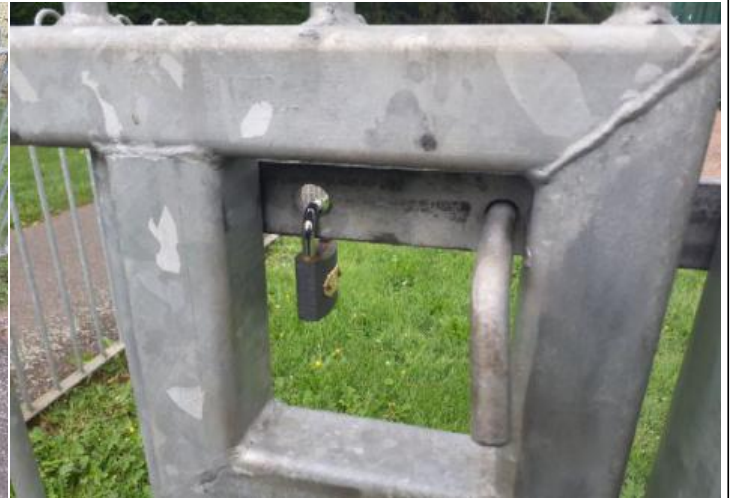
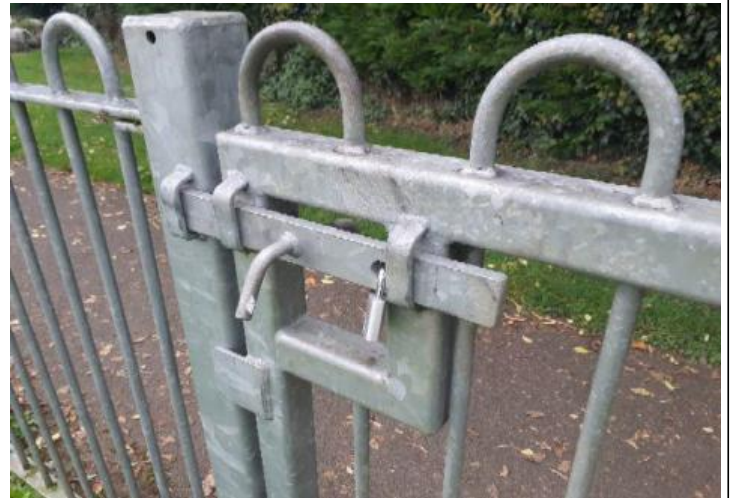
**Finding:** The gate/s was / were locked or secured at the time of the inspection and a full inspection could not be undertaken

**Action:** Complete inspection of gate/s when re-opened

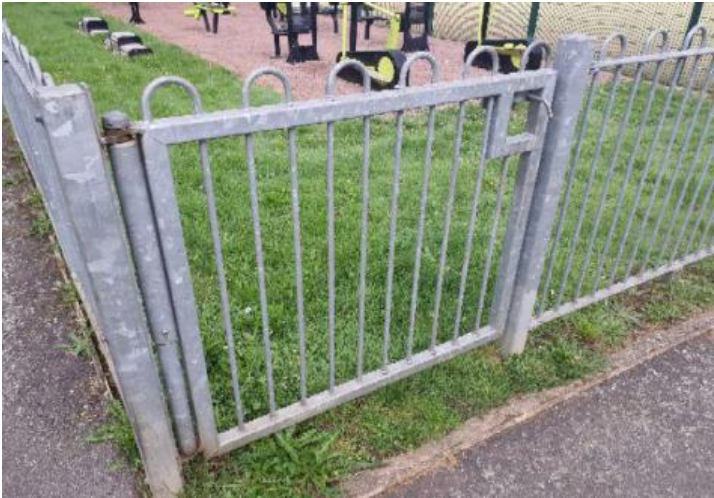
**Finding:** The rubber buffer is missing from the latch plate

**Action:** Replace rubber buffer

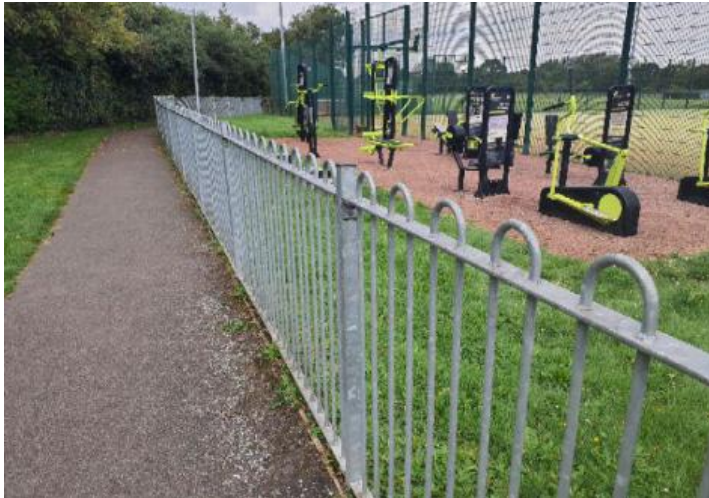
**Finding:** There is or are fixings missing on the item

**Action:** Replace all missing fixings

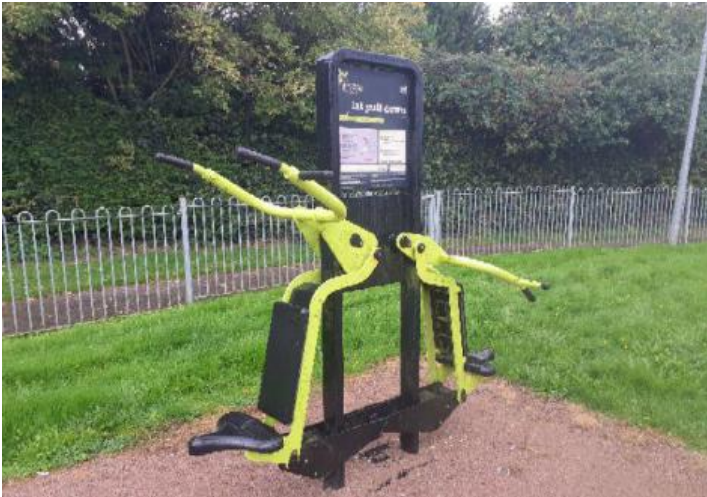
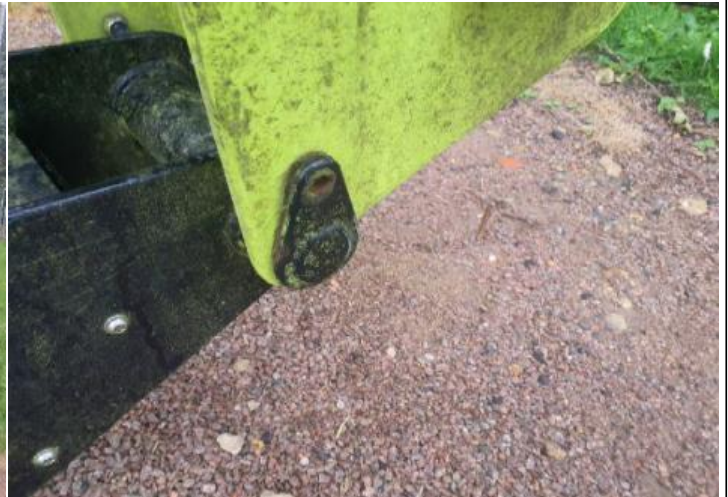
**Finding:** There is or are fixings missing on the item

**Action:** Replace all missing fixings

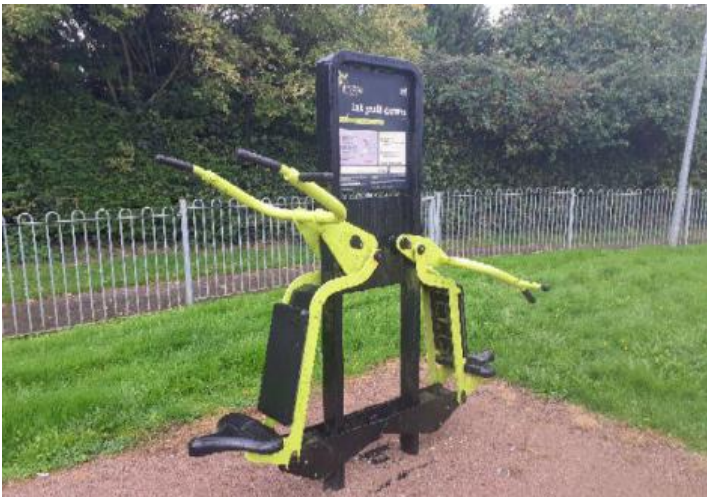
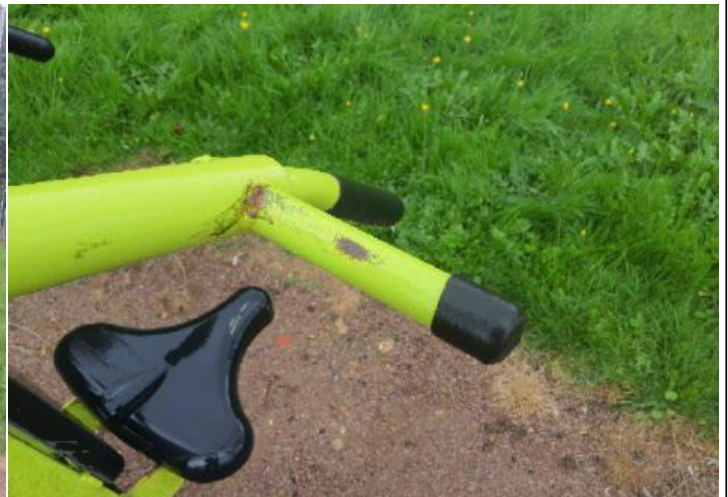
**Finding:** One or more handgrip(s) are damaged or missing. **Action:** Replace missing or damaged handgrips

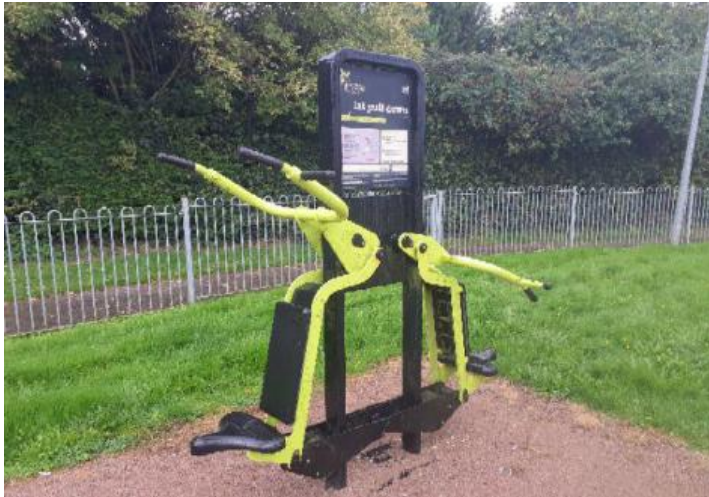
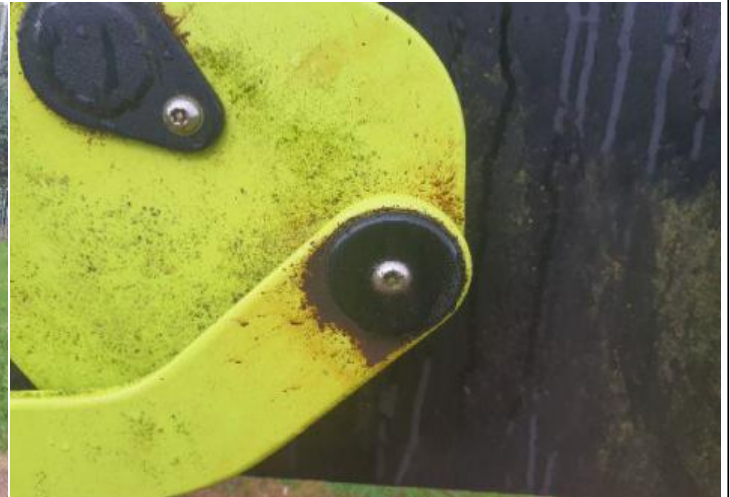
**Finding:** The paintwork on this item has been damaged or worn exposing the metal underneath which is rusting / corroding

**Action:** Treat affected areas and repaint

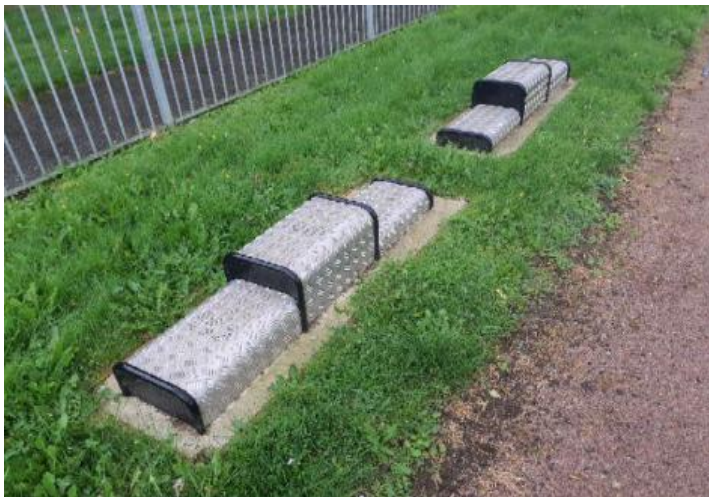
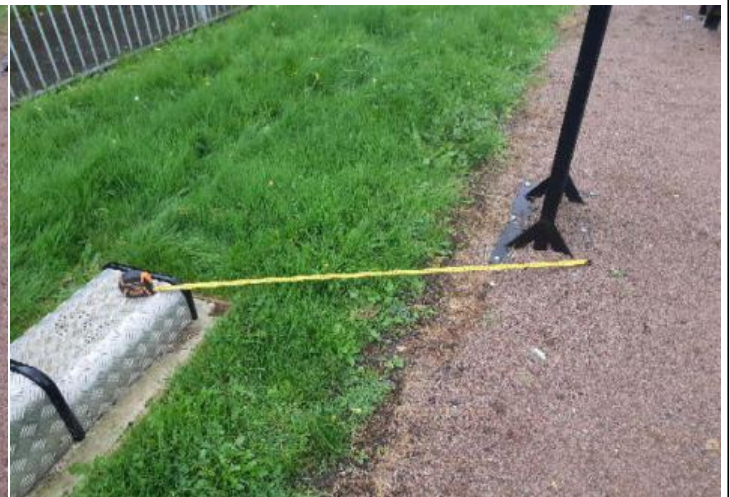
**Finding:** There are obstacles located within the movement space of the item in contravention of the requirements of BS EN 16630

**Action:** Monitor - No remedial work recommended

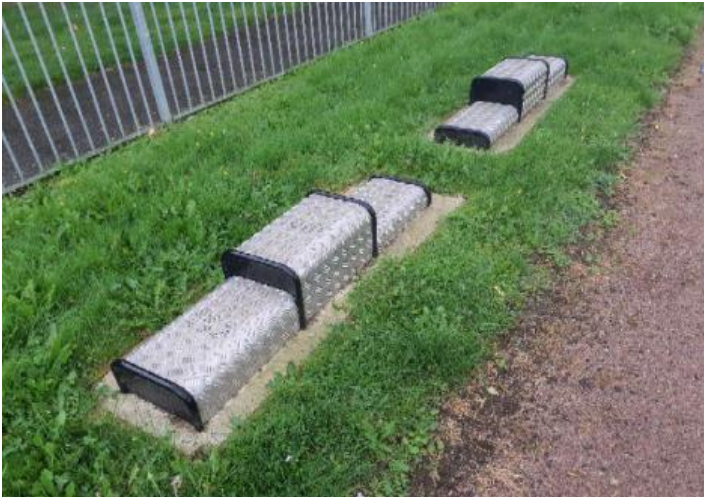
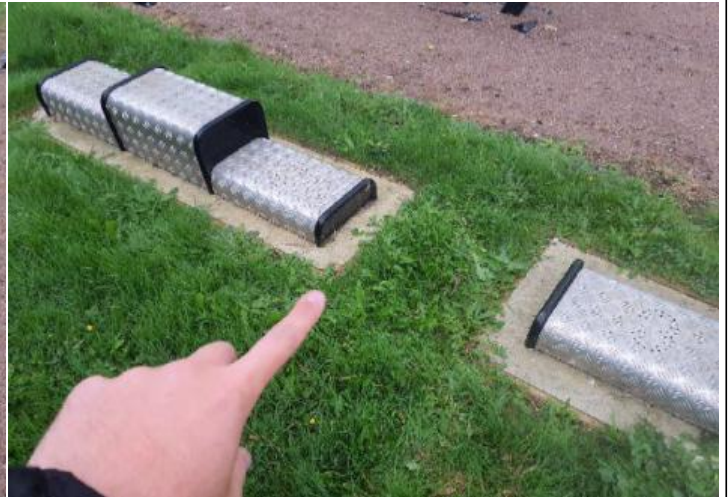
**Finding:** There are trip hazards at the edges of the surface

**Action:** Reinstate surrounding surface levels to remove the trip points

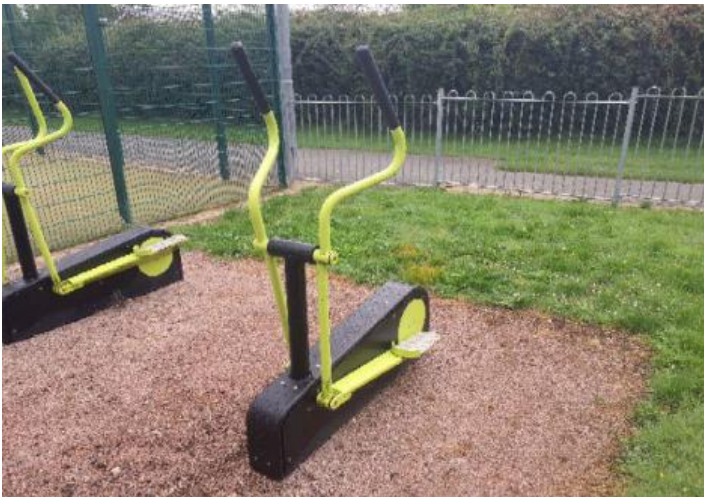
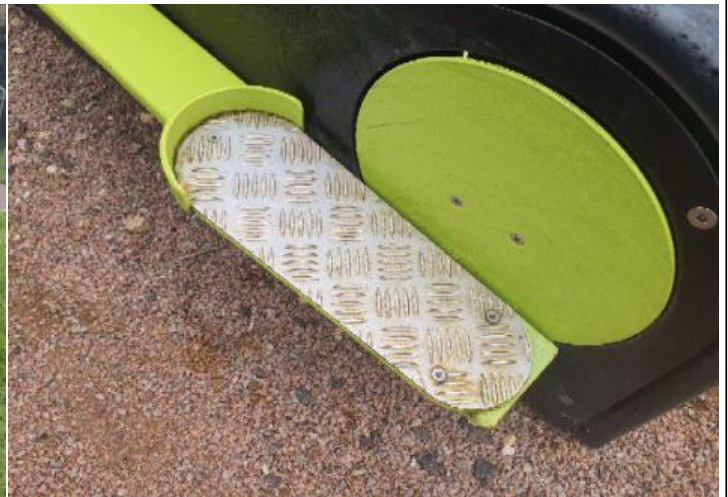
**Finding:** The tread surface does not have a 10mm high safeguard that extends around the front of the surface and at least 75% of the sides of the surface as required by BS EN 16630

**Action:** Monitor - No remedial work recommended

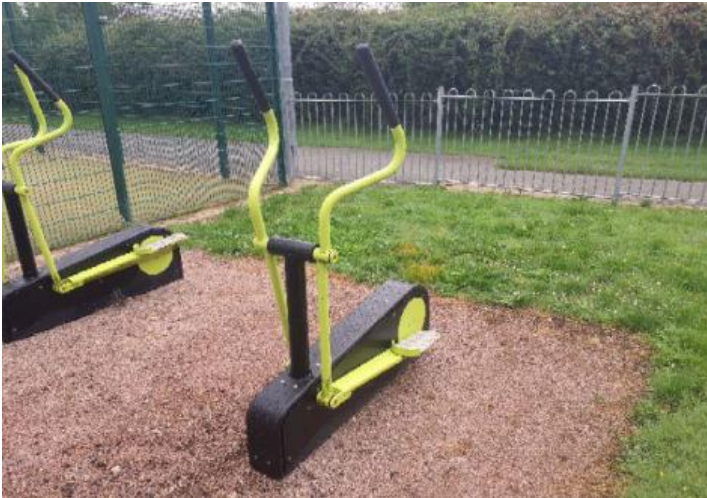
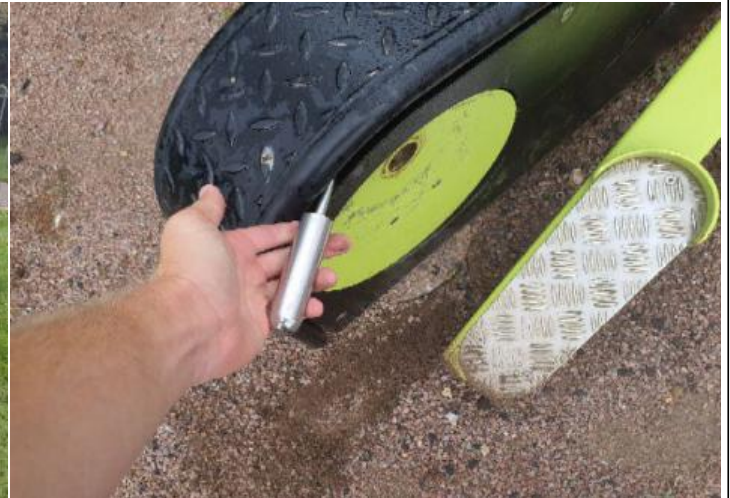
**i** 8 - Low Risk (Finding 2)

**Item:** Outdoor Fitness Equipment - Cross Trainer **Risk Level:** L - Low Risk  
**Manufacturer:** The Great Outdoor Gym Company **Surface:** Crushed Stone

**Finding:** There are gaps between 8 and 60mm creating a potential crush/shear point in contravention of the requirements of BS EN 16630 **Action:** Adjust the cover

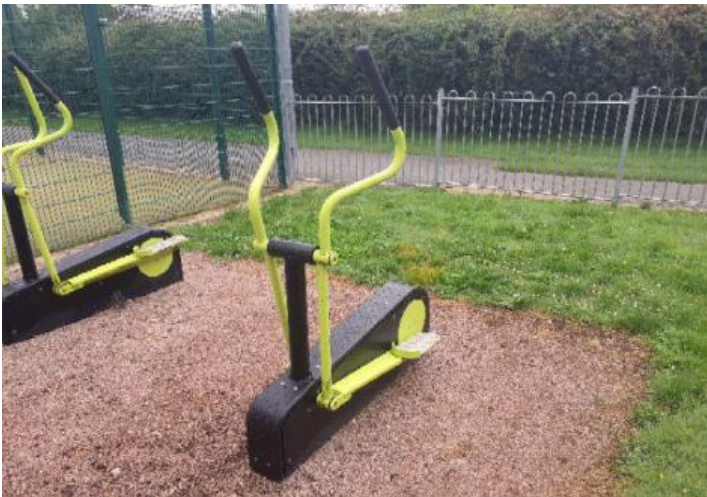
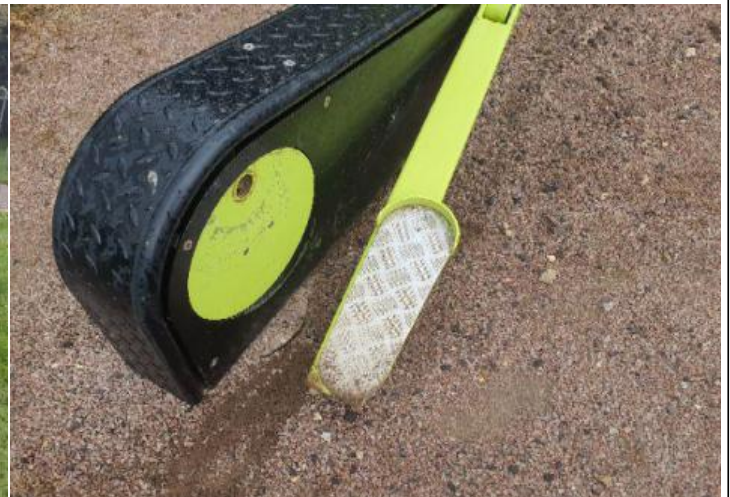
**!** 15 - Moderate Risk (Finding 3)

**Item:** Outdoor Fitness Equipment - Cross Trainer **Risk Level:** M - Moderate Risk  
**Manufacturer:** The Great Outdoor Gym Company **Surface:** Crushed Stone

**Finding:** The cross trainer foot has become unattached **Action:** Repair item

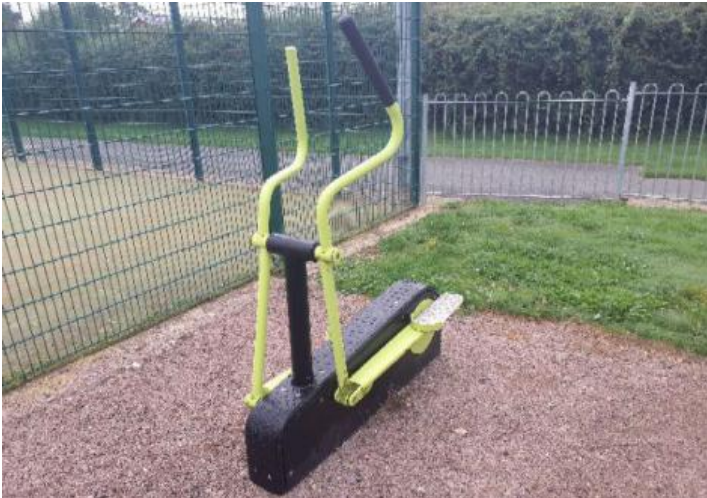
**i** 8 - Low Risk (Finding 1)

**Item:** Outdoor Fitness Equipment - Cross Trainer **Risk Level:** L - Low Risk  
**Manufacturer:** The Great Outdoor Gym Company **Surface:** Crushed Stone

**Finding:** One or more handgrip(s) are damaged or missing. **Action:** Replace missing or damaged handgrips

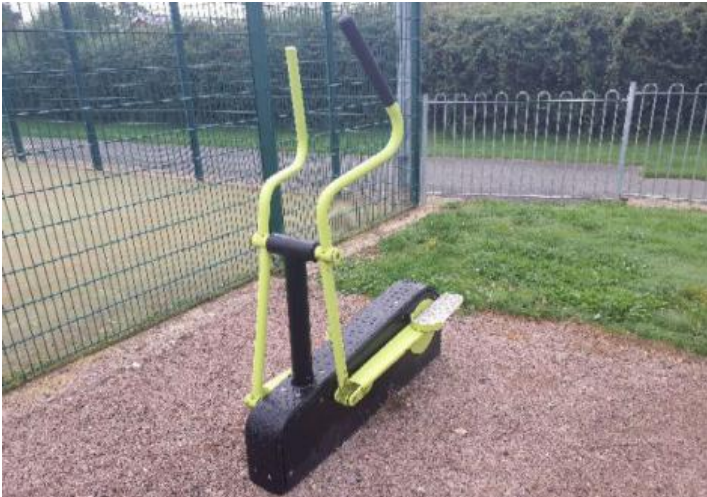
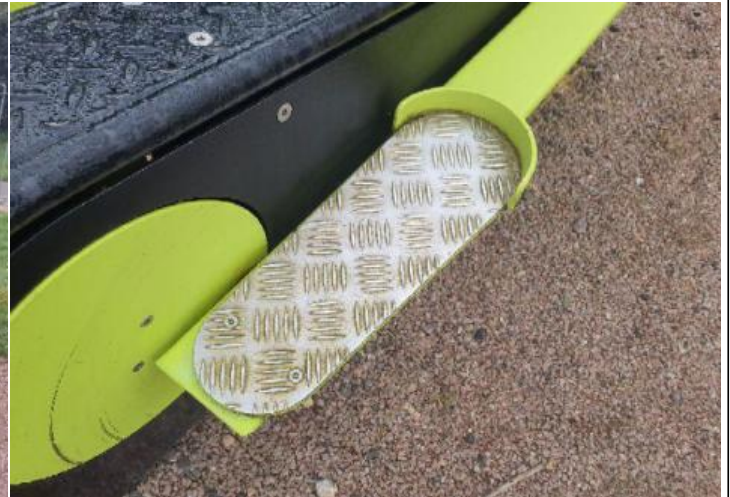
**i** 8 - Low Risk (Finding 2)

**Item:** Outdoor Fitness Equipment - Cross Trainer **Risk Level:** L - Low Risk  
**Manufacturer:** The Great Outdoor Gym Company **Surface:** Crushed Stone

**Finding:** The tread surface does not have a 10mm high safeguard that extends around the front of the surface and at least 75% of the sides of the surface as required by BS EN 16630 **Action:** Monitor - No remedial work recommended

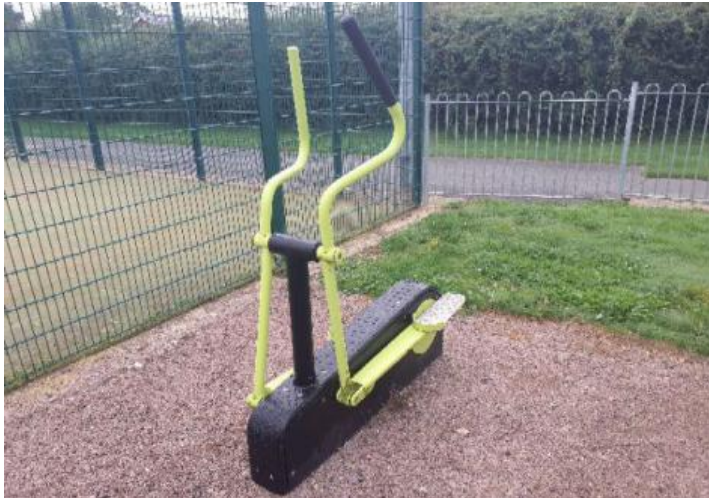
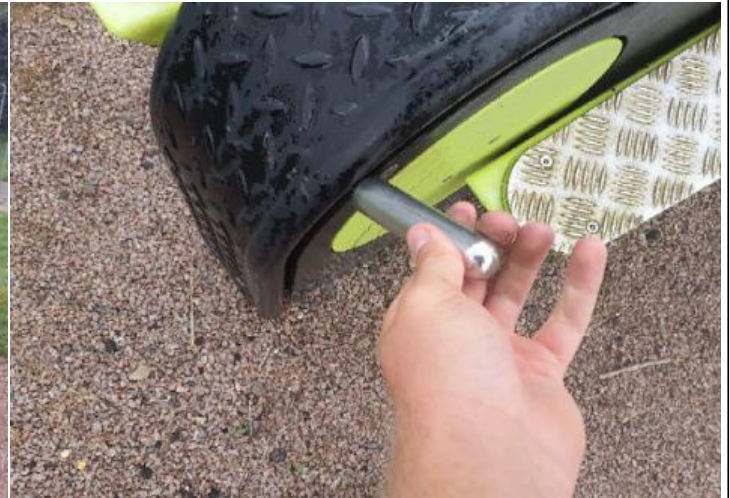
**i** 8 - Low Risk (Finding 3)

**Item:** Outdoor Fitness Equipment - Cross Trainer **Risk Level:** L - Low Risk  
**Manufacturer:** The Great Outdoor Gym Company **Surface:** Crushed Stone

**Finding:** There are gaps between 8 and 60mm creating a potential crush/shear point in contravention of the requirements of BS EN 16630

**Action:** Monitor - No remedial work recommended

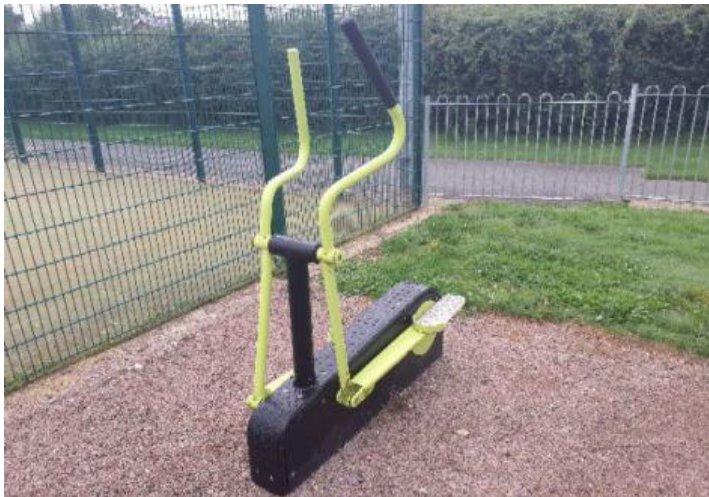
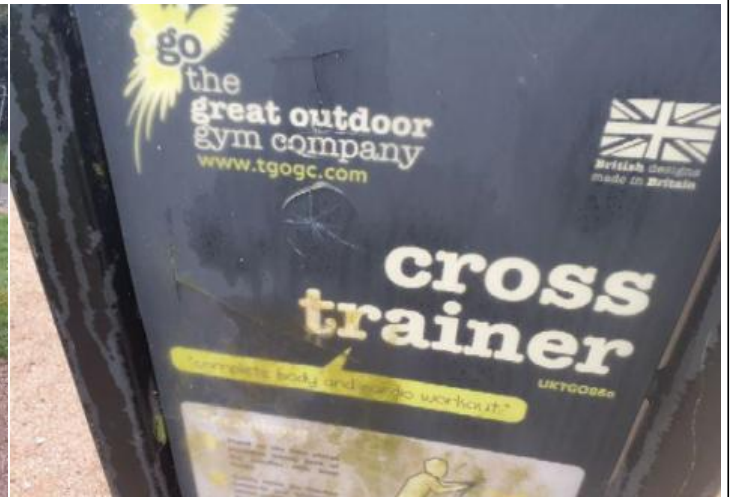
**i** 6 - Low Risk (Finding 4)

**Item:** Outdoor Fitness Equipment - Cross Trainer **Risk Level:** L - Low Risk  
**Manufacturer:** The Great Outdoor Gym Company **Surface:** Crushed Stone

**Finding:** There is some damage to the sign

**Action:** Monitor for any further deterioration and repair as required

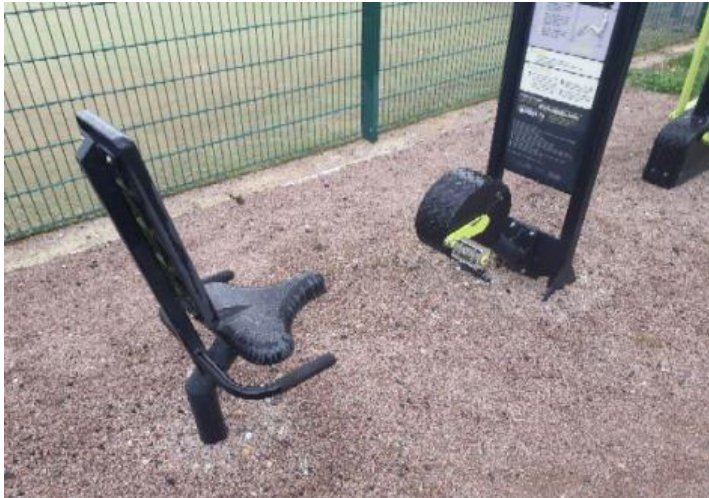
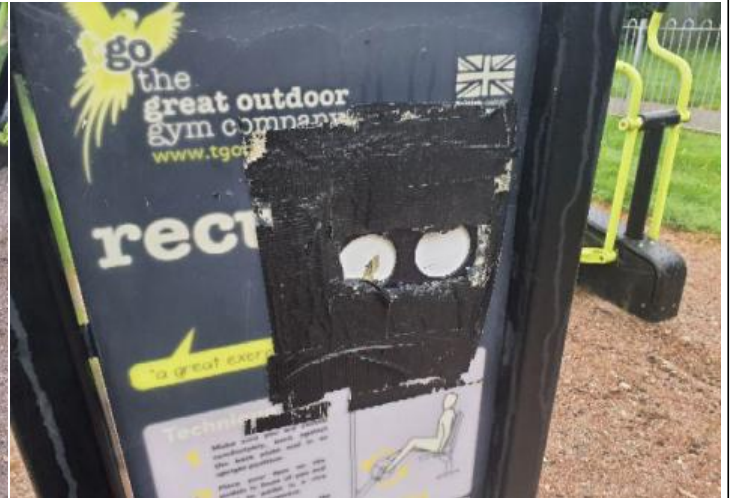
**Item:** Outdoor Fitness Equipment - Cycle  
**Manufacturer:** The Great Outdoor Gym Company

**Risk Level:** L - Low Risk  
**Surface:** Crushed Stone

**Finding:** There is some damage to the sign

**Action:** Replace sign

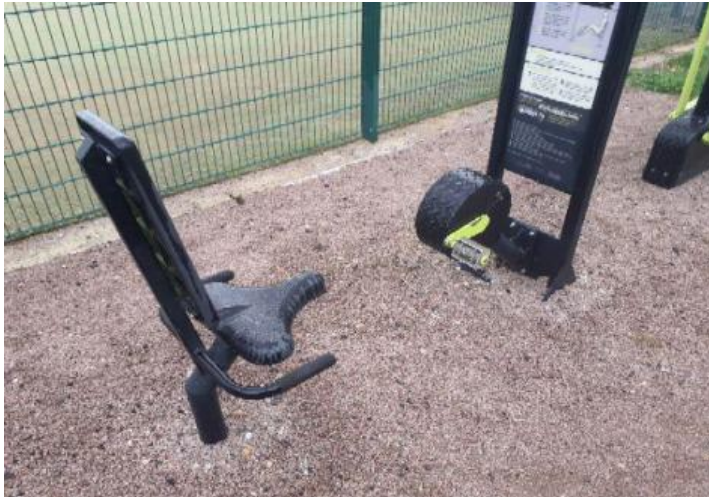
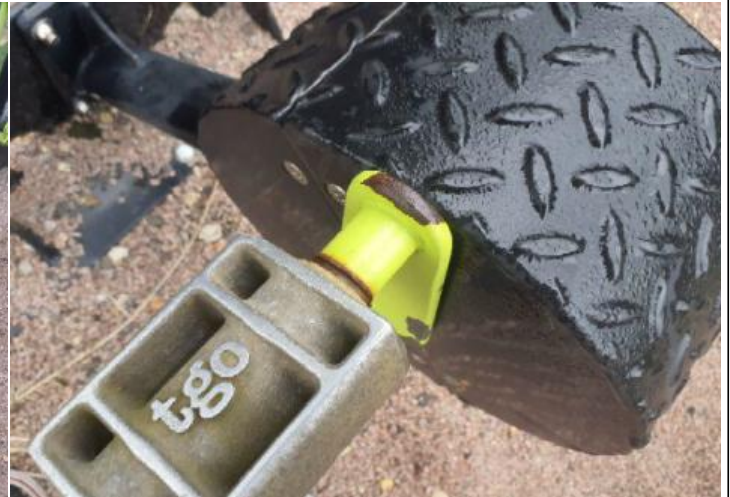
**Item:** Outdoor Fitness Equipment - Cycle  
**Manufacturer:** The Great Outdoor Gym Company

**Risk Level:** L - Low Risk  
**Surface:** Crushed Stone

**Finding:** The paintwork on this item has been damaged or worn exposing the metal underneath which is rusting / corroding

**Action:** Treat affected areas and repaint

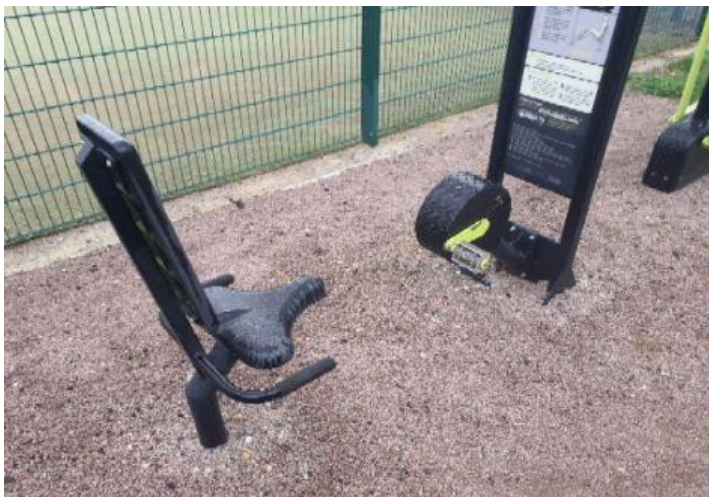
**Item:** Outdoor Fitness Equipment - Cycle  
**Manufacturer:** The Great Outdoor Gym Company

**Risk Level:** L - Low Risk  
**Surface:** Crushed Stone

**Finding:** There are obstacles located within the movement space of the item in contravention of the requirements of BS EN 16630

**Action:** Monitor - No remedial work recommended

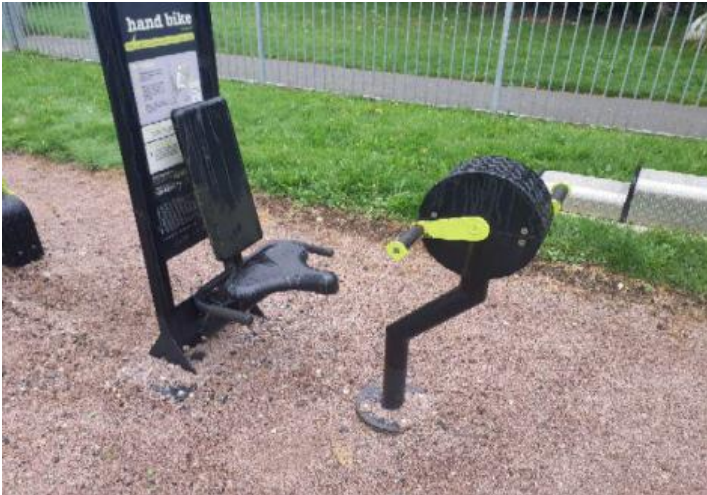
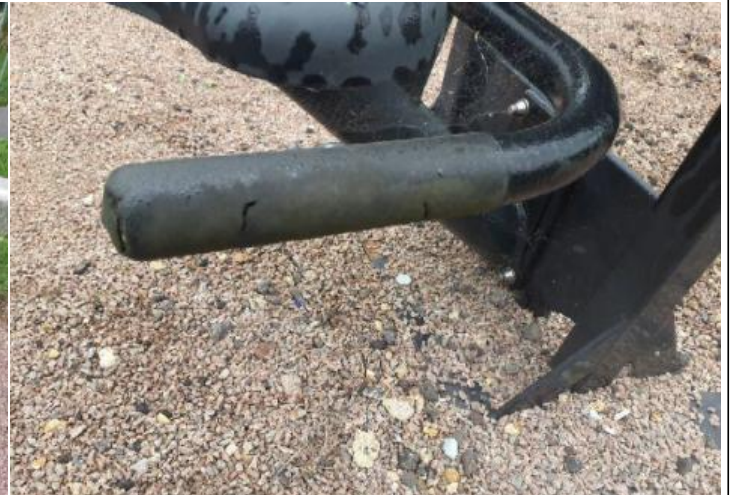
**Item:** Outdoor Fitness Equipment - Hand Bike  
**Manufacturer:** The Great Outdoor Gym Company

**Risk Level:** L - Low Risk  
**Surface:** Crushed Stone

**Finding:** There is some damage to the handgrip

**Action:** Monitor for any further deterioration and repair as required

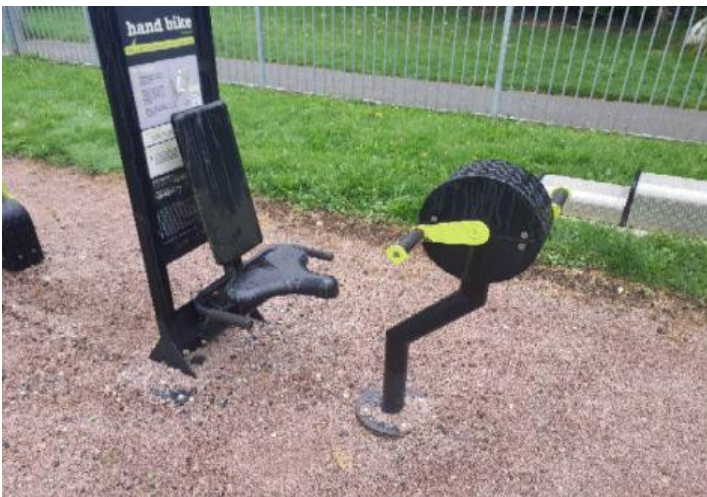
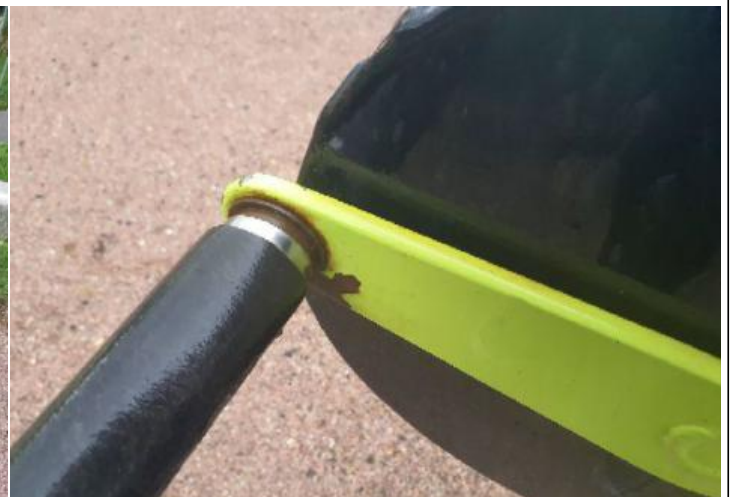
**Item:** Outdoor Fitness Equipment - Hand Bike  
**Manufacturer:** The Great Outdoor Gym Company

**Risk Level:** L - Low Risk  
**Surface:** Crushed Stone

**Finding:** The paintwork on this item has been damaged or worn exposing the metal underneath which is rusting / corroding

**Action:** Treat affected areas and repaint

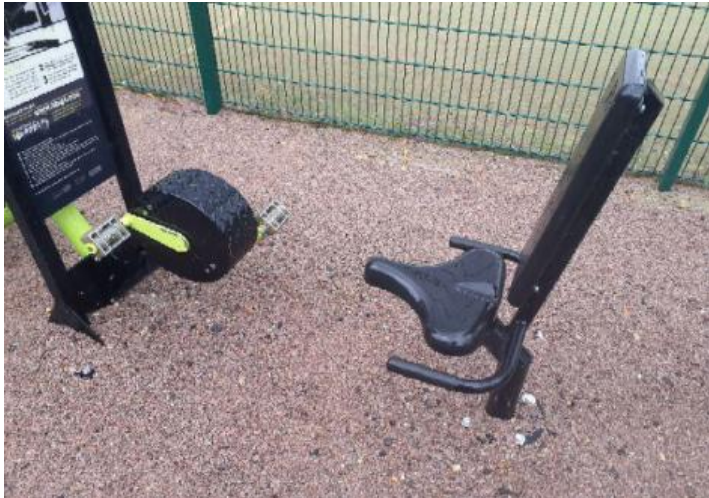
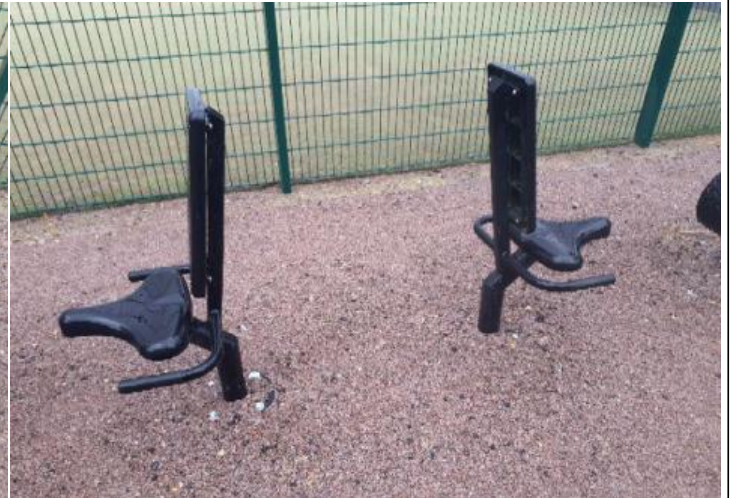
**Item:** Outdoor Fitness Equipment - Cycle  
**Manufacturer:** The Great Outdoor Gym Company

**Risk Level:** L - Low Risk  
**Surface:** Crushed Stone

**Finding:** There are obstacles located within the movement space of the item in contravention of the requirements of BS EN 16630

**Action:** Monitor - No remedial work recommended

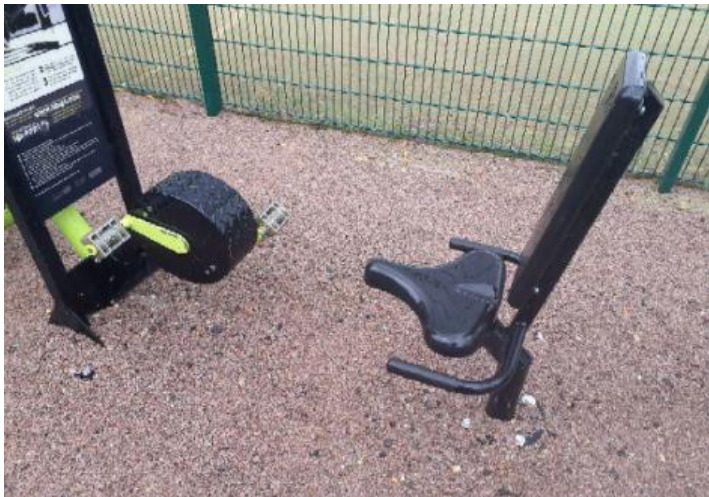
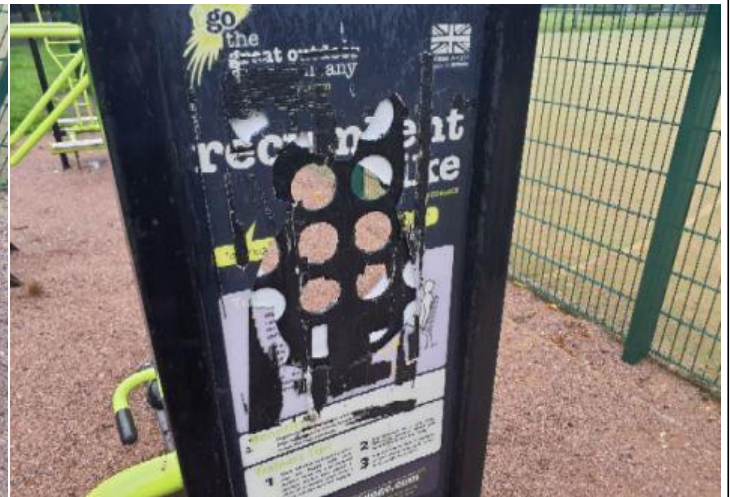
**Item:** Outdoor Fitness Equipment - Cycle  
**Manufacturer:** The Great Outdoor Gym Company

**Risk Level:** L - Low Risk  
**Surface:** Crushed Stone

**Finding:** There is some damage to the sign

**Action:** Replace

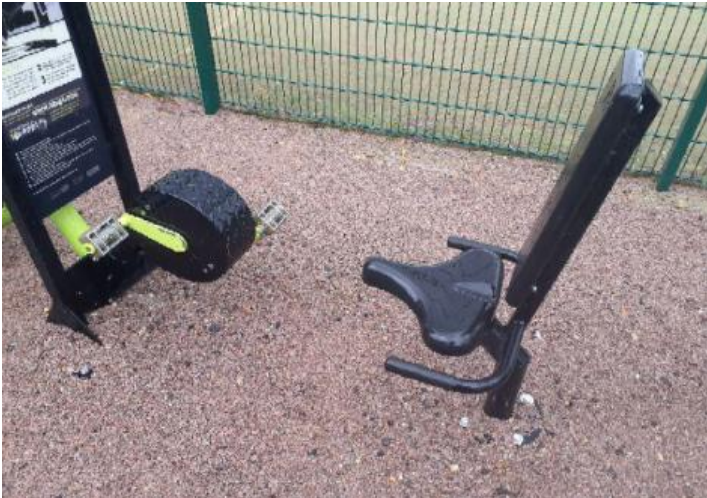
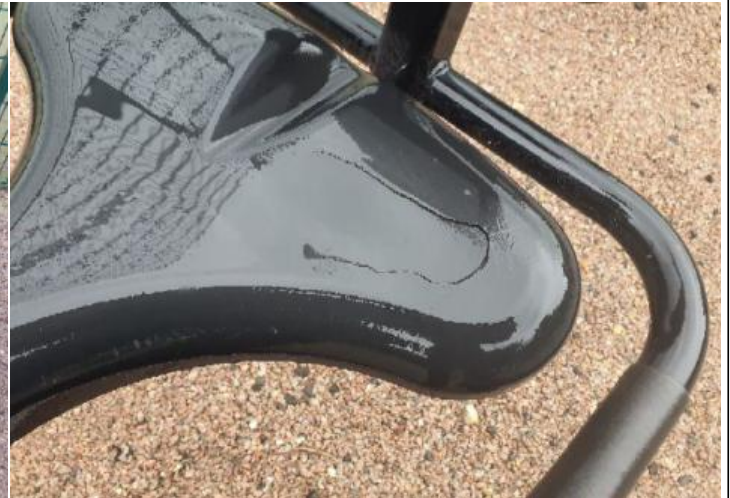
**Item:** Outdoor Fitness Equipment - Cycle  
**Manufacturer:** The Great Outdoor Gym Company

**Risk Level:** L - Low Risk  
**Surface:** Crushed Stone

**Finding:** There is some damage to the item

**Action:** Monitor for any further deterioration and repair as required

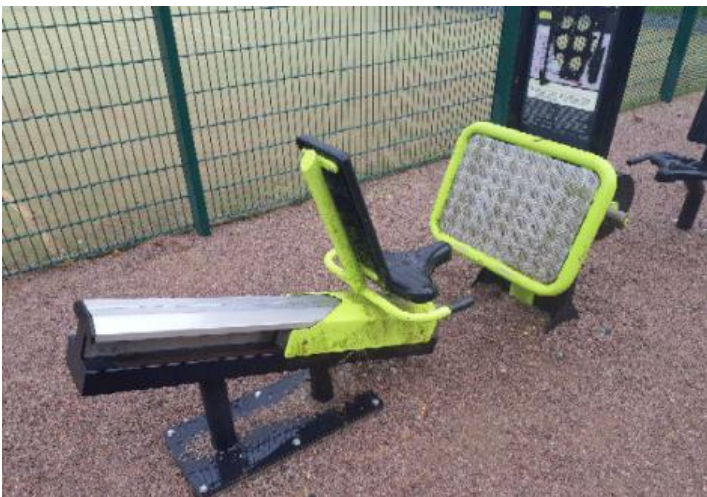
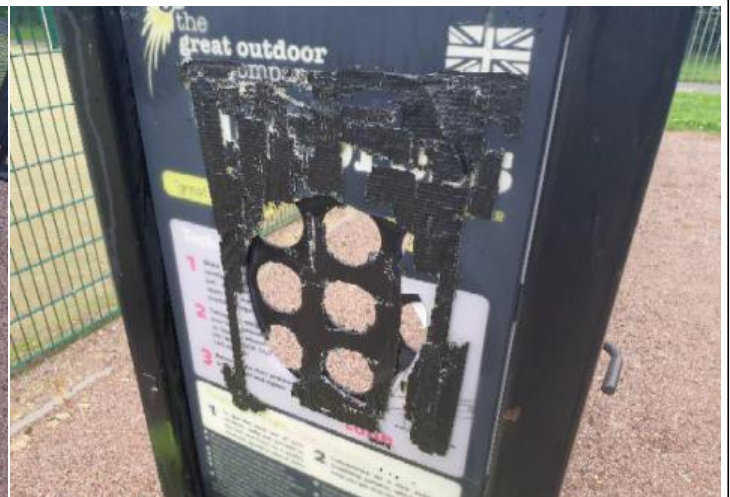
**Item:** Outdoor Fitness Equipment - Leg Press  
**Manufacturer:** The Great Outdoor Gym Company

**Risk Level:** L - Low Risk  
**Surface:** Crushed Stone

**Finding:** There is some damage to the sign

**Action:** Replace

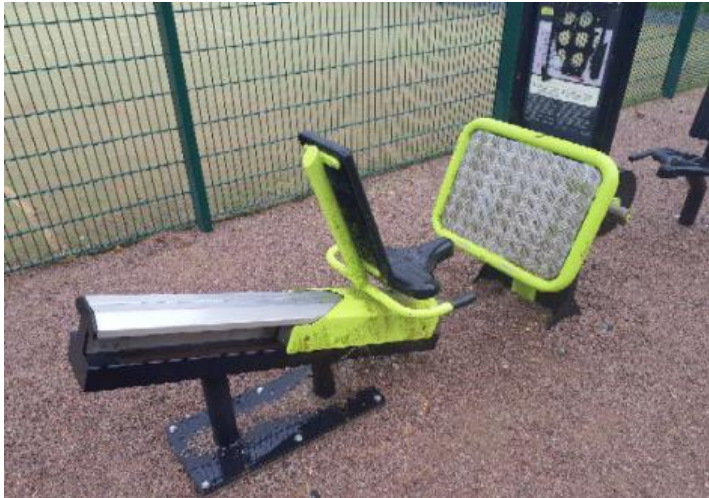
**Item:** Outdoor Fitness Equipment - Leg Press  
**Manufacturer:** The Great Outdoor Gym Company

**Risk Level:** L - Low Risk  
**Surface:** Crushed Stone

**Finding:** There are obstacles located within the movement space of the item in contravention of the requirements of BS EN 16630

**Action:** Monitor - No remedial work recommended

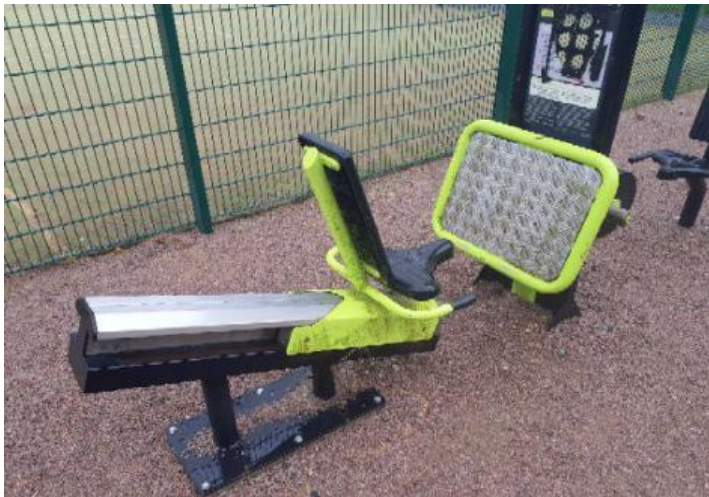
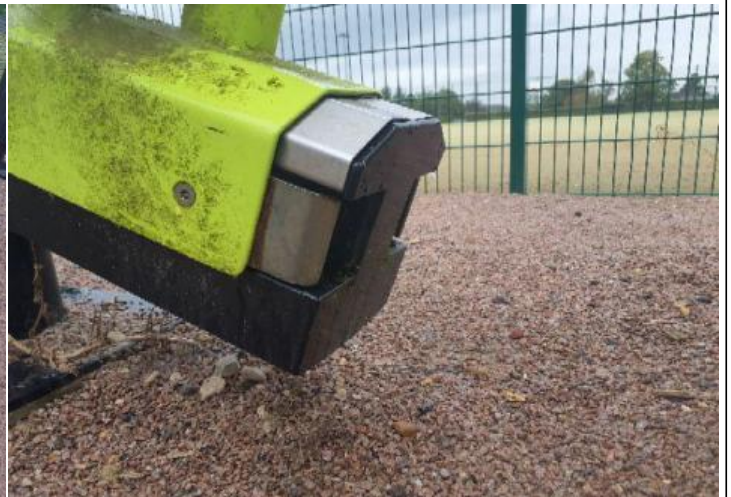
**Item:** Outdoor Fitness Equipment - Leg Press  
**Manufacturer:** The Great Outdoor Gym Company

**Risk Level:** L - Low Risk  
**Surface:** Crushed Stone

**Finding:** The item has missing component(s)

**Action:** Consider replacing missing components

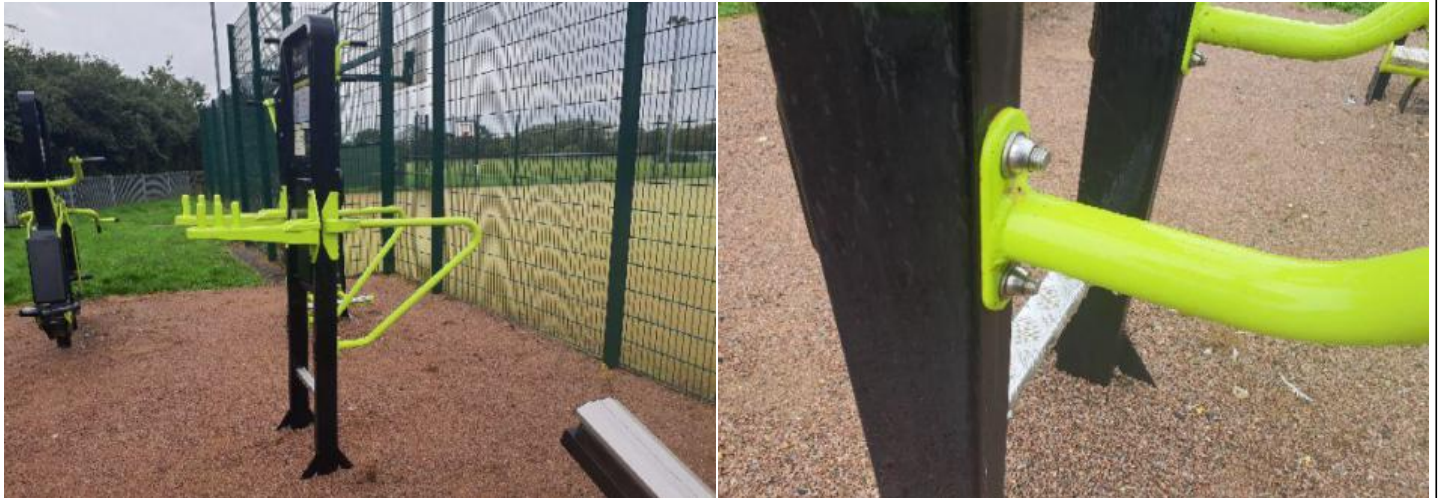
**i** 8 - Low Risk (Finding 1)

**Item:** Outdoor Fitness Equipment - Dip Station  
**Manufacturer:** The Great Outdoor Gym Company  
**Risk Level:** L - Low Risk  
**Surface:** Crushed Stone

**Finding:** There are projecting bolt thread(s) present  
**Action:** Remove excess thread length and deburr or provide cap
